U. S. PUBLIC LAND SURVEY MONUMENT RECORD

SOUTH MEANDER CORNER TO SECTIONS 17 AND 18, TWP. 34 N., R.16E.

South meander corner to Sections 17 and 18, T.34N., R.16E.

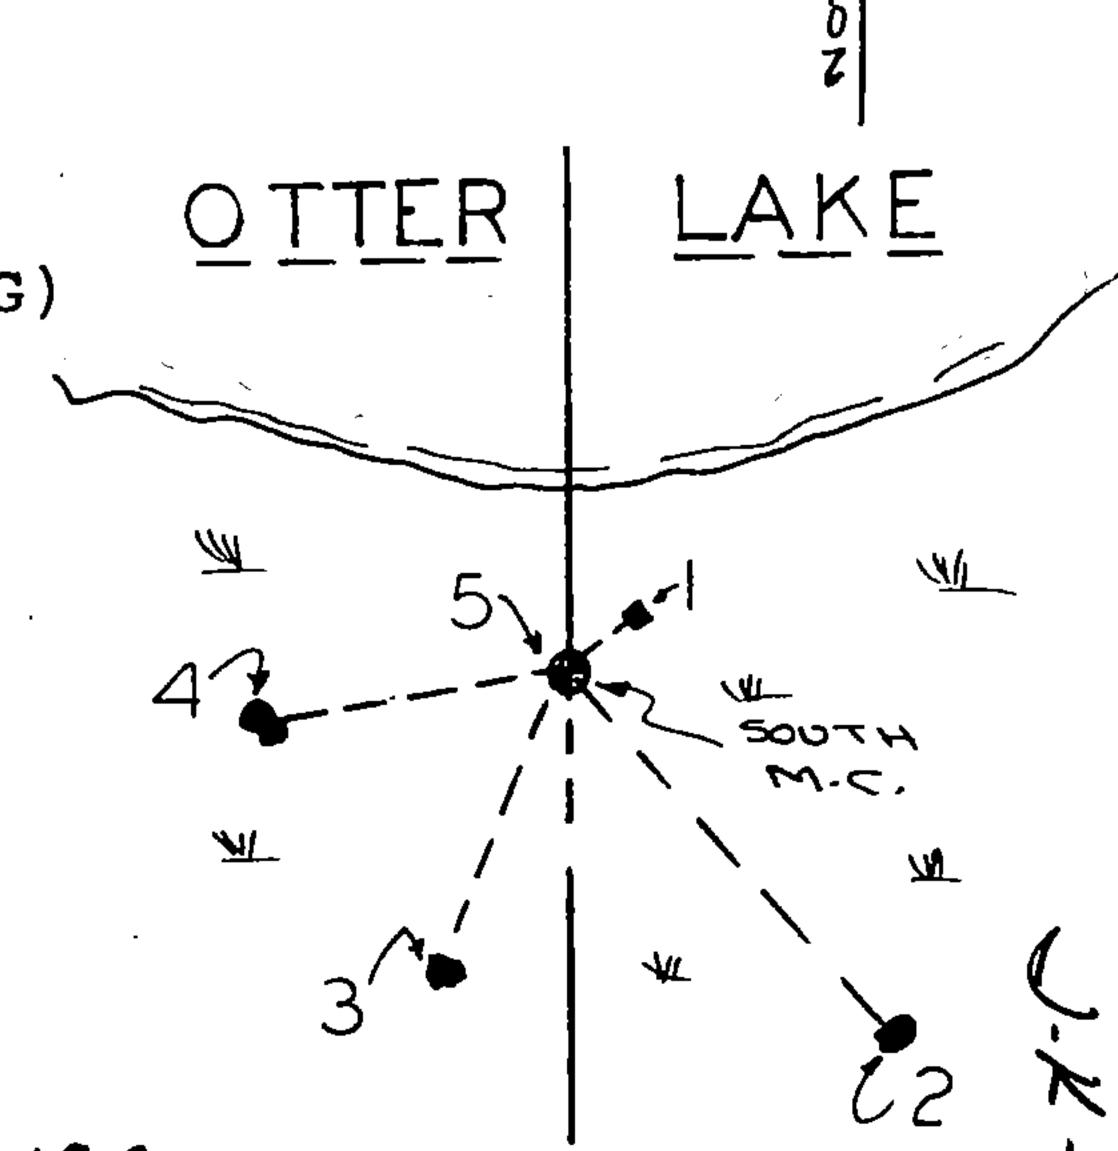
WITNESS

1993 - DOBBRATZ R.L.S? NO. S-973, FOUND MONUMENT, STEEL SIGN POST AND B.Ts EXCEPT B.T. CEDAR 10" N.64°W. 39.65FT. IS DOWN.

- 1. STEEL SIGN POST NE 1.28FT. (EXISTING)
- 2. B.T. CEDAR 8" S.43°E. 48.55FT. (EXISTING)
- 3. B.T. CEDAR 8" S.21°W. 31.35FT. (EXISTING)
- 4. B.T. CEDAR 7" S.80°W. 31.70FT. (NEW)
- 5. 2" DIA. ALUMINUM MONUMENT AT M.C. CORNER (EXISTING)

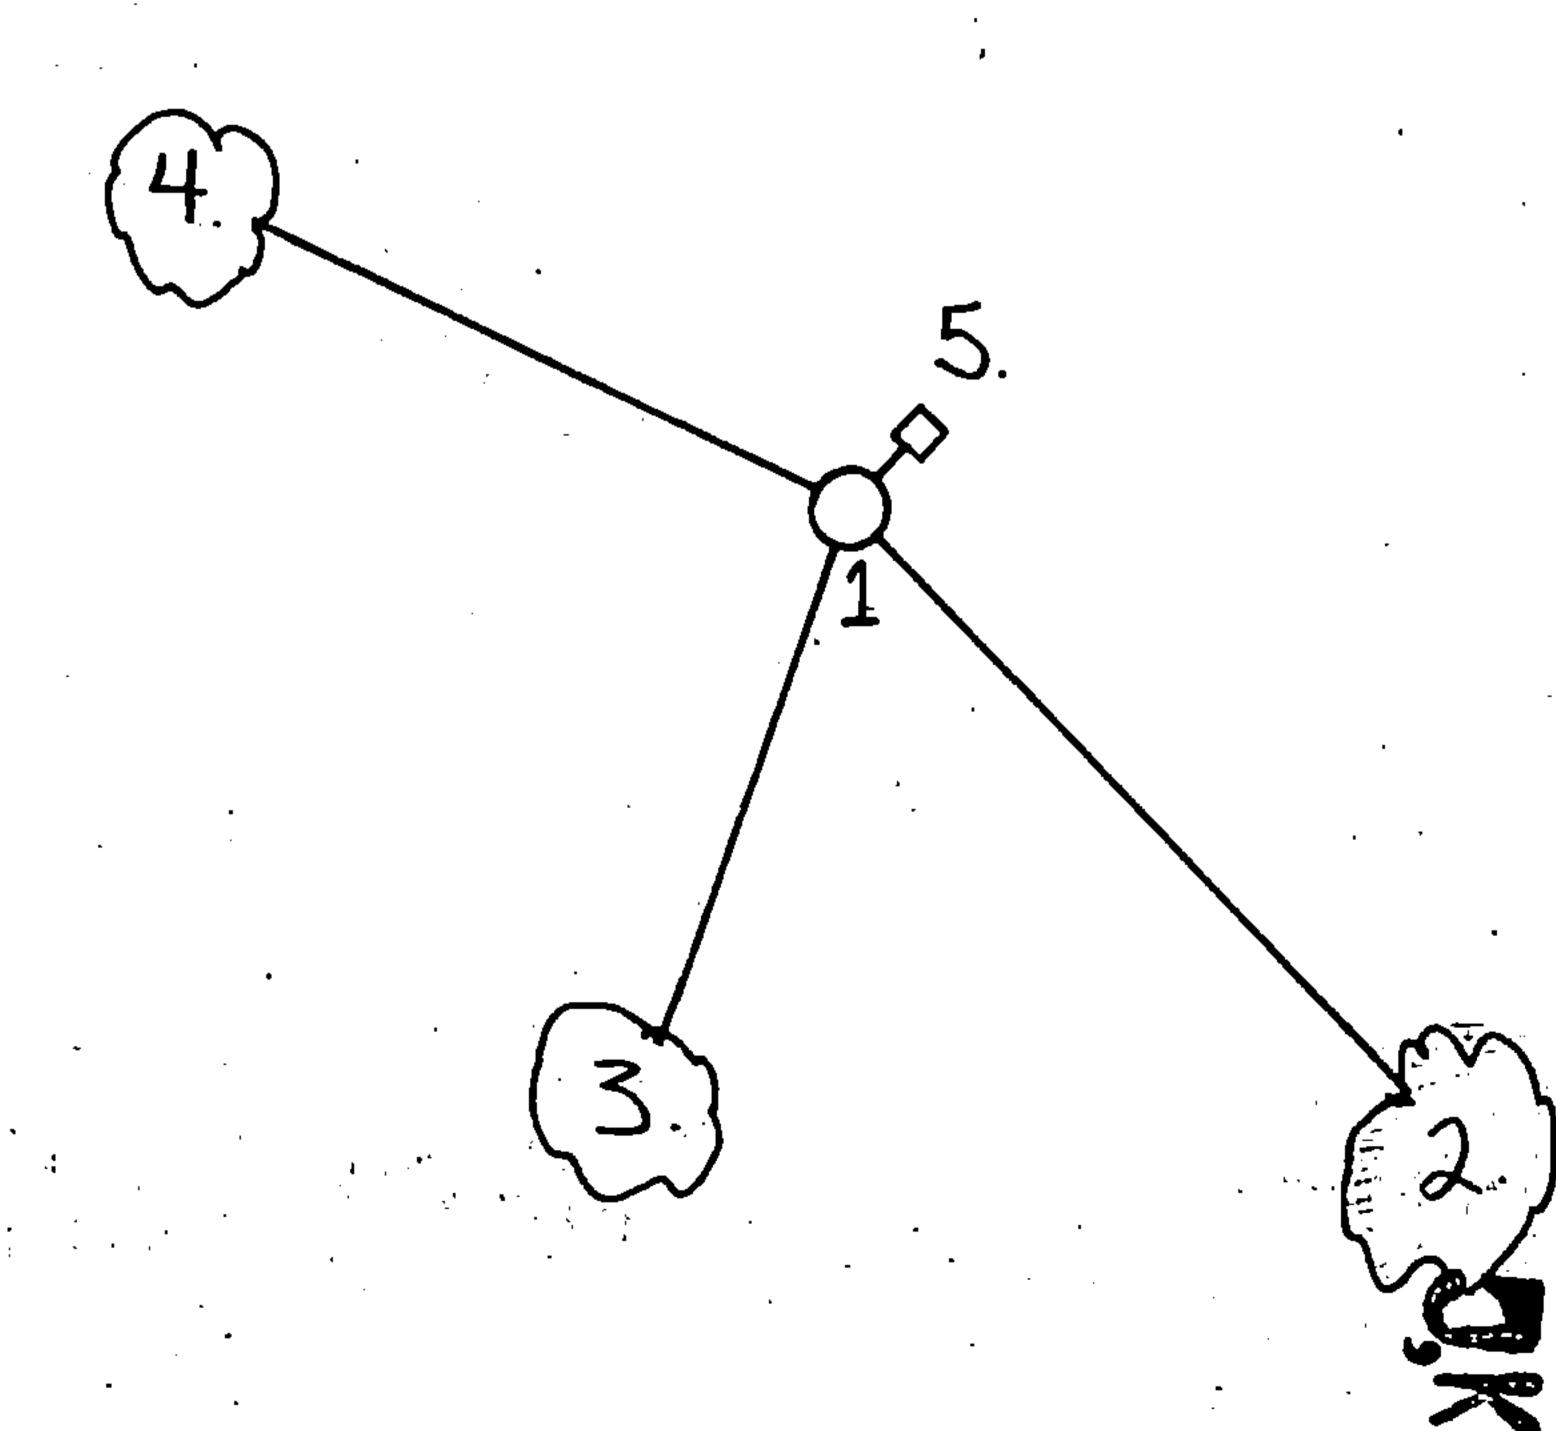
July 23, 1984, Alan Harrison found no evidence of original corner. Distance to north M.C. is very close to original distance. Accepted this as best corner location evidence.

Describe witness monuments.
- (d) Show a plan view drawing depicting the relevant monuments and reference ties which is sufficient in detail to enable accurate relocation of the corner monument if the corner monument is disturbed. Indicate north.
- 1. 2" x 60" aluminum monument stamped to identify the corner.
- 2. Cedar, 6", S.43°E., 48.38'
- 3. Cedar, 6", S.21°W., 31.40'
- 4. Cedar, 10", N.64°W., 39.65'
- 5. Steel Sign Post, Northeast, 1.28'
