CERTIFIED LAND CORNER RESTORATION

U. S. PUBLIC LAND SURVEY MONUMENT RECORD

SOUTHWEST CORNER OF SECTION 34, TWP.34 N., R. 16 E.

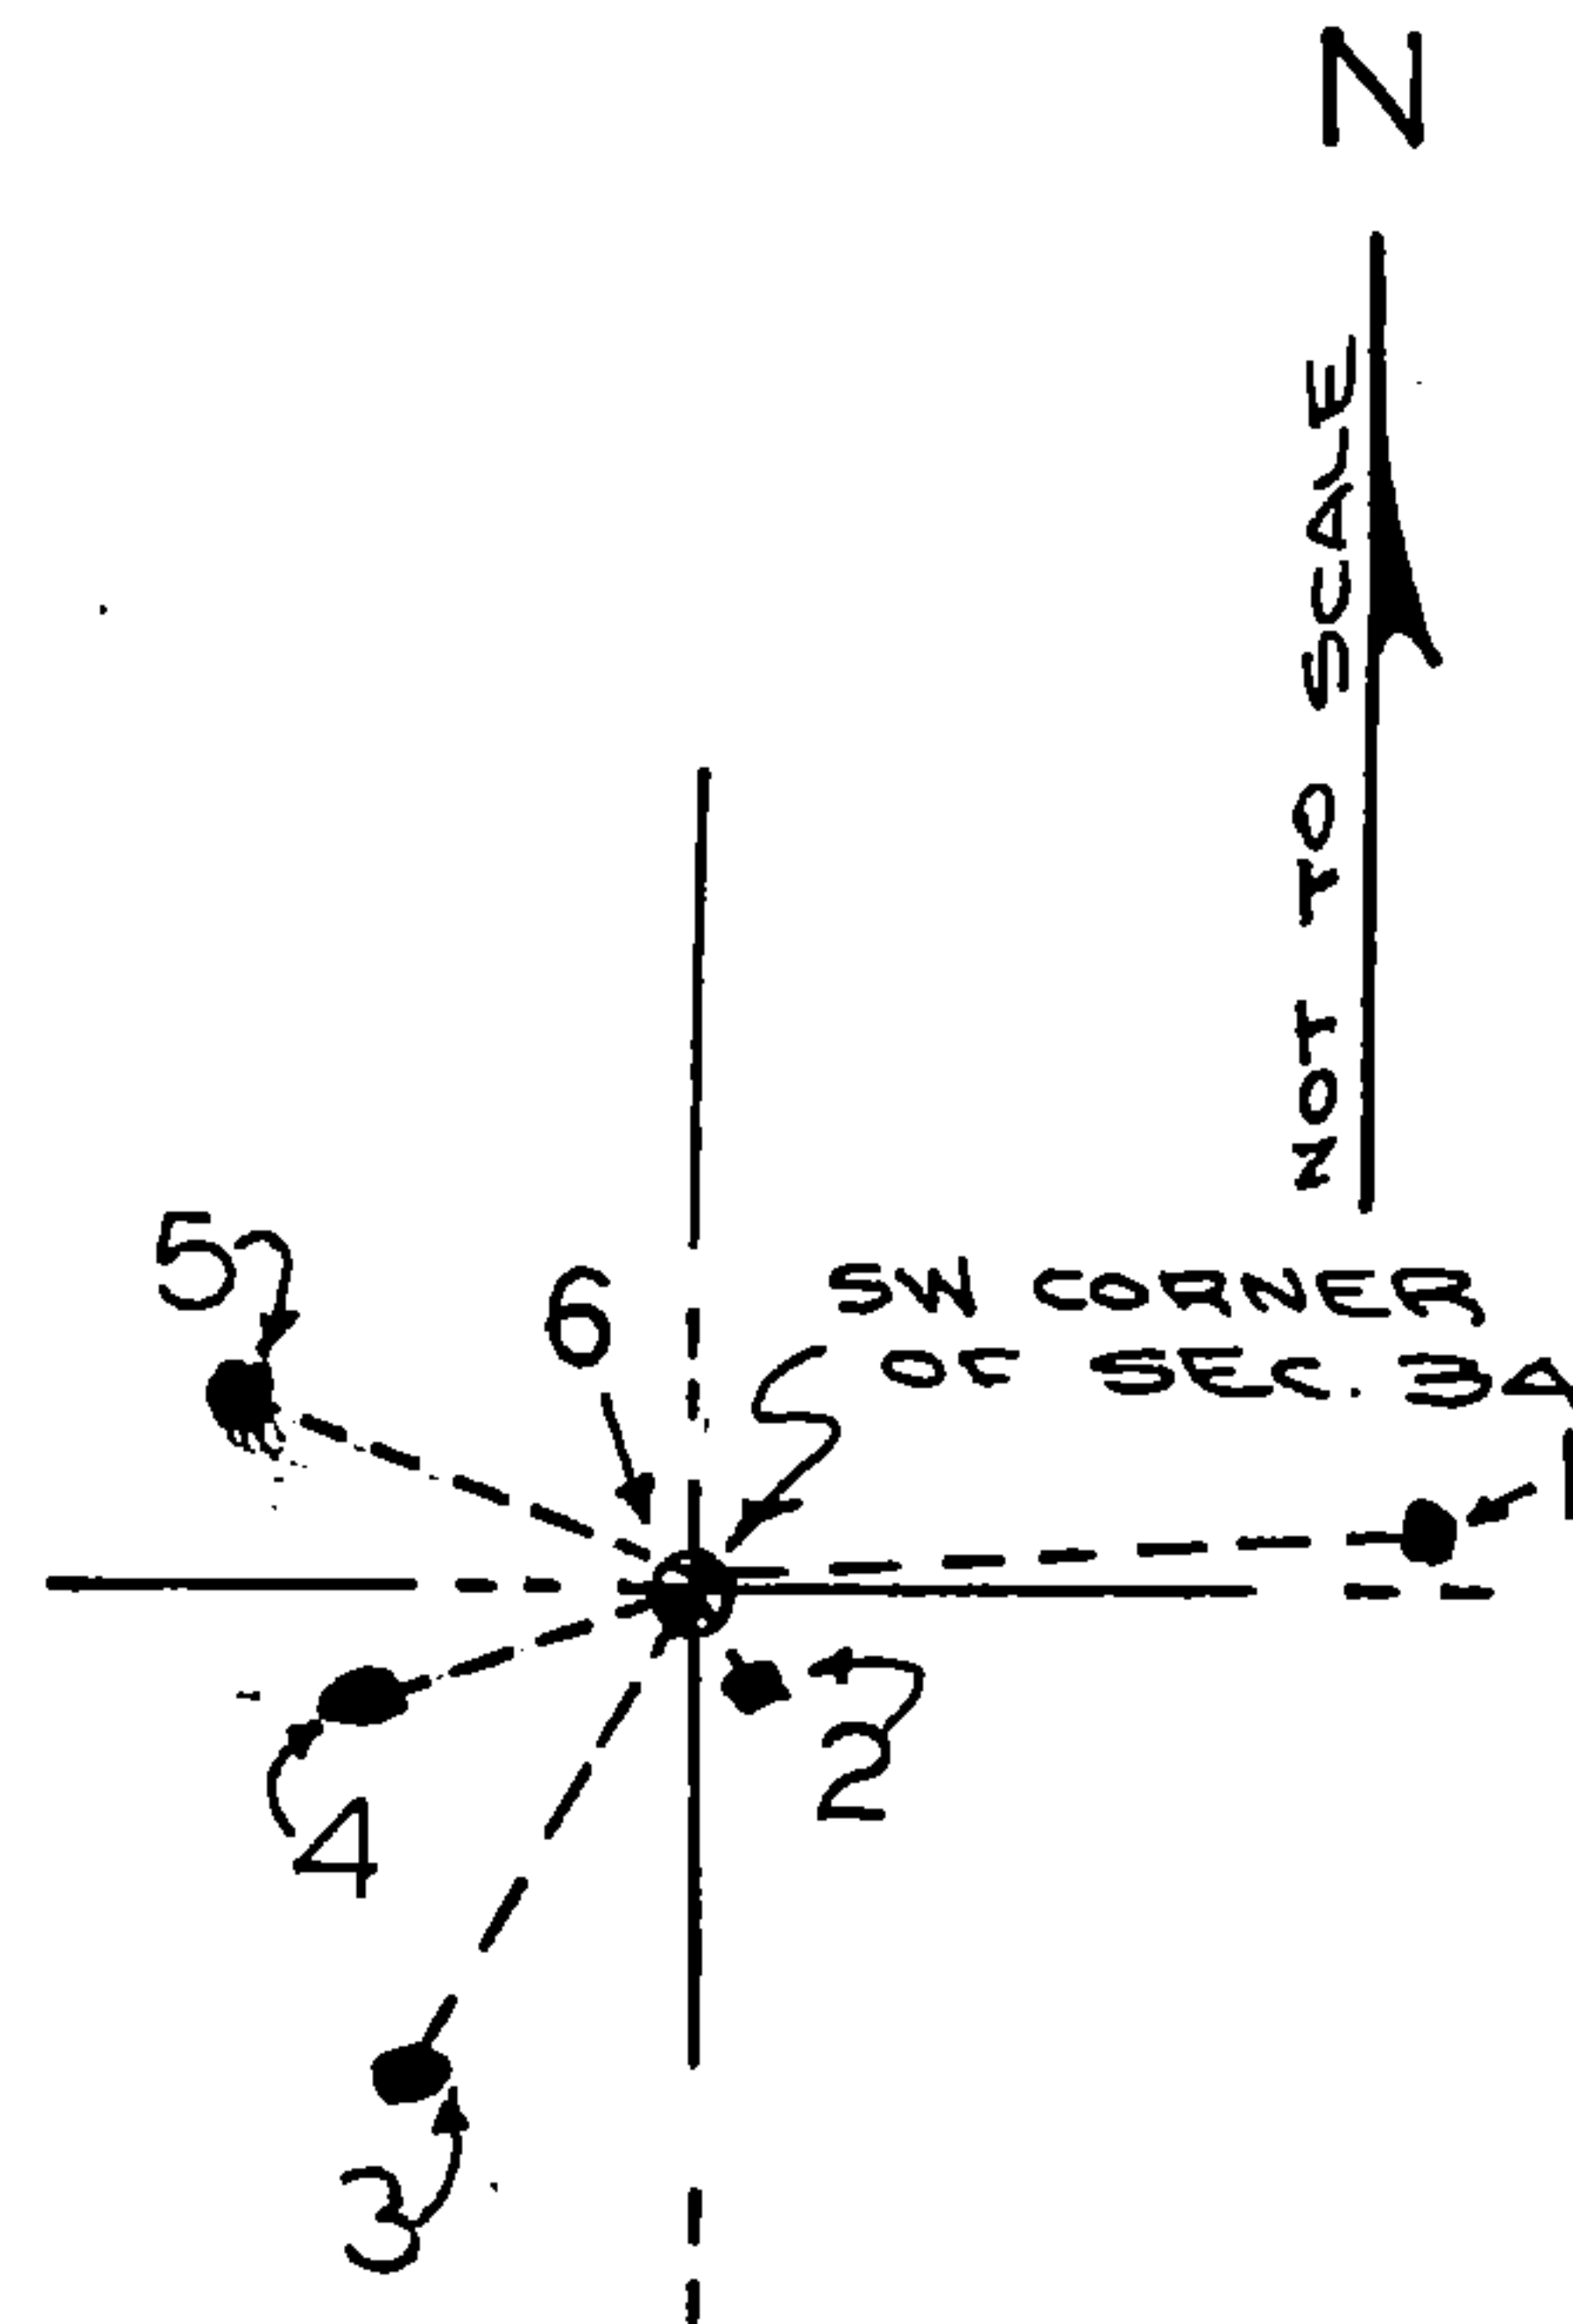
WITNESS

1993 - DOBRATZ, R.L.S. NO. S-973, FOUND MONUMENT, SIGN POST AND 2 OF THE ABOVE B.Ts STILL ALIVE - CEDAR 12" S.71° W. 14.18FT. AND HEMLOCK 8" N.70° W. 22.34FT., OTHERS ARE DEAD OR DOWN.

1. B.T. HEMLOCK 12" N.87° E. 30.80FT. (NEW)
2. STEEL SIGN POST SE 0.50FT. (NEW)
3. B.T. ASH 9" S.32° W. 25.23FT. (NEW)
4. B.T. CEDAR 12" S.71° W. 14.18FT. (EXISTING)
5. B.T. HEMLOCK 8" N.70° W. 22.34FT. (EXISTING)
6. 2" DIA. IRON PIPE WITH BRASS CAP AT SECTION CORNER (EXISTING)
