U. S. PUBLIC LAND SURVEY MONUMENT RECORD

Section Corner to Sections 11, 12,
 13 & 14; T35N, R14E, 4th P.M.

CERTIFIED LAND CORNER RESTORATION

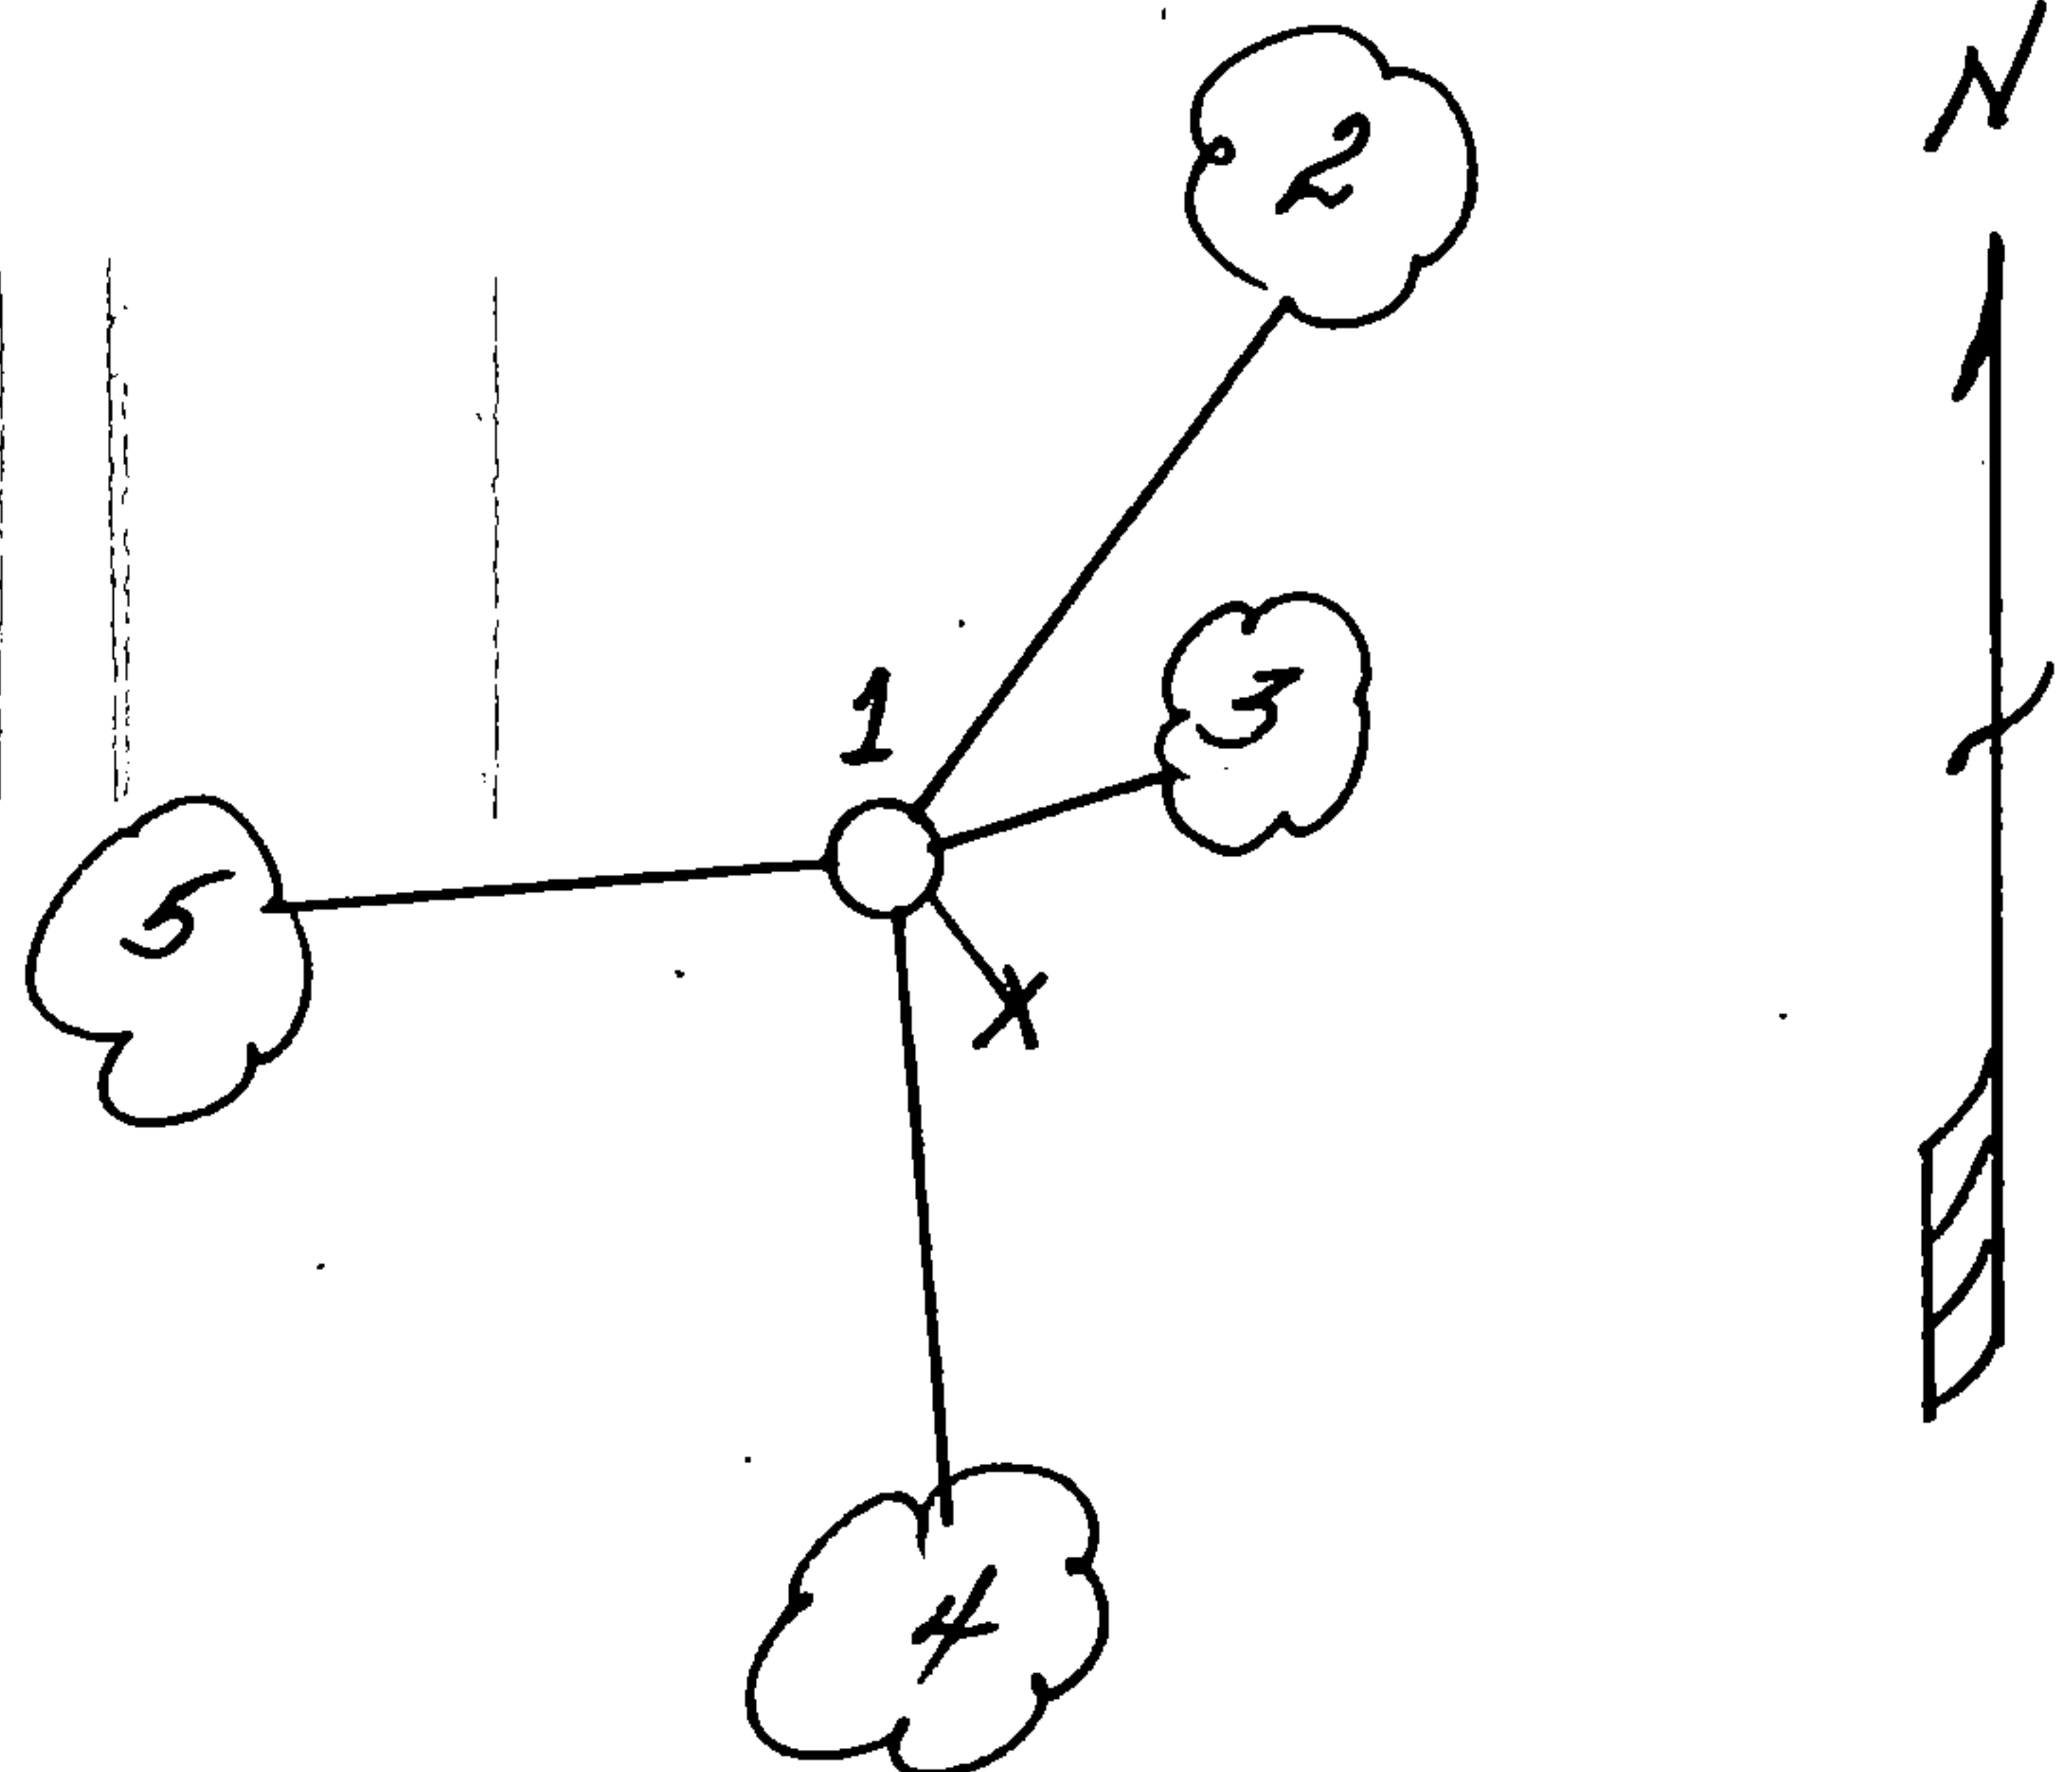
Found 2" iron pipe with brass cap as set by Resvick in 1974. Two BTs okay. Made two new BTs: White Spruce, 8", N31°E, 10.48'
 White Spruce, 6", S85°W, 11.98'

- 1) 2" iron pipe/brass cap
- 2) 8" White Spruce, N31°E, 10.48'
- 3) 4" White Spruce, N75°E, 1.68'
- 4) 9" White Spruce, S06°E, 13.61'
- 5) 6" White Spruce, S85°W, 11.98'
- 6) Steel sign post, SE, 1.0'
