U. S. PUBLIC LAND SURVEY MONUMENT RECORD

Quarter Corner to Sections 6 & 7,
T35N, R15E, 4th P.M.

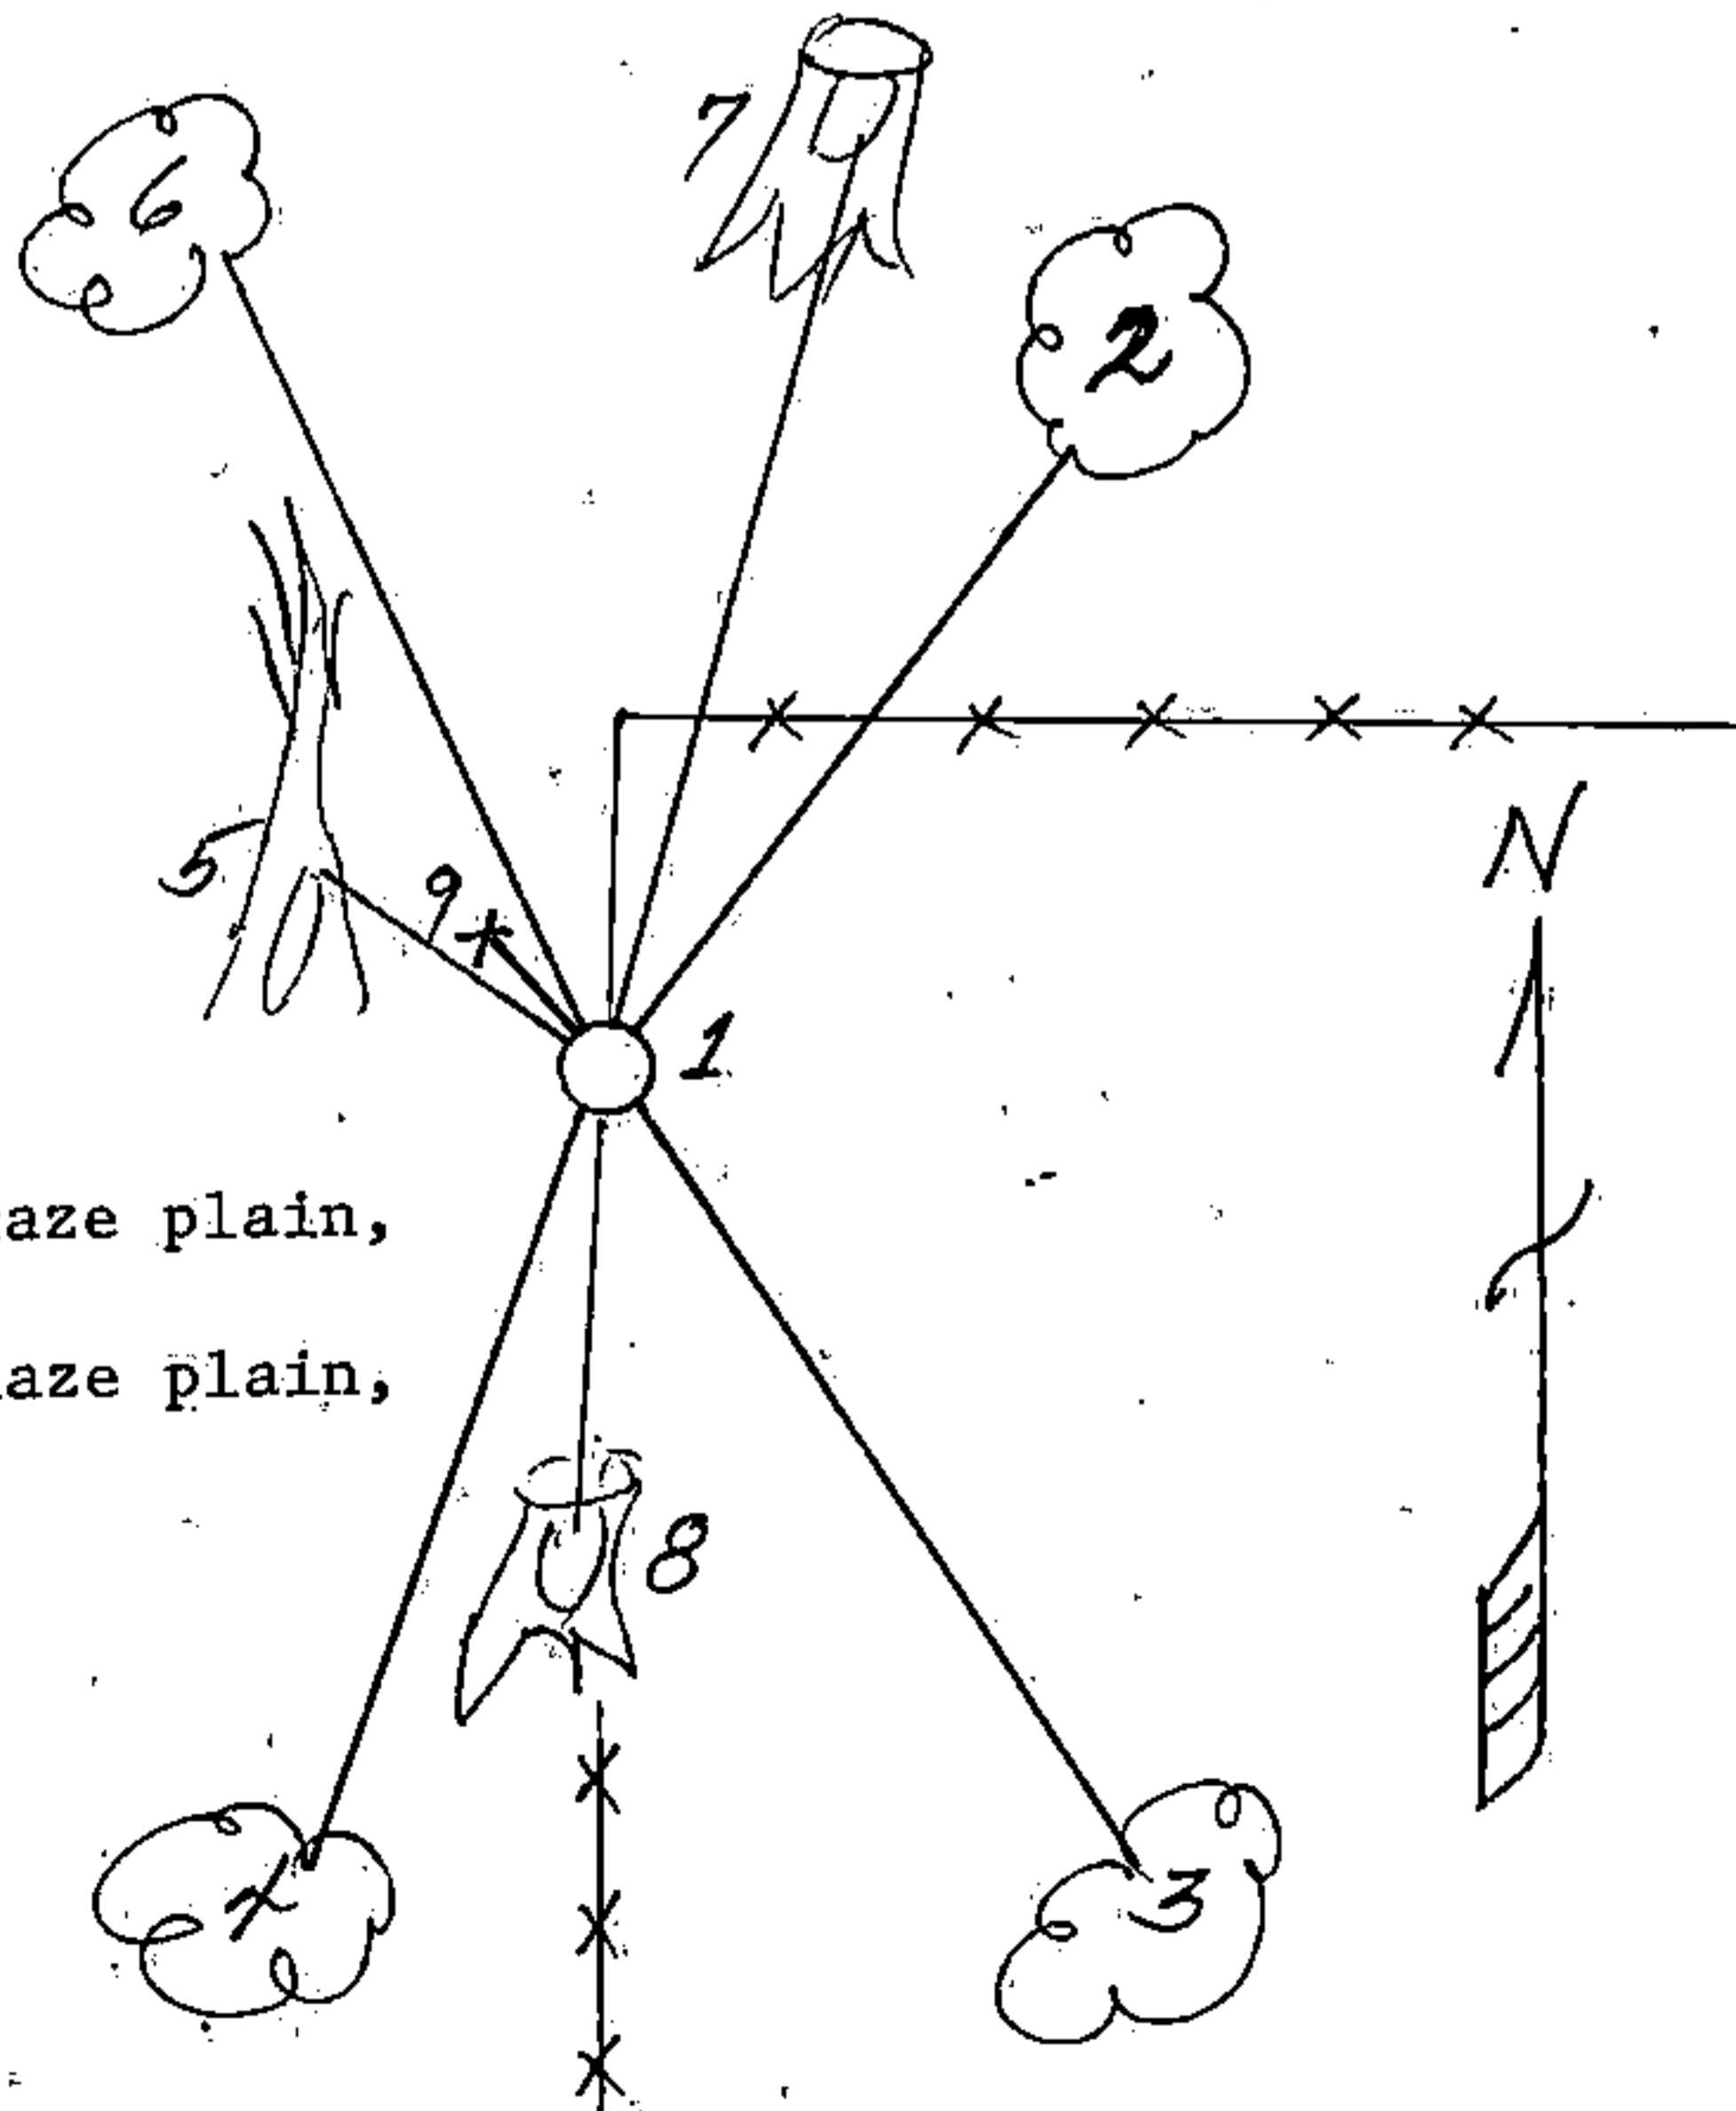
3/21/89 I found the iron pipe/B.C. removed and lying next to the NW BT.

- 1) 2" x 60" Galvanized Iron Pipe with Brass Cap.
- 2) 4" Black Spruce, N33°E, 13.39'
- 3) 4" Black Spruce, S32°E, 21.41'
- 4) 6" Black Spruce, S20°W, 26.46'
- 5) 5" Black Spruce, (Dead), N67°W, 5.62'
- 6) 6" Black Spruce, N24°W, 20.30'
- 7) 16"-18" White Pine stump with "BT" blaze plain, N21°E, 27.1'
- 8) 18"-20" White Pine stump with "BT" blaze plain, S5°W, 9.9'
- 9) Steel Sign Post, NW, 1.70'

6/27/89 I restored the corner by replacing it in the proper location from the original White Pine bearing trees and the Resvick bearing tree.
