CERTIFIED LAND CORNER RESTORATION

Township 35 North, Range 15 East, Section 12, Index No. G-25, Page No.

U. S. PUBLIC LAND SURVEY MONUMENT RECORD

Quarter Corner Common to Sections 7 and 12,
 T.35N., R.15 - 16E., Forest County, Wisconsin.

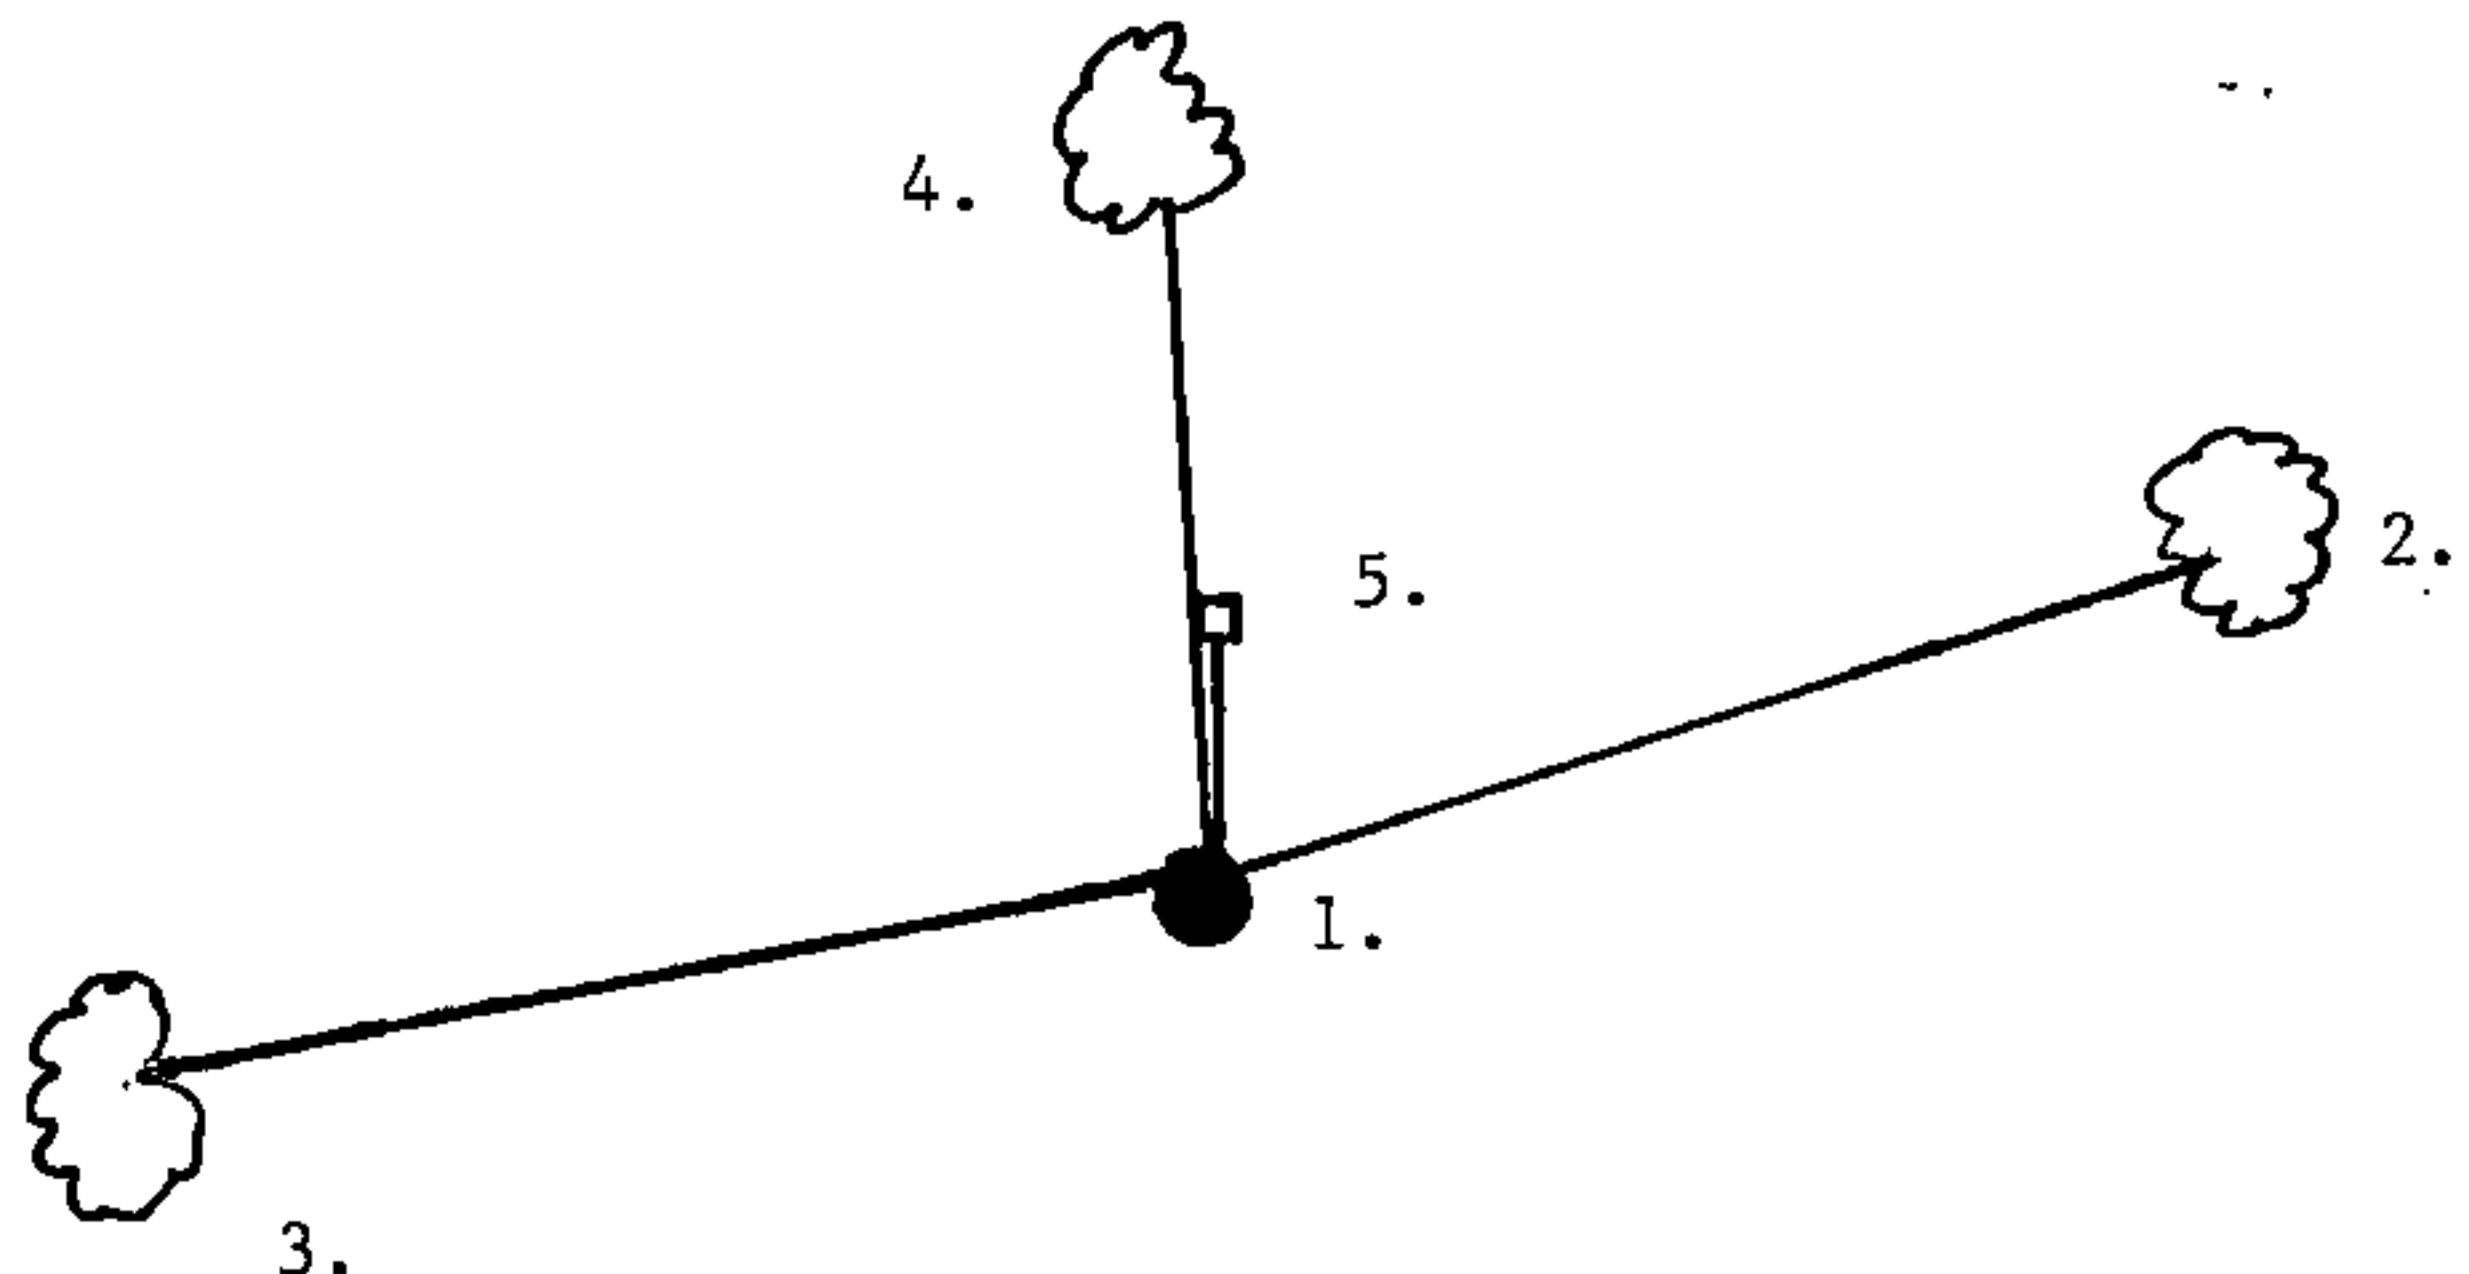
1. 2" X 36" iron pipe with brass cap stamped to identify corner.
2. Cedar, 9", N.61°E., 60.80 feet.
3. Cedar, 8", S.75°W., 44.70 feet.
4. Cedar, 7", N.04°W., 25.35 feet.
5. Steel Sign Post, North, 0.50 feet.
