U. S. PUBLIC LAND SURVEY MONUMENT RECORD.

Section Corner to Sections 19, 20, 29 & 30, T35N, R15E, 4th P.M.

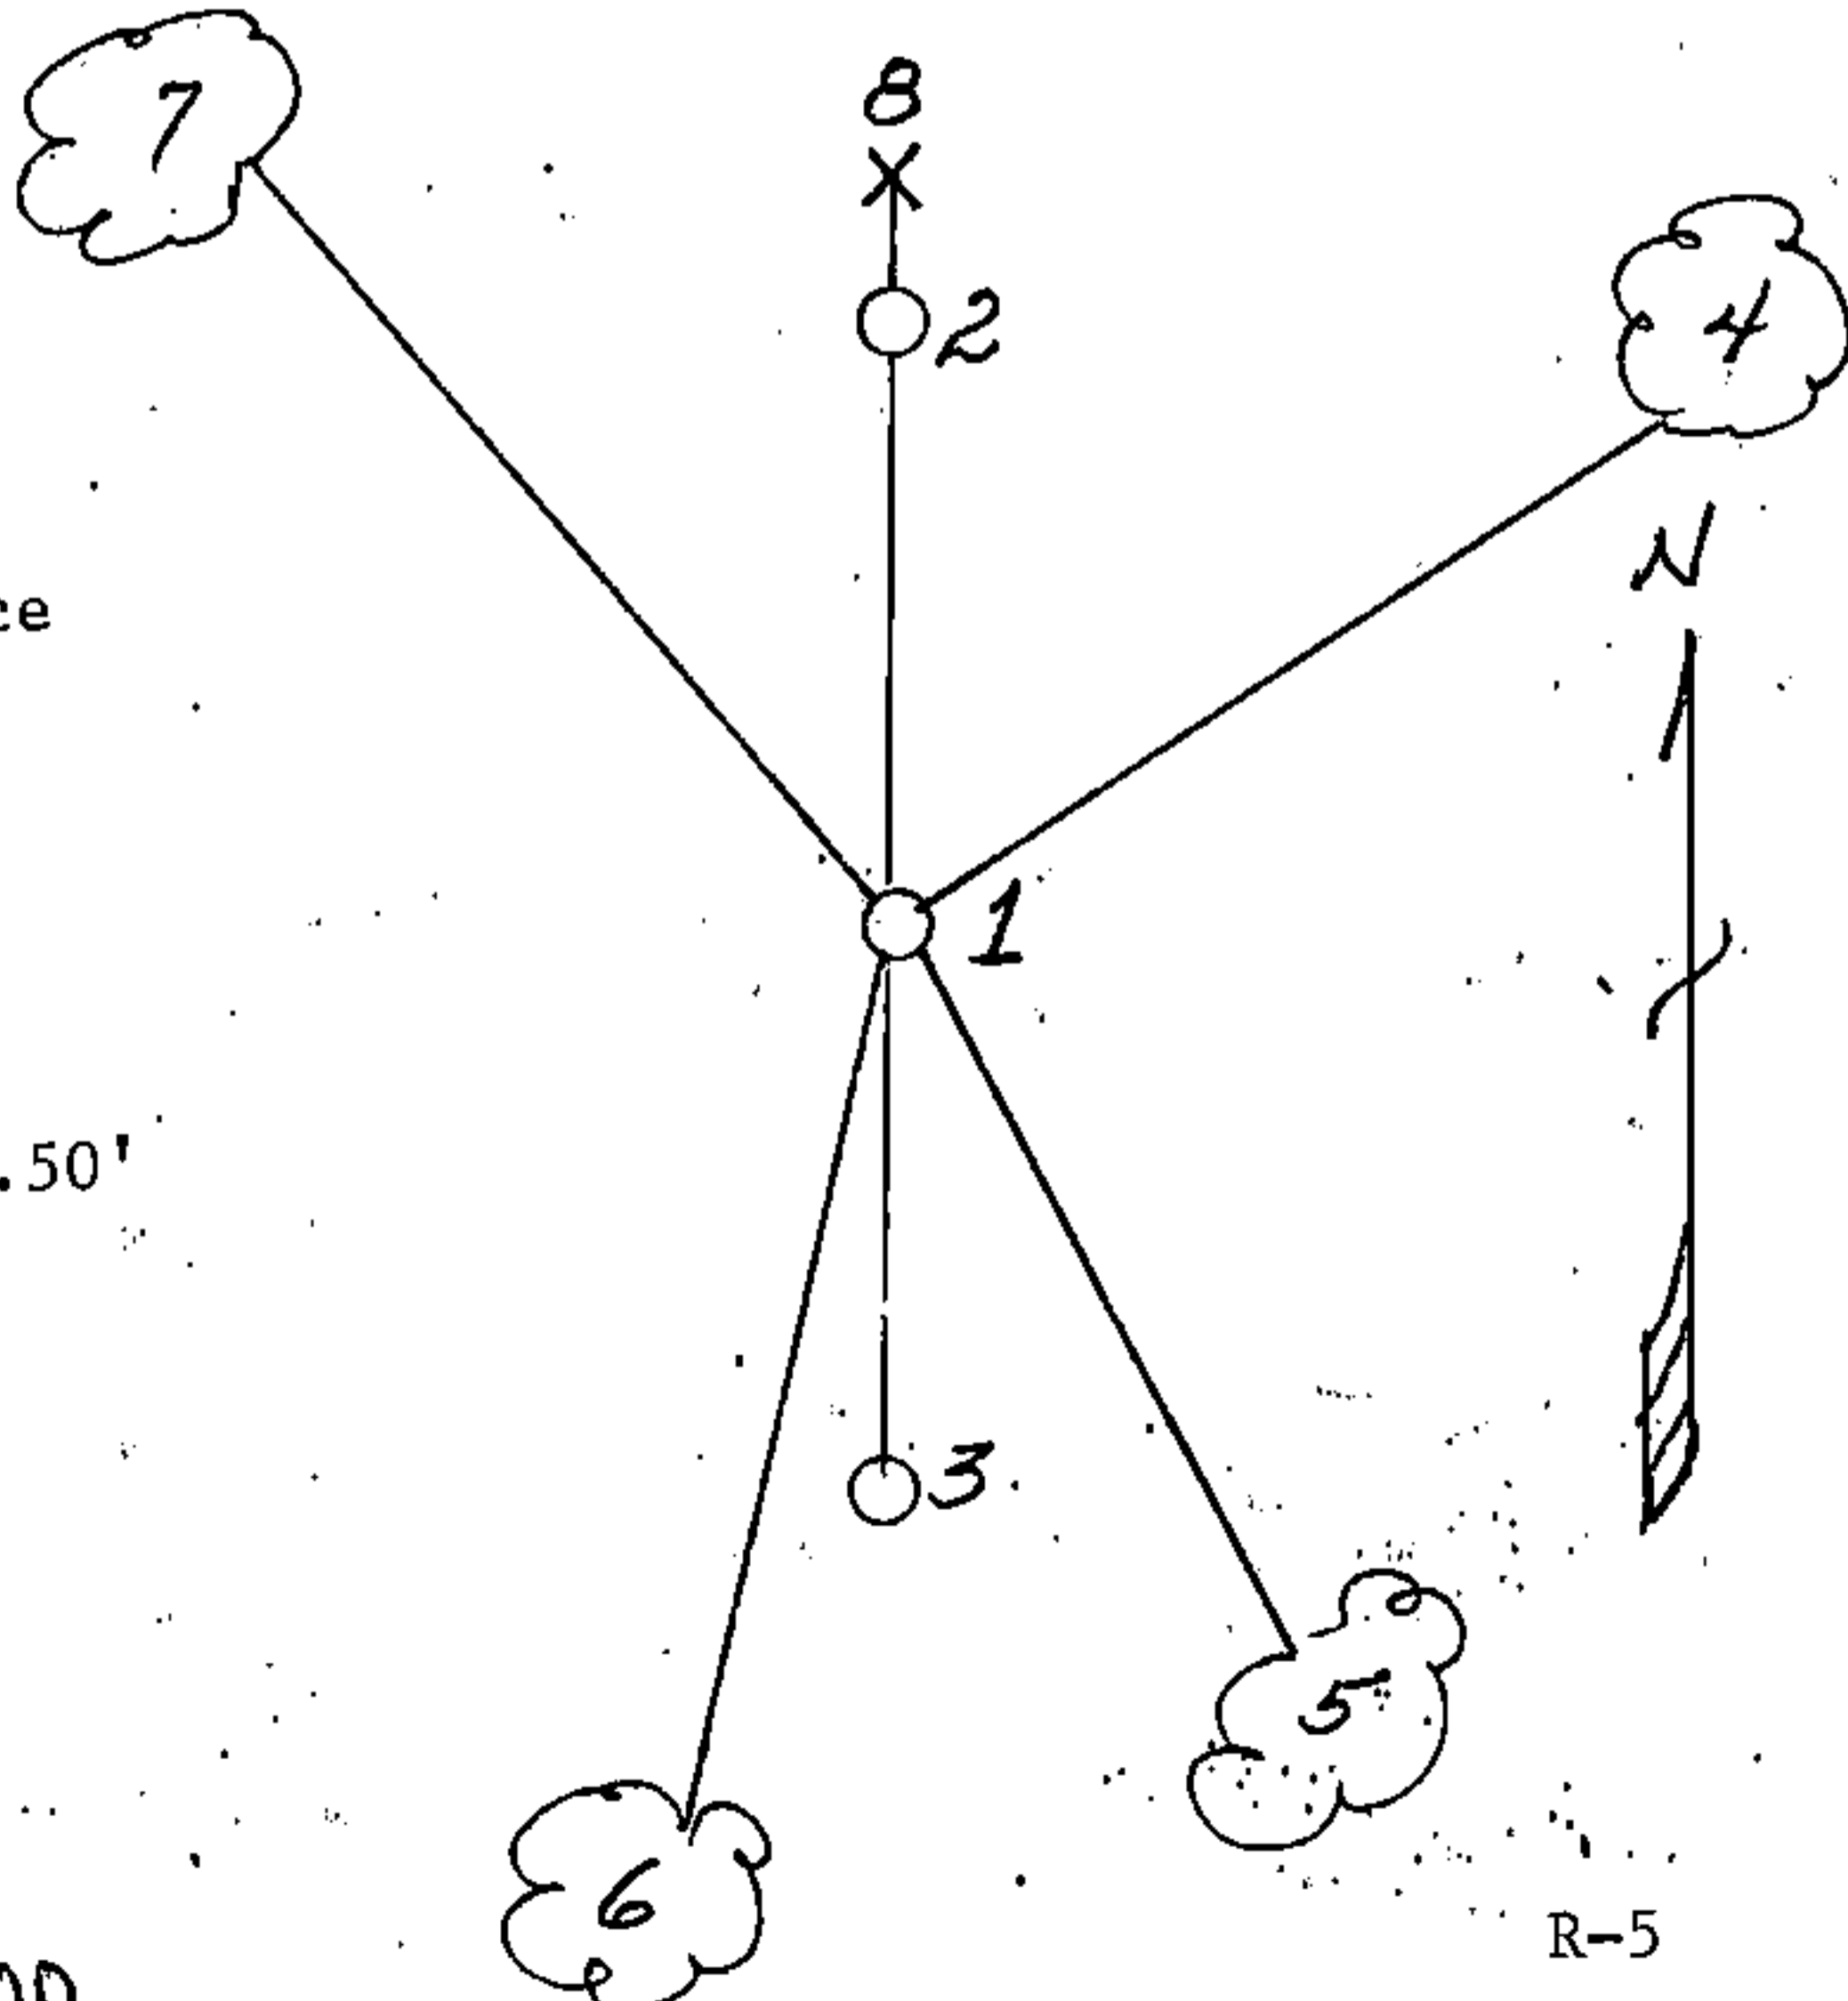
11/19/81 - Milo Stefan and Alan Harrison of the Forest Service found large birch stump at N 1/2°E, 53.9 feet. We restored the corner. As the corner falls in the middle of an old road, we established two reference monuments north and south of true corner position. We also made four new bearing trees to the corner and placed a steel sign post.

6/8/89 - Forest Service crew; Young, Huettle and Downs set a 1 1/4" iron pipe in road for corner.

- 1) 1 1/4" iron pipe in road below surface
- 2) Reference monument #1, north, 32.01'
- 3) Reference monument #2, south, 24.10'
- 4) 7" Sugar Maple, N59°E, 71.44'
- 5) 5" Yellow Birch, S31°E, 22.23'
- 6) 10" Black Ash, S12°W, 52.19'
- 7) 22" Hemlock, N39°W, 45.91'
- 8) Steel sign post, North of R.M. #1, 1.50'
