U. S. PUBLIC LAND SURVEY MONUMENT RECORD

Quarter corner to Sections 31 and 36, T.37N., R.11-12E., Forest and Oneida Counties.

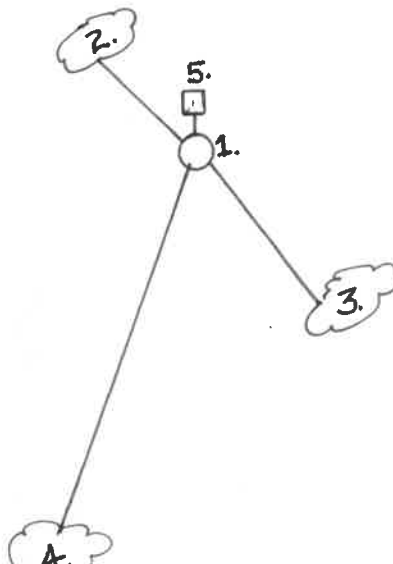
July, 1984, Milo Stefan found notes by H. C. Lawrence, who worked for Consolidated Paper in 1958. Lawrence questioned Main survey. It is suspected that Lawrence moved the Main monument to his surveyed position and made the two BTs we found (Resvick found in 1971). Corner position is nearly where we would place it today by single proportionate measure.

1. 2" galvanized iron pipe with brass tablet stamped to identify the corner.
2. Cedar, 11", N.35°W., 18.15 feet
3. Cedar, 9", S.58°E., 20.98 feet
4. Hemlock, 20", S.20°W., 121.27 feet
5. Steel Sign Post, North, 2.04 feet
