U. S. PUBLIC LAND SURVEY MONUMENT RECORD.

Section Corner Common to Sections 19, 20, 29 and 30, T.37N., R.15E.

CERTIFIED LAND CORNER RESTORATION

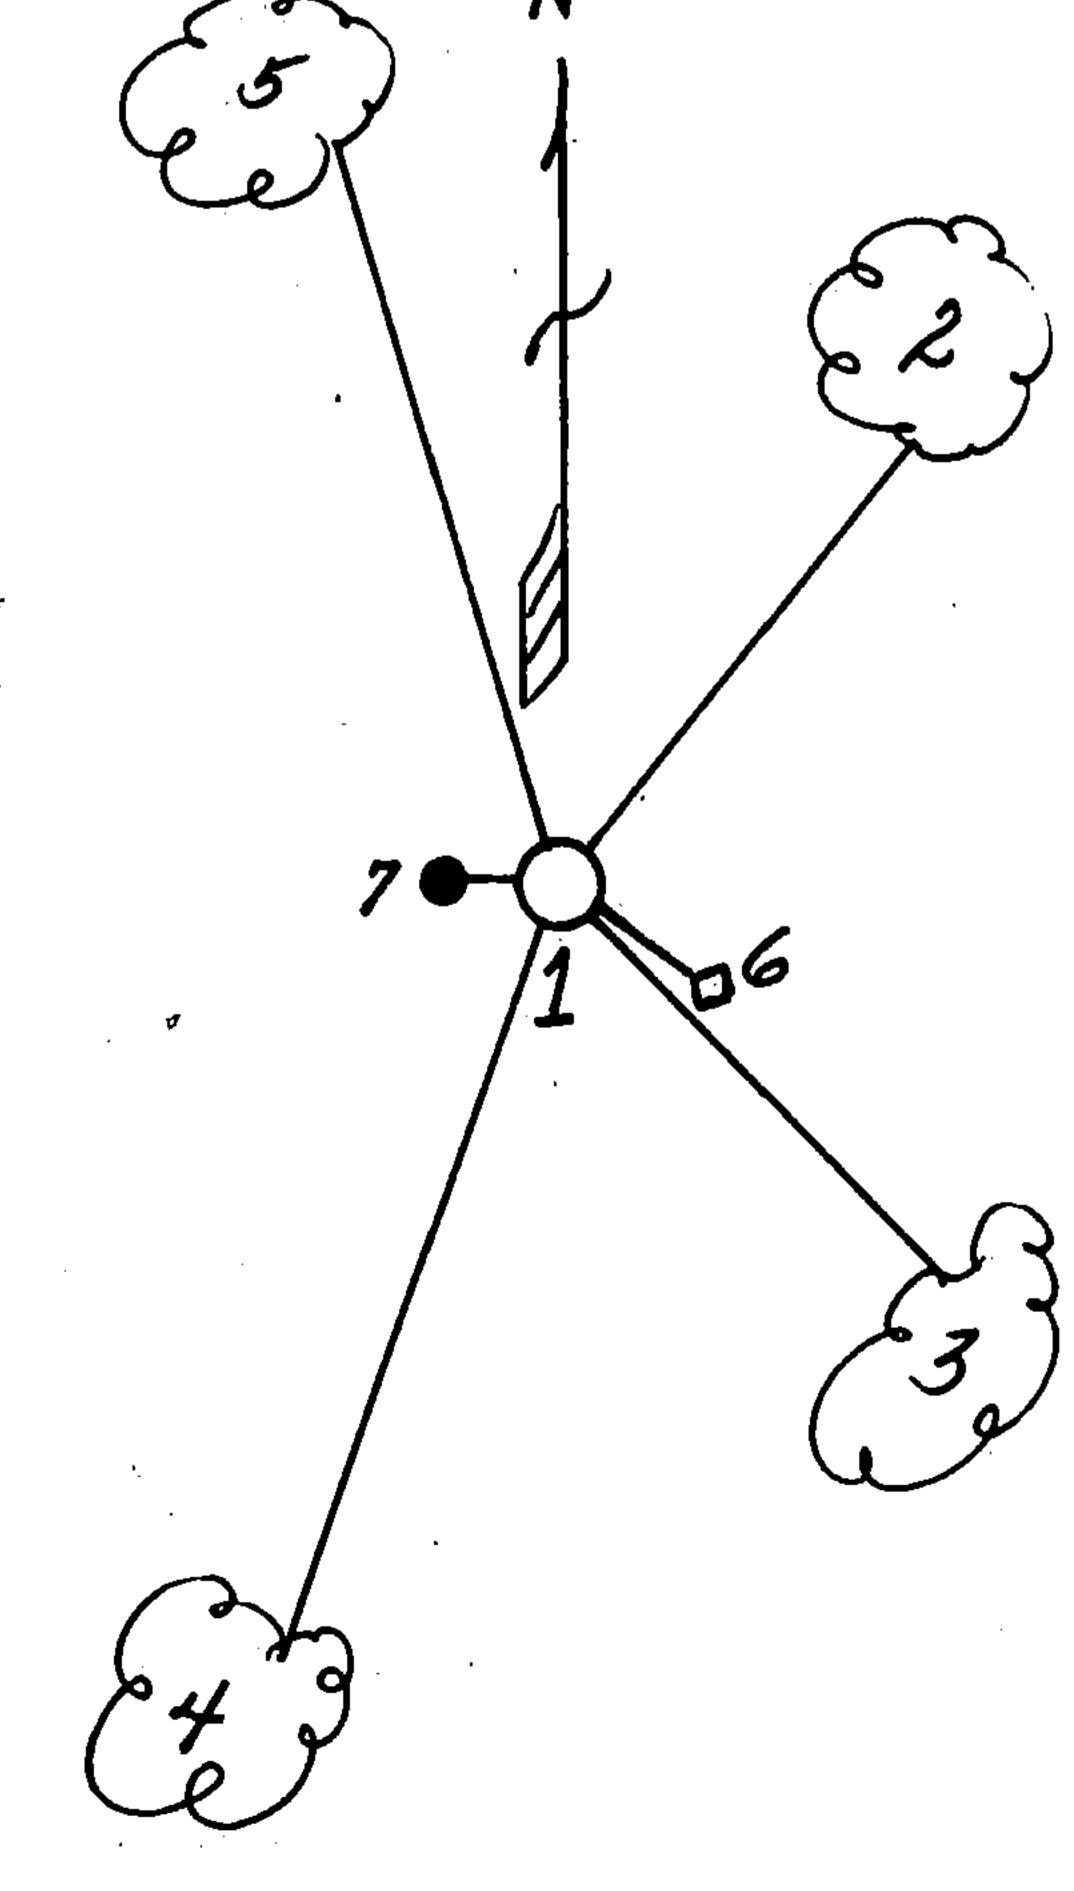
6/14/1988, Milo E. Stefan found monument and 3 BTs in excellent condition. Painted up references and made one new BT: 6" Red Maple, S44°E, 35.16 Feet.

- (d) Show a plan view drawing depicting the relevant monuments and reference ties which is sufficient in detail to enable accurate relocation of the corner monument if the corner monument is disturbed. Indicate north.
 - 1. Brass tablet on 2" galv. iron pipe 36" long.
 - 2. 7" White Birch, N50°E, 29.63 Feet.
 - 3. 6" Red Maple, S44°E, 35.16 Feet.
 - 4. 16" White Pine, S19°W, 118.91 Feet.
 - 5. 8" White Spruce, N29°W, 50.46 Feet.
 - 6. 6" x 6" Cedar sign post, SE, 2.0 Feet
 - 7. Steel sign post, West, .5 Feet.
