U. S. PUBLIC LAND SURVEY MONUMENT RECORD

West Meander Corner #2 common to Sections 6 and 7, T.34N., R.14E., Forest County, Wisconsin.

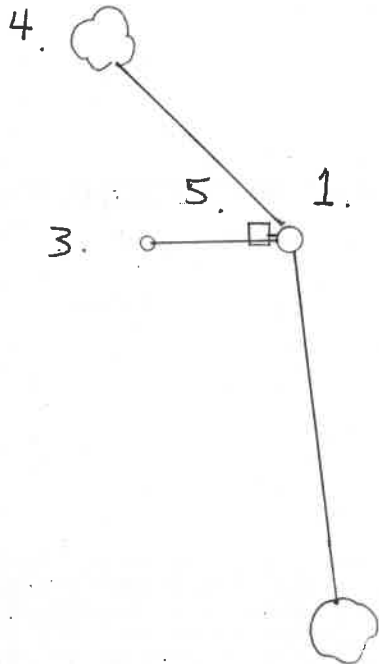
In 1988, A. Harrison found monument tipped over and Y. Birch B.T. now a dead stub. Reset monument from Crawford's B.T.'s and added references.

1. 6" concrete monument with brass cap.
2. Sugar, 8", S.05°E., 50.14 feet.
3. Iron Pipe, 1 1/2", S.85°W., 14.57 feet.
4. R. Oak, 18", N.46°W., 34.30 feet.
5. Steel sign post, West, 1.88 feet.
