## U. S. PUBLIC LAND SURVEY MONUMENT RECORD

Section Corner to Sections 5, 6, 7 & 8,  
T35N, R15E, 4th P.M.

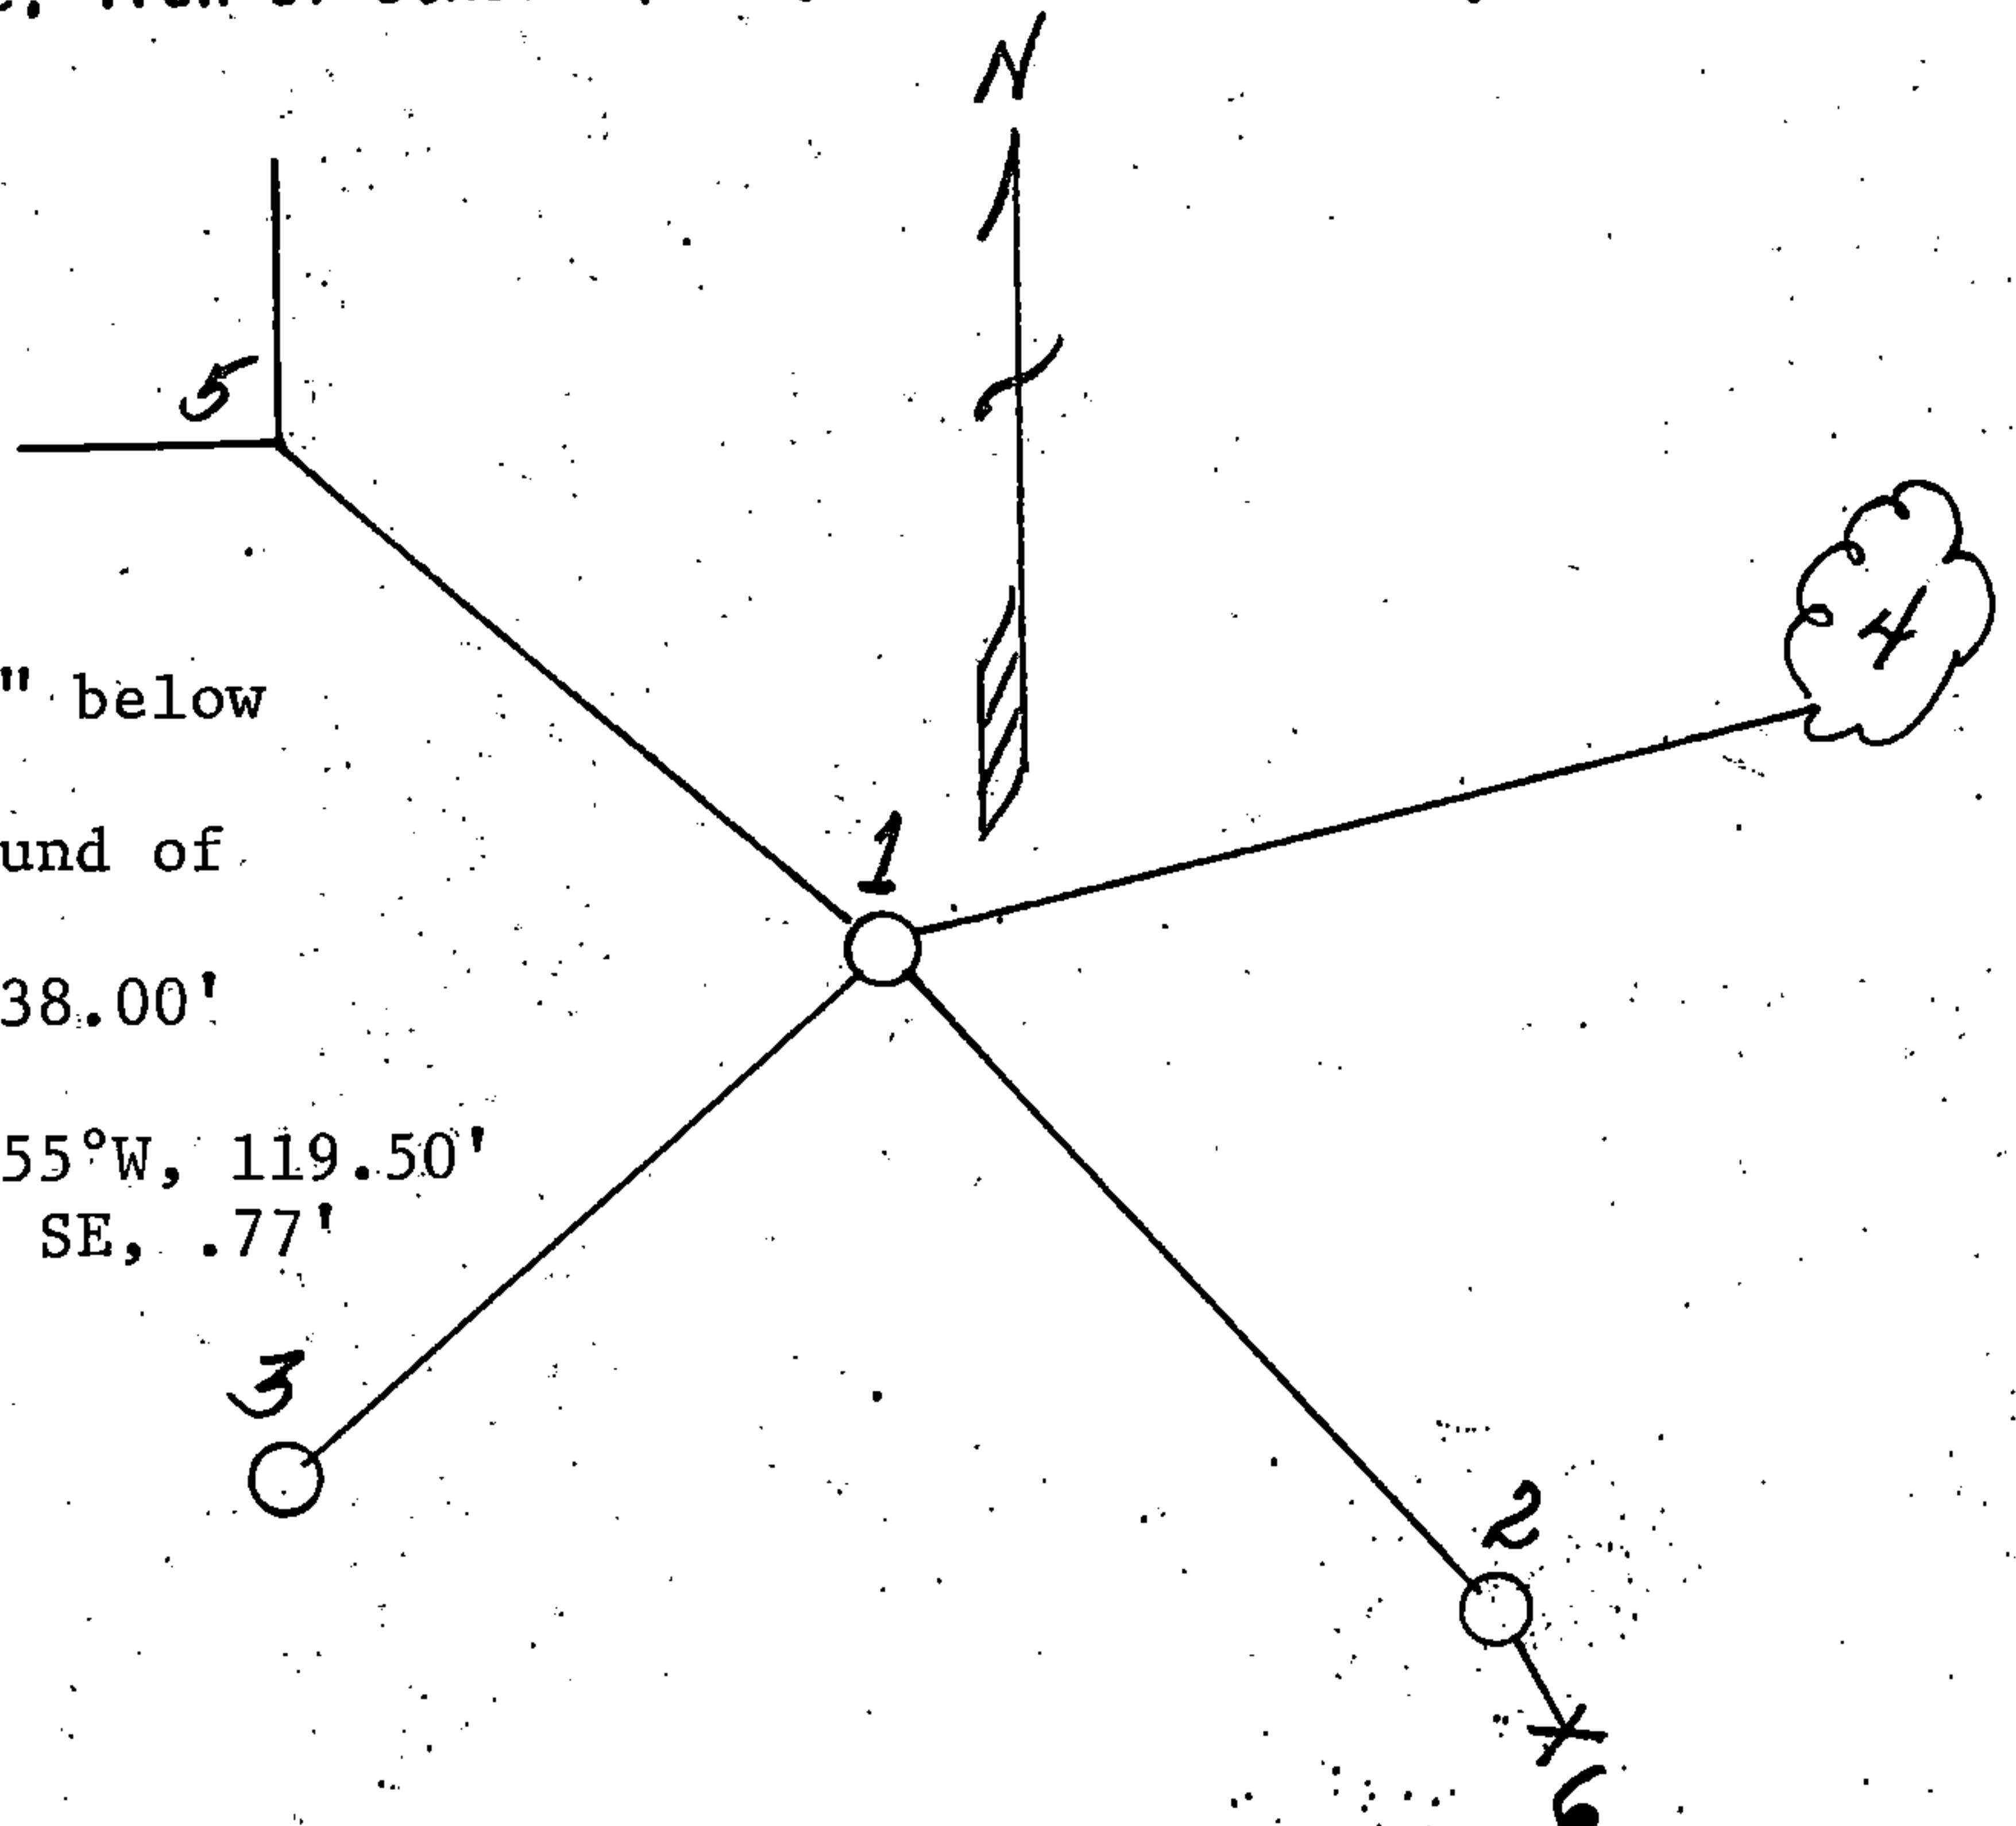
An iron pipe 1" x 24" marks the accepted Section Corner position. It lies at the intersection of roads, in all four directions. This iron pipe was witnessed by two Forest Service references in 1965 when Jean Resvick worked Section 6. This same pipe was used by Thomas Arnott and John Fisher when Section 5 was subdivided in 1982.

6/28/89 I replaced the 1" x 24" iron pipe with a 2 1/2" x 36" aluminum monument. As Resvick's W.C. to the southeast was badly damaged, we also replaced it with a 1" x 36" drive type aluminum monument. We stamped both tablets, placed steel sign post at the W.C. and made two additional references.

- 1) 2 1/2" x 36" aluminum monument 2" below road surface.
- 2) 1" x 36" aluminum monument in mound of stone, SE, 49.90'
- 3) 6" x 60" concrete monument, SW, 38.00'
- 4) 18" White Spruce, N83°E, 127.00'
- 5) SE corner of cabin foundation, N55°W, 119.50'
- 6) Steel sign post, SE of RM to the SE, .77'
