CERTIFIED LAND CORNER RESTORATION

Township 35 North, Range 16 East Section 24 Index No. P-25, Page No.

U. S. PUBLIC LAND SURVEY MONUMENT RECORD

Quarter Corner to Sections 19 and 24, T35N, R16 and 17E.

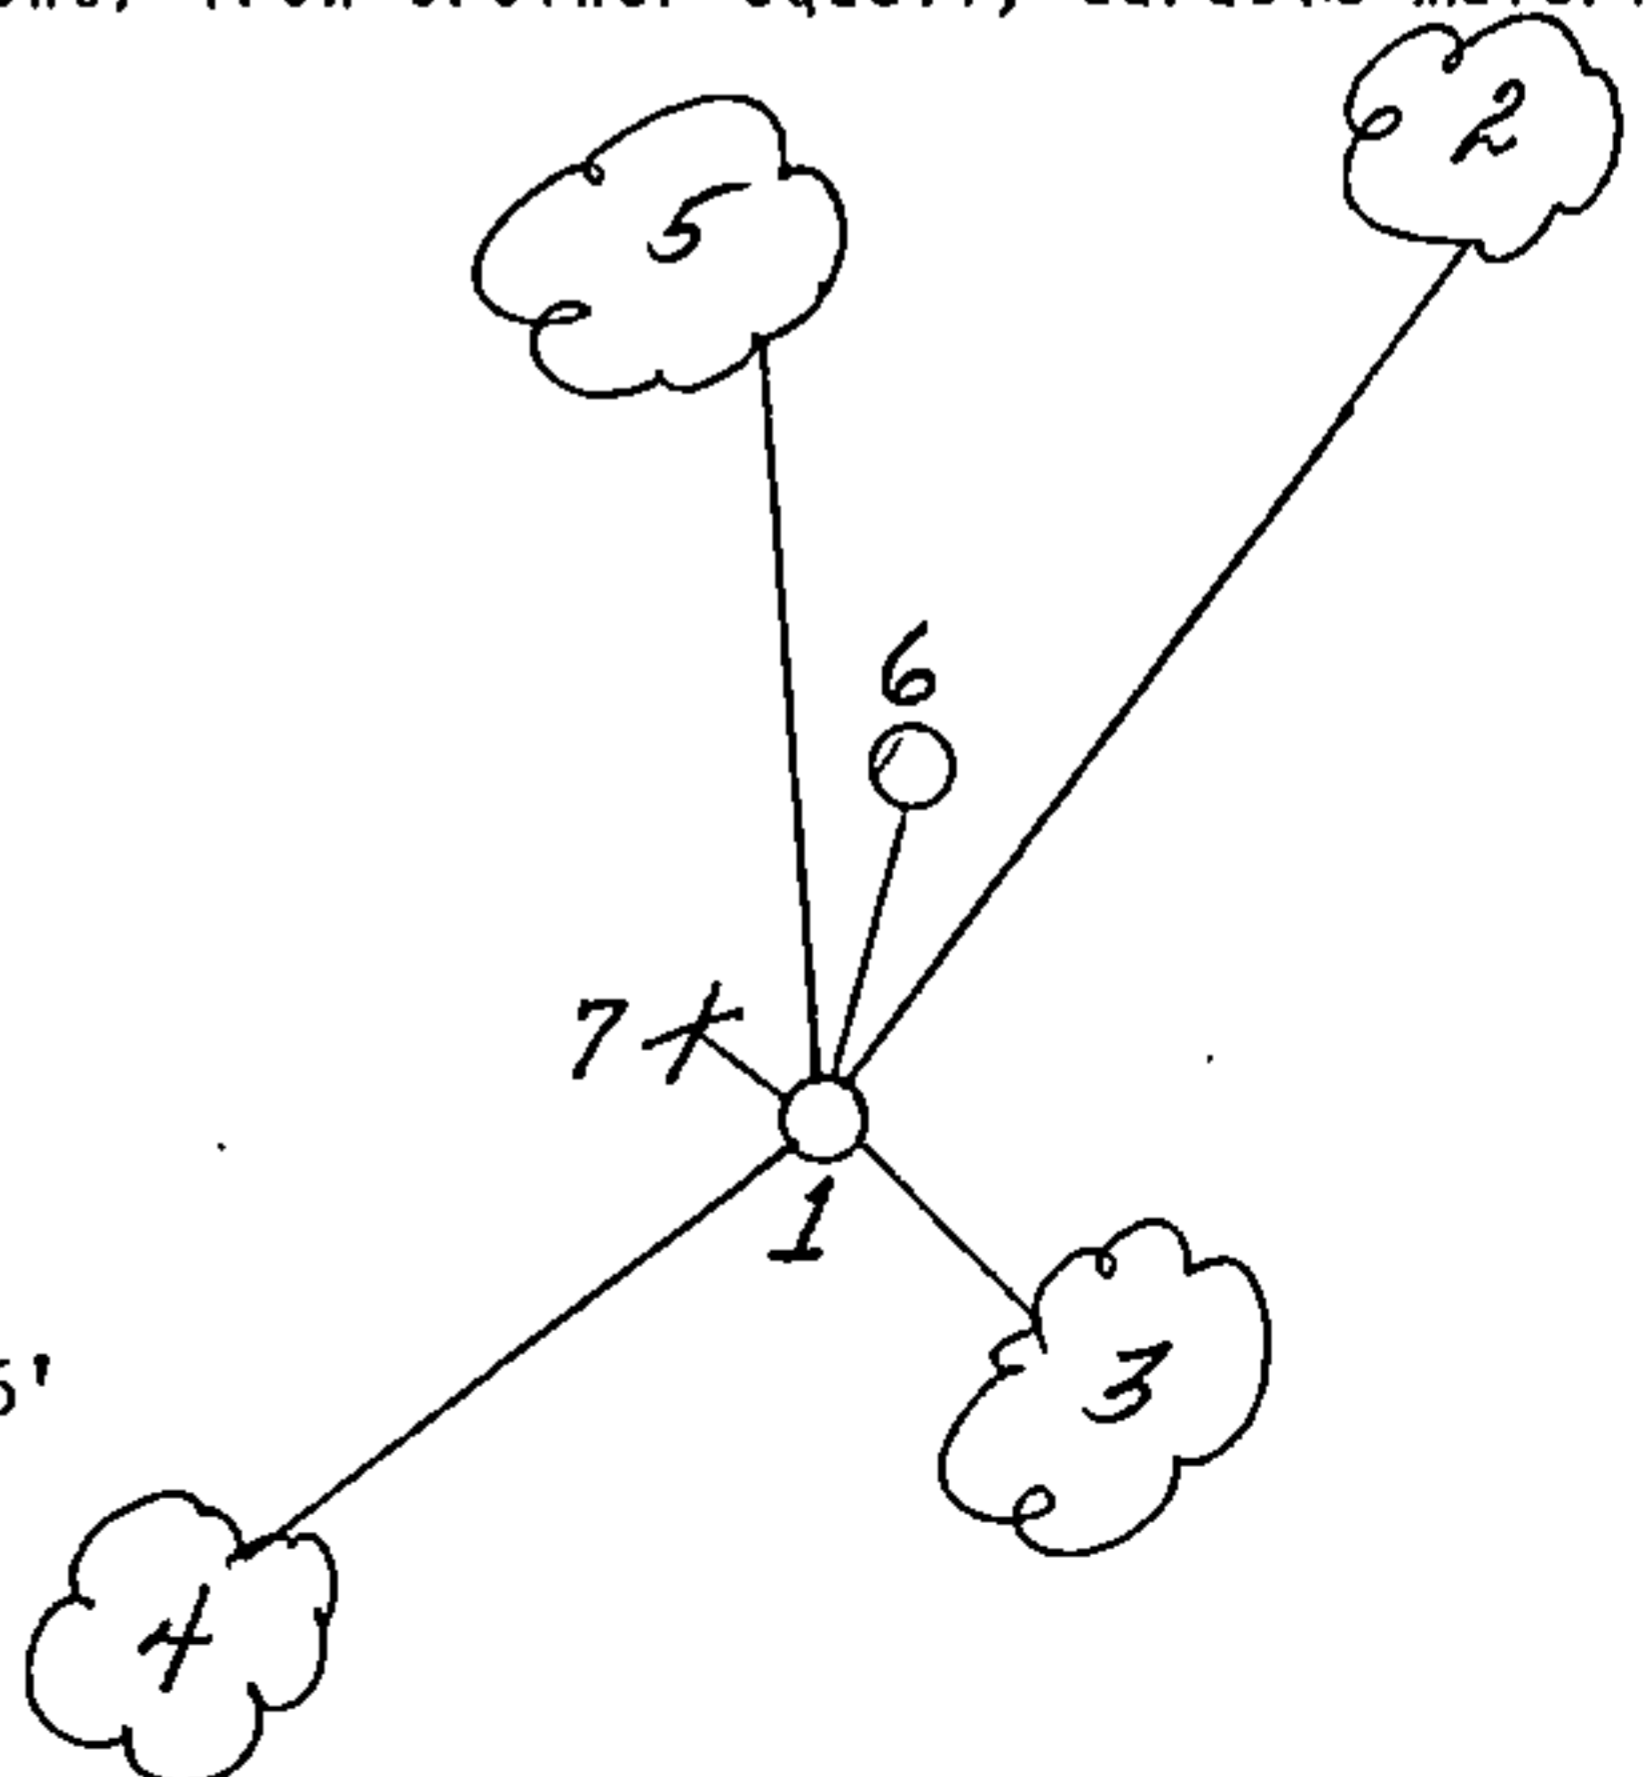
August 7, 1990 - Milo E. Stefan, in the section subdivision of Section 24 to the West, found this corner to be in error by 10.6 feet. In consultation with Nicolet National Forest Surveyor, Al Harrison, and Marinette County Surveyor, Jerome Pillath, decided to use the county monument as a Witness Corner and restore this corner at its proper location by single proportionate measure between the Section Corners North and South.

- 1) 2½" x 36" aluminum monument in mound of stone
- 2) Sugar Maple, 16", N28°E, 40.54'
- 3) Sugar Maple, 16", S32°E, 4.35'
- 4) Sugar Maple, 10", S49°W, 24.84'
- 5) Sugar Maple, 10", N07°W, 21.57'
- 6) 4" x 36" iron pipe with brass cap buried to ground level, N06°-07.9'E, 10.6'
- 7) Steel Sign Post, Northwest, 2.10'

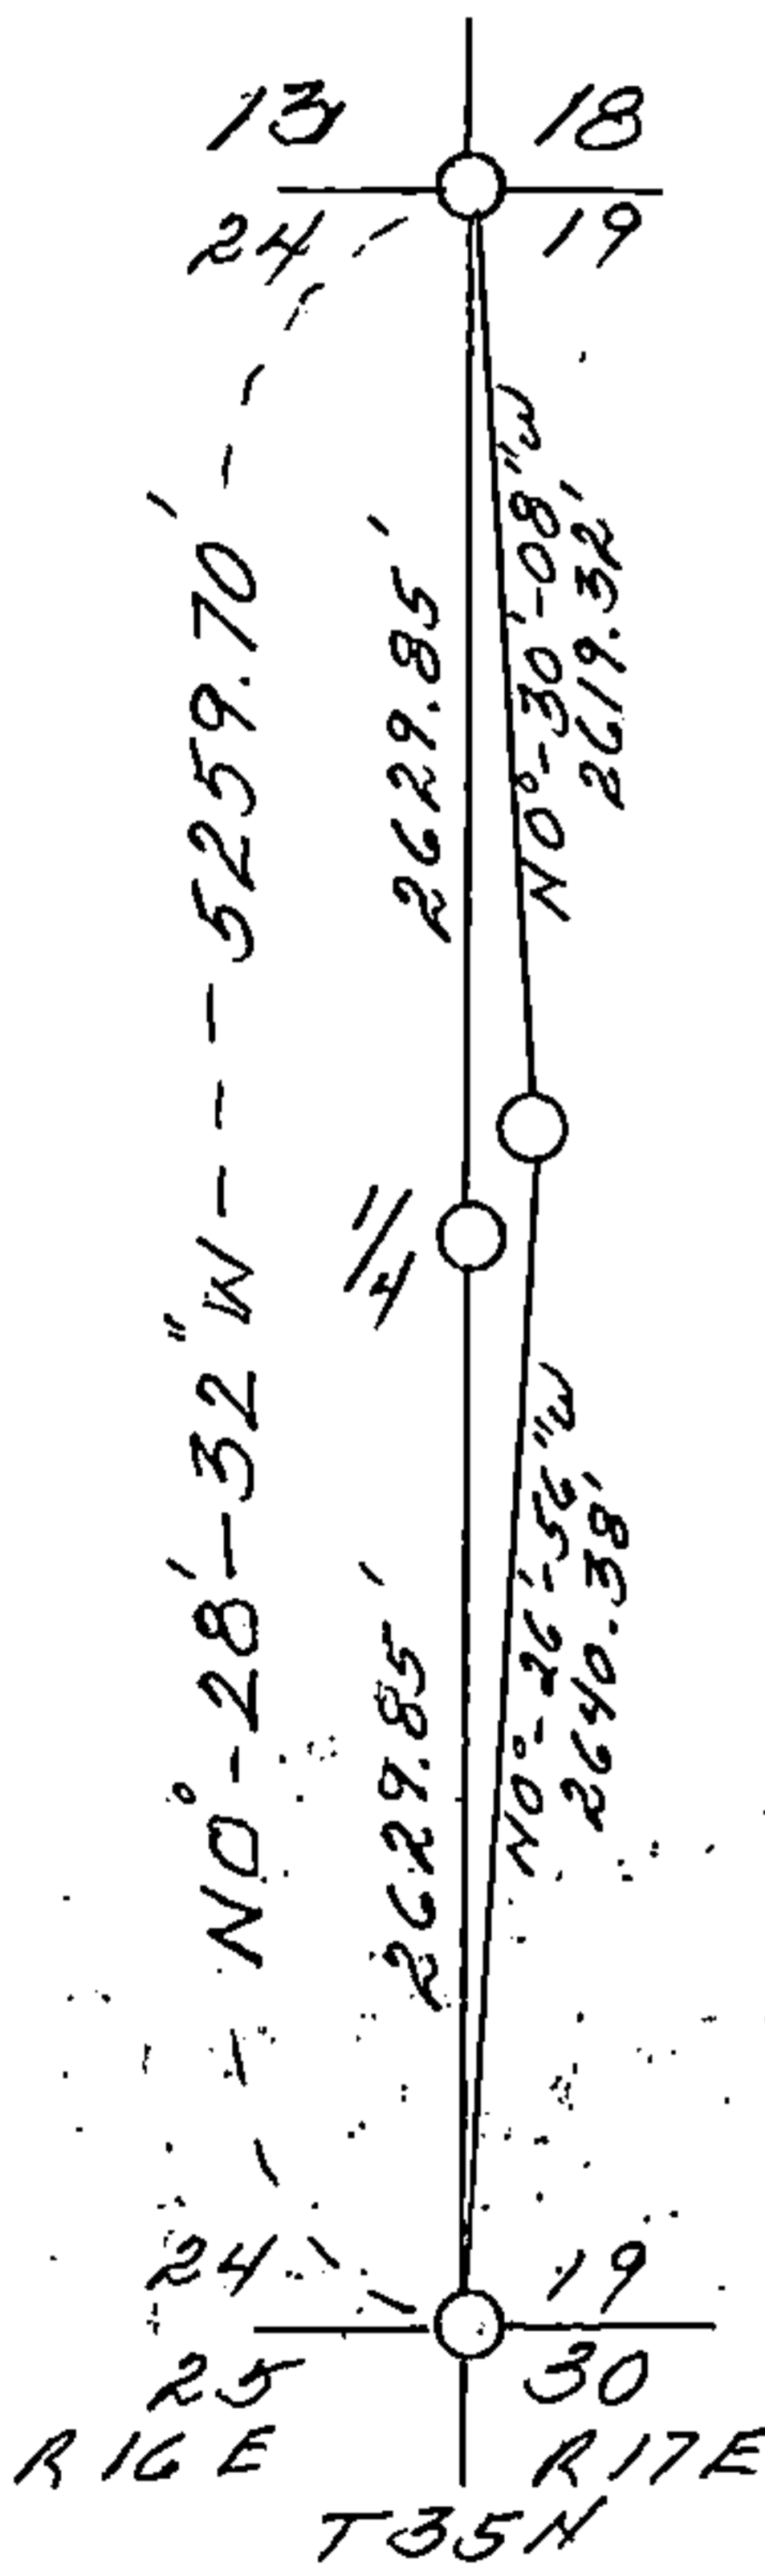
(g & h) Was the corner reestablished through lost corner proportionate methods? If so, show the method, including the directions and distances to other public land survey corners used as evidence or used for proportioning in determining the corner location?

See drawing under g and h.
