## U. S. PUBLIC LAND SURVEY MONUMENT RECORD.

Quarter Corner Common to Sections 15 and 22, T36N, R16E, Forest County, Wisconsin.

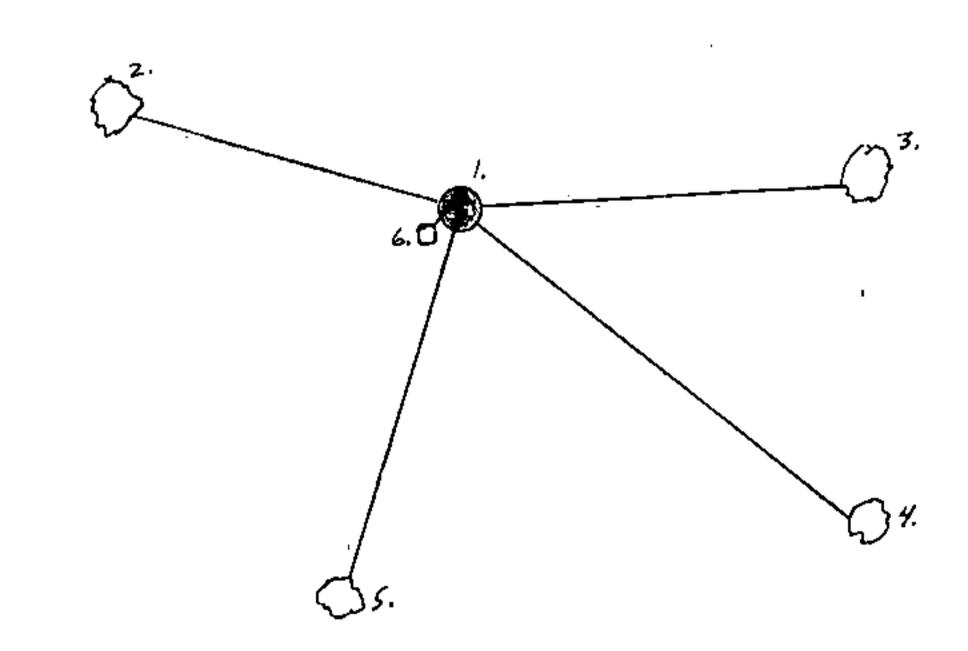
In 1988, John Schulke found the iron pipe but did not accept it. Placed 2 1/2" X 36" aluminum monument. The 1 1/2" dia. iron pipe is S86°E 6.85 feet from the monument.

Describe witness monuments.
- (d) Show a plan view drawing depicting the relevant monuments and reference ties which is sufficient in detail to enable accurate relocation of the corner monument if the corner monument is disturbed. Indicate north.
  - 1. 2 1/2" dia. X 36" aluminum magnetic cap monument stamped to identify the corner.
  - 2. Hemlock 6" N74°W 41.00 feet
  - 3. Basswood 17" N86°E 45.35 feet
  - 4. Hemlock 13" S52°E 57.89 feet
  - 4. Remlock 13" S52"E 57.89 feet 5. Sugar Maple 8" S17°W 45.07 feet
  - 6. Steel sign post Southwest 1.0 feet
