CERTIFIED LAND CORNER RESTORATION

Index No. T-1

U.S. PUBLIC LAND SURVEY MONUMENT RECORD

Index No. T-25

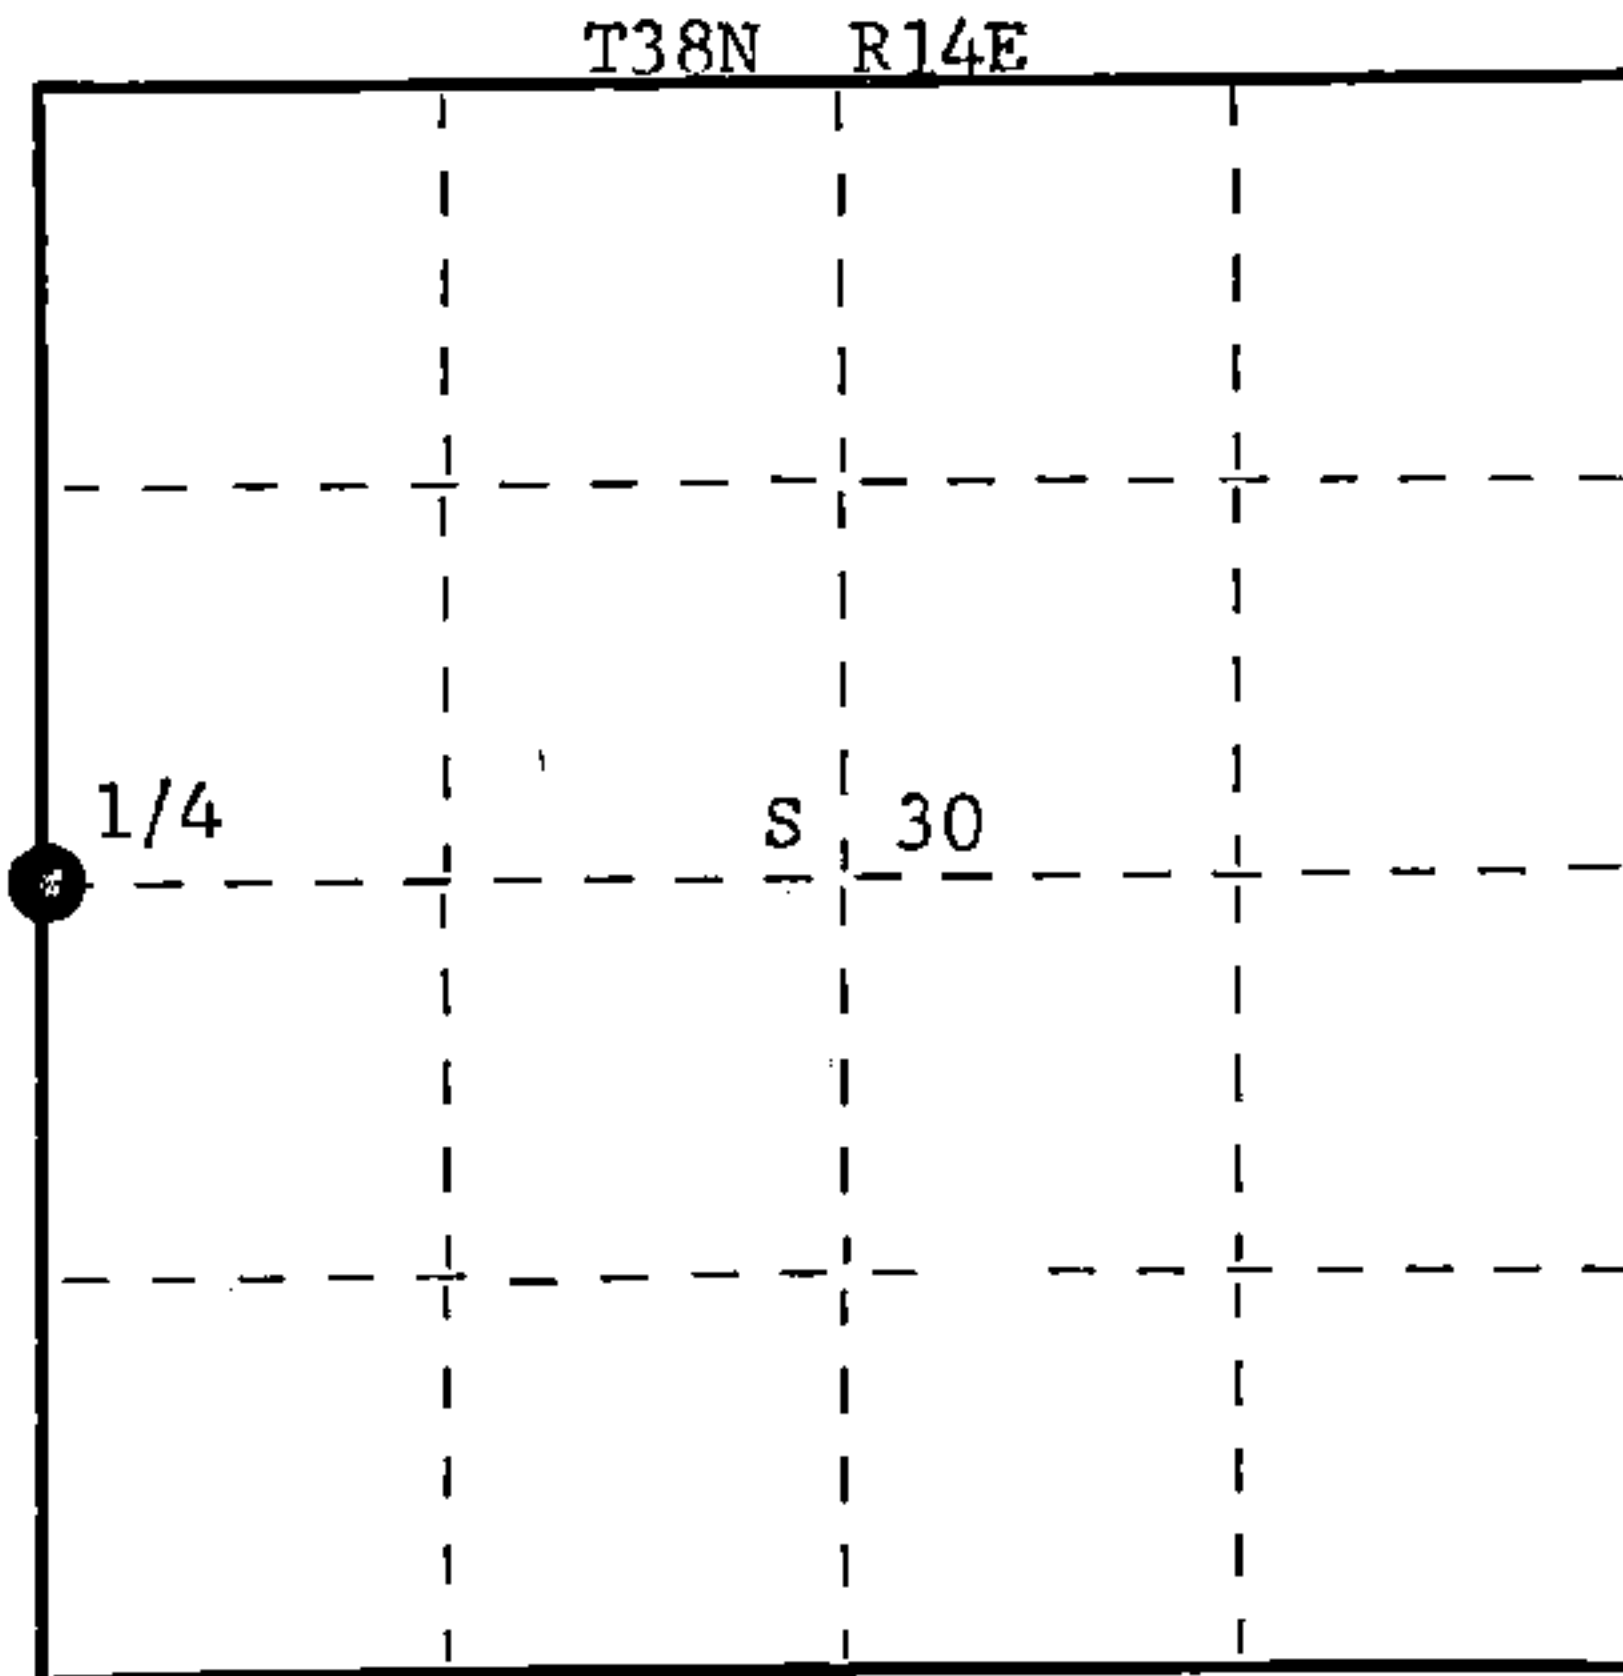
Description of corner evidence found:

Recovered very old 5" squared cedar post, scribed 1/4S S25. This post was upright, rotted badly on three sides. Recovered rotted stumps of Tamarack BTs.

Description of monument and accessories I established to perpetuate the original location of this corner.

Replaced cedar post with 2 1/2" Berntsen A-1 Federal Monument, aluminum with magnet in cap and base. Monument projects 8" above ground. Cap stamped: Drove support stakes around base of monument.

Marked NBTs - Cedar 7" N60°E, 19.4 links
Cedar 9" S76°W, 24.9 links
Cedar 8" S15°E, 77.4 links
All scribed 1/4 BT.

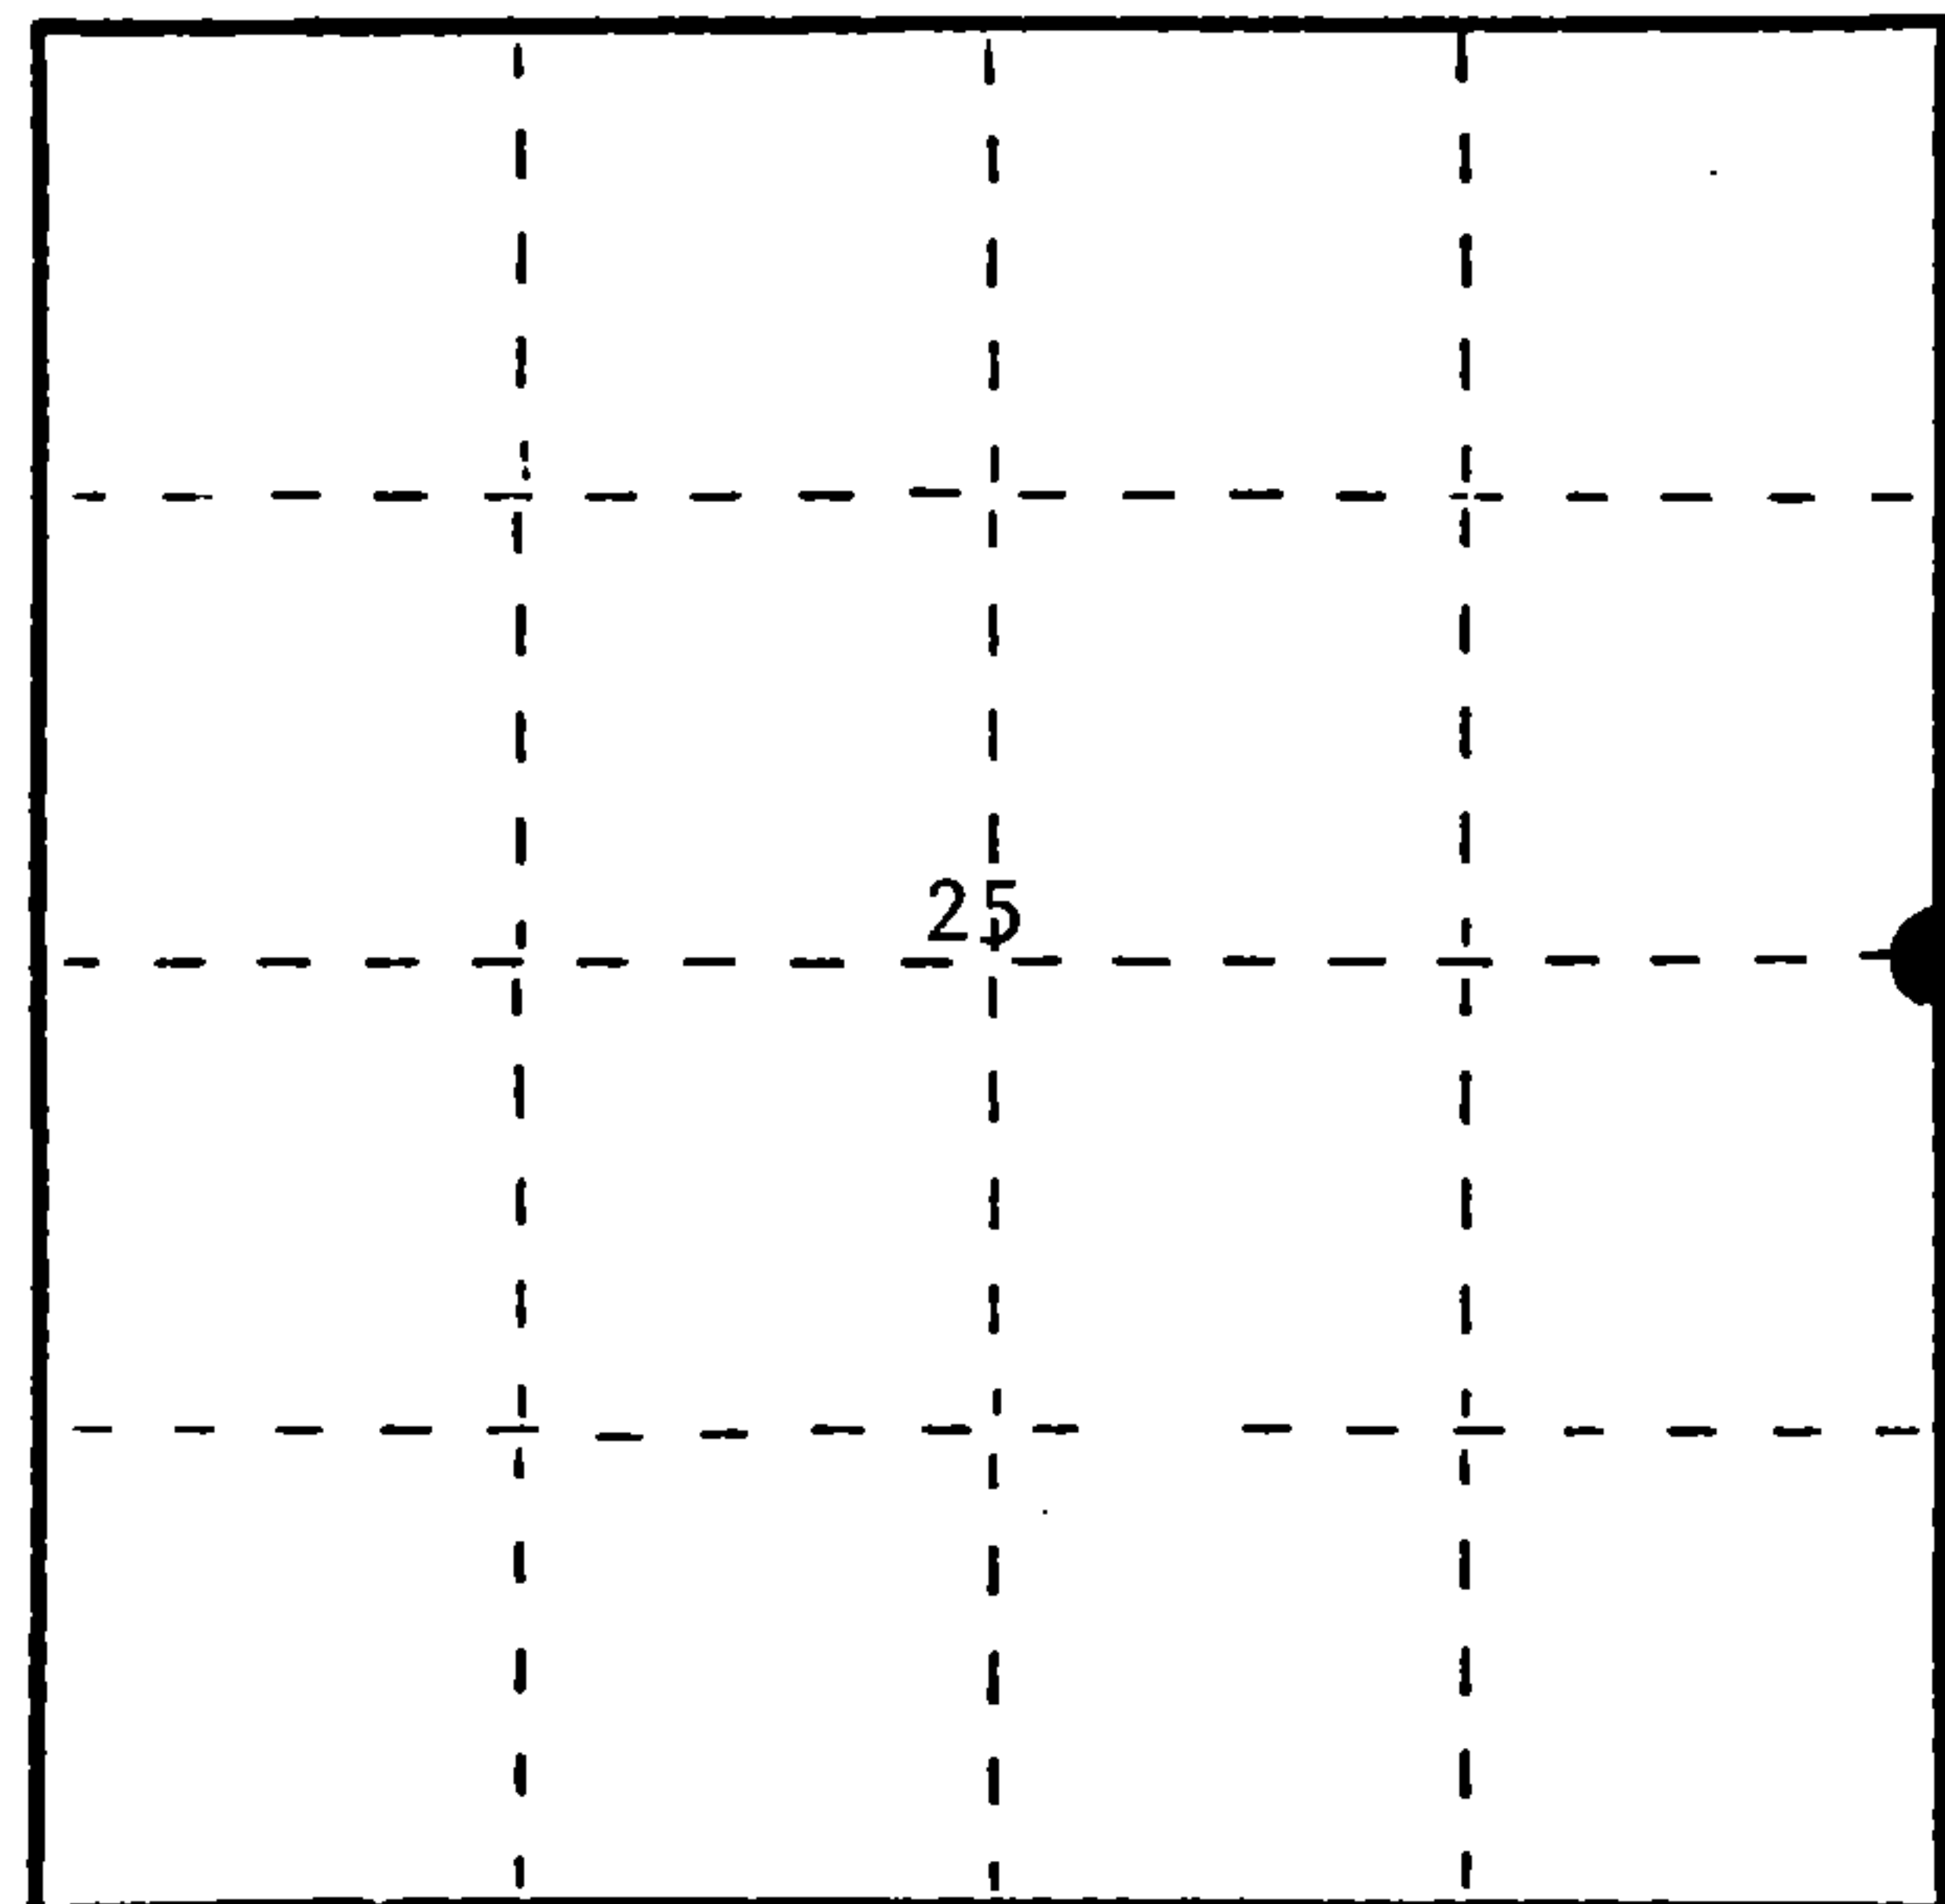
Description of corner evidence found: 6/19/90

Corner found in poor condition in loose soil. Forest County Monument too short. BTs by Hansen okay.

Description of monument and accessories I established to perpetuate the original location of this corner.

We replaced Forest County monument with a 2" x 60" aluminum monument, lying old monument along side. Made one new BT and set steel sign post.

- 7" Cedar, N60°E, 13.12' * * -Old BT's
- 10" Cedar, S48°E, 50.82' ** ** -New BT
- 9" Cedar, S76°W, 16.98' *
- 8" Cedar, S15°E, 51.34' *
- 6' Steel Sign Post, NW .6'
