U. S. PUBLIC LAND SURVEY MONUMENT RECORD

Section corner to Sections 28, 29, 32, and 33, T.34N., R.14E.

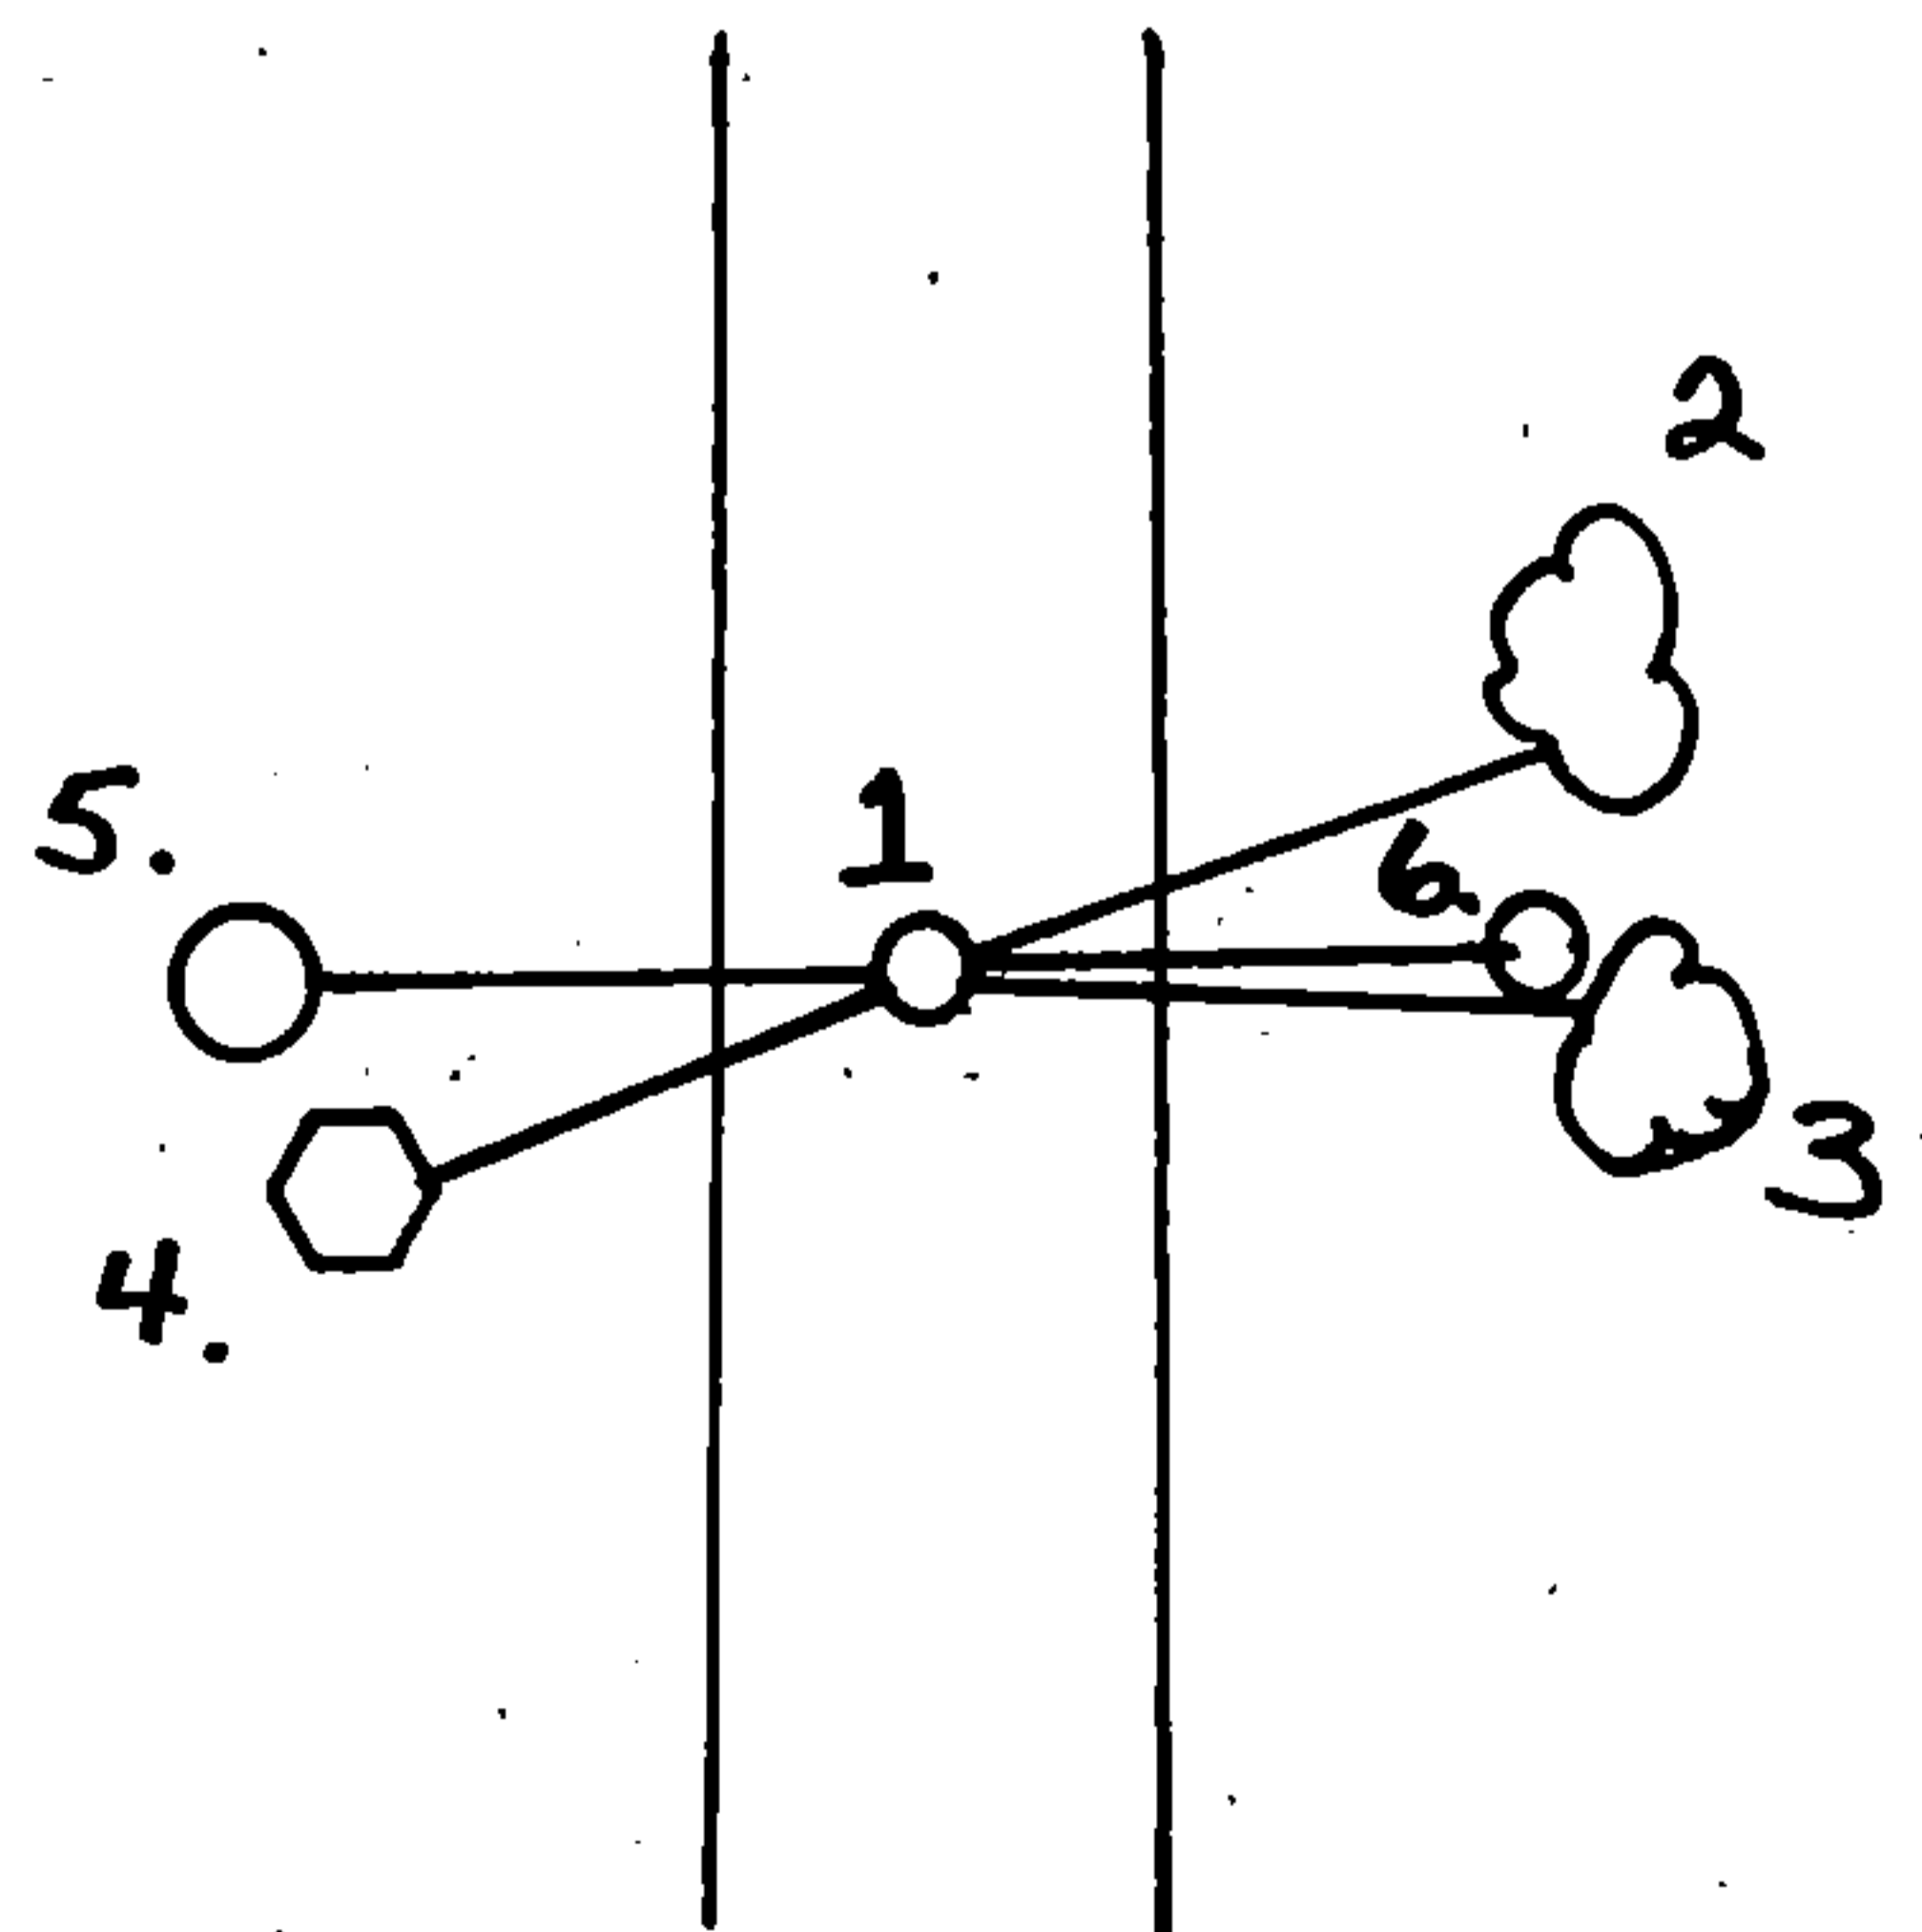
1. An iron pipe in the roadbed.
2. Sugar, 6", N.66°E., 38.11 feet
3. Sugar, 4", S.86°E., 39.57 feet
4. Power Pole #3414-32E3, S.63°W., 23.59 feet
5. Reference corner, 2" x 36" aluminum monument, West, 33.0 feet.
6. Iron pipe, 1½" diameter, East, 32.95 feet
