## U. S. PUBLIC LAND SURVEY MONUMENT RECORD

Section corner to Sections 15, 16, 21, and 22, T.34N., R.16E., Forest County, Wisconsin.

Section Corner to Sections 15, 16, 21 & 22, T.34N., R.16E., 4th P.M.

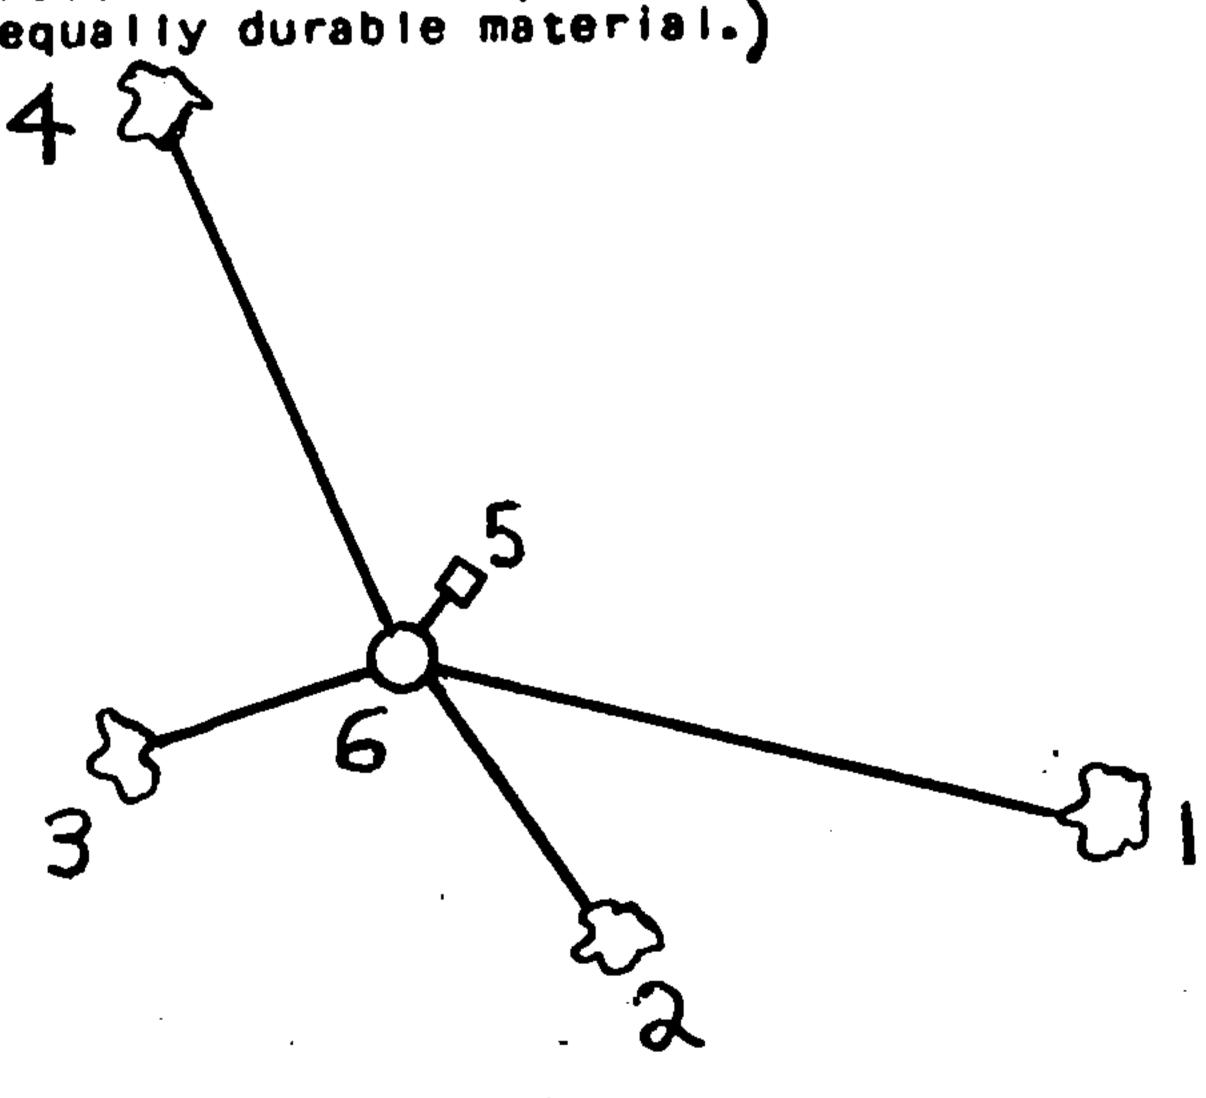
In 1983, Milo Stefan found black and white corner post and original Cedar stump, S.73°W., 15.8'. Set a 2" x 36" aluminum monument at corner position.

- (d) Show a plan view drawing depicting the relevant monuments and reference ties which is sufficient in detail to enable accurate relocation of the corner monument if the corner monument is disturbed. Indicate north.
- 1. Cedar, 11", S.82°E., 80.58'
- 2. Cedar, 5", S.24°E., 44.97'
- 3. Balsam, 7", S.79°W., 17.91'
- 4. Tamarack, 3", N.14°W., 82.02'
- 5. Steel Sign Post, Northeast, 1.2'
- 6. 2" x 36" aluminum monument stamped to identify the corner.

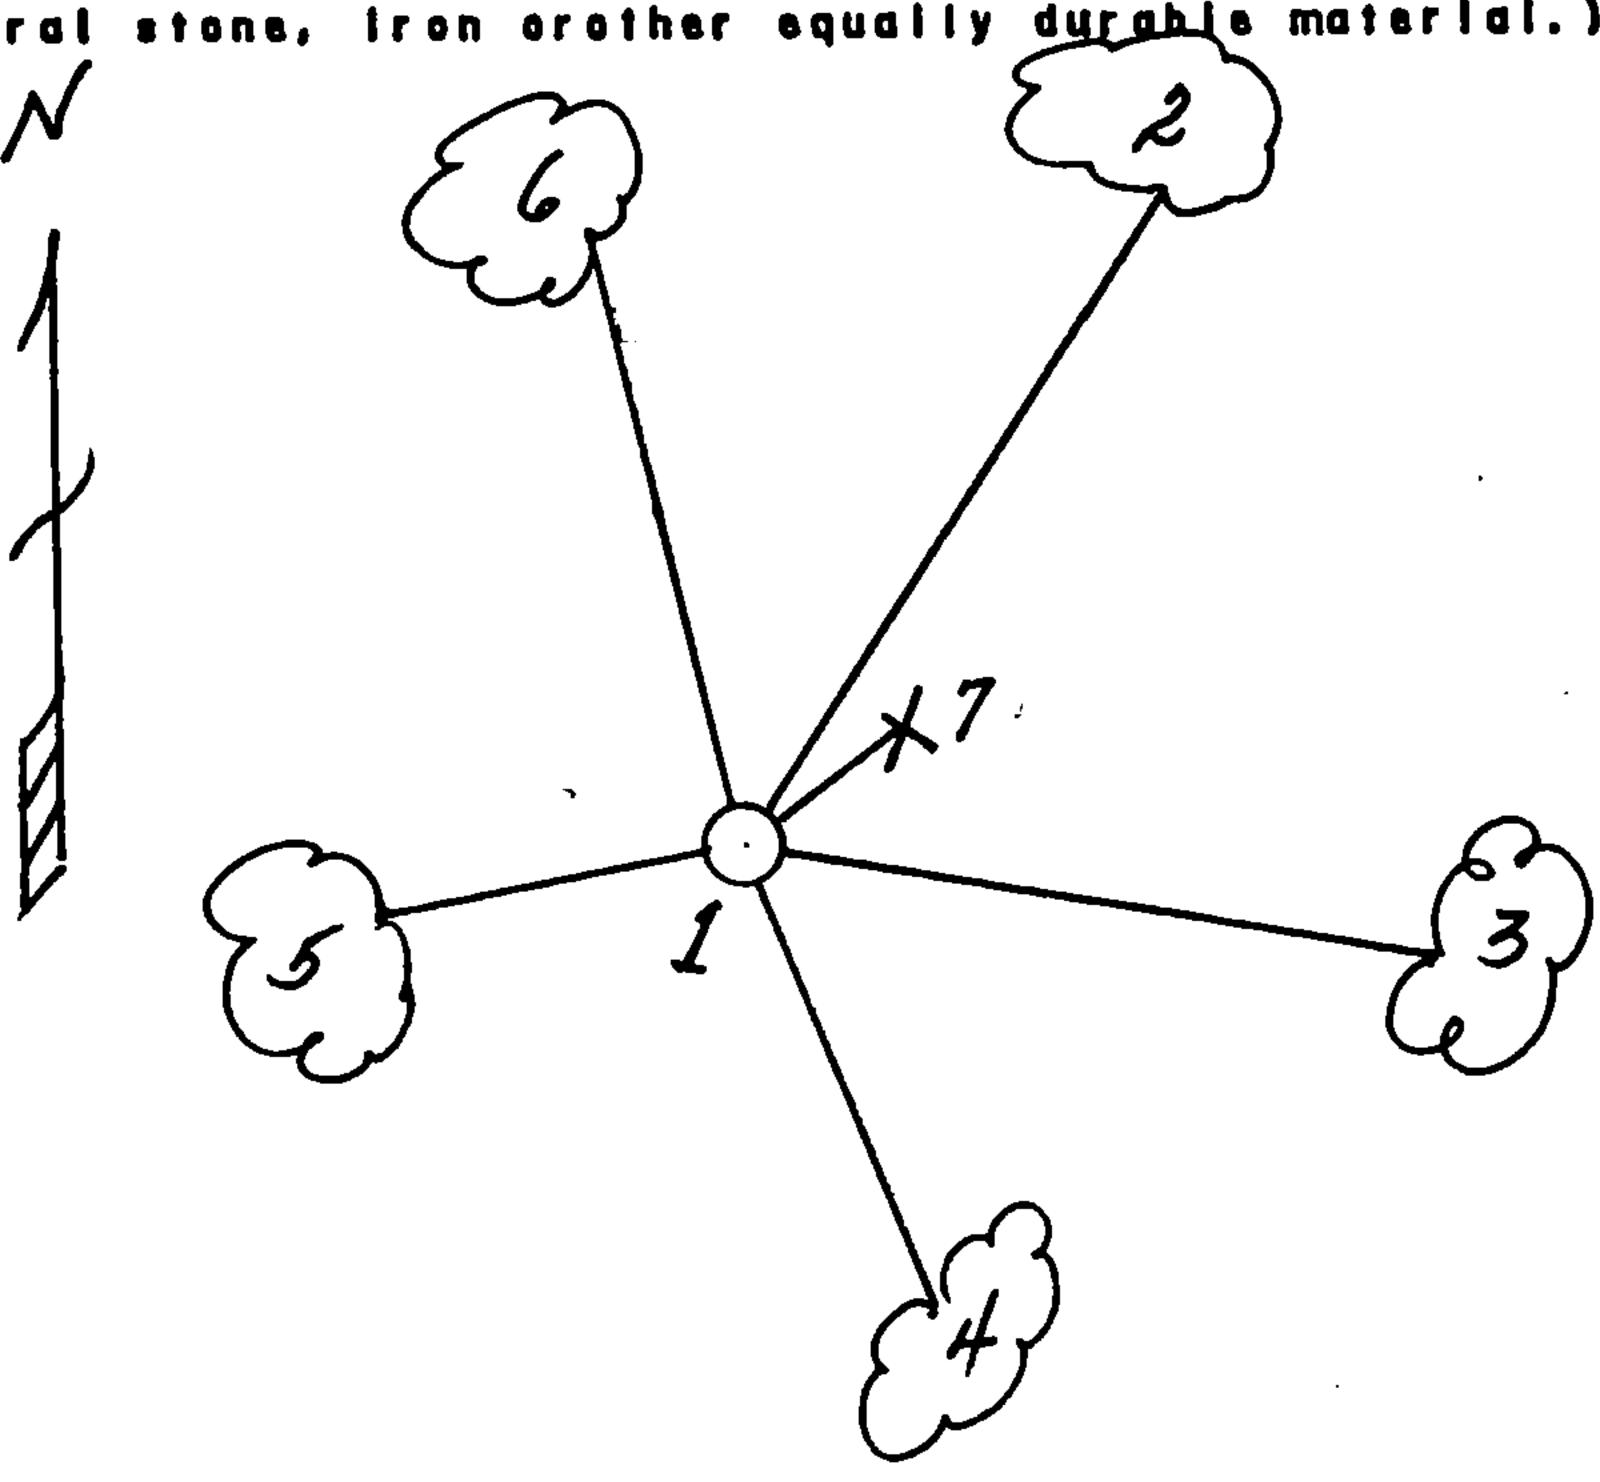
Found aluminum monument, three BTs and steel sign post in good condition. Tamarack BT - dead.

Made one new BT: Black Ash, 6", N.33°E., 112.98'

- 1. 2" Aluminum monument.
- 2. Black Ash, 6", 'N.33°E., 112.98'.
- 3. Cedar, 11", S.82°E., 80.58'.
- 4. Cedar, 5", S.24°E., 44.97'.
- 5. Balsam Fir, 7", S.79°W., 17.91'.
- 6. Tamarack, 3", N.14°W., 82.02'.
- 7. Steel sign post, Northeast, 1.20'.
