CERTIFIED LAND CORNER RESTORATION

U. S. PUBLIC LAND SURVEY MONUMENT RECORD

SOUTHWEST CORNER OF SECTION 34, TWP.34 N., R. 16 E.

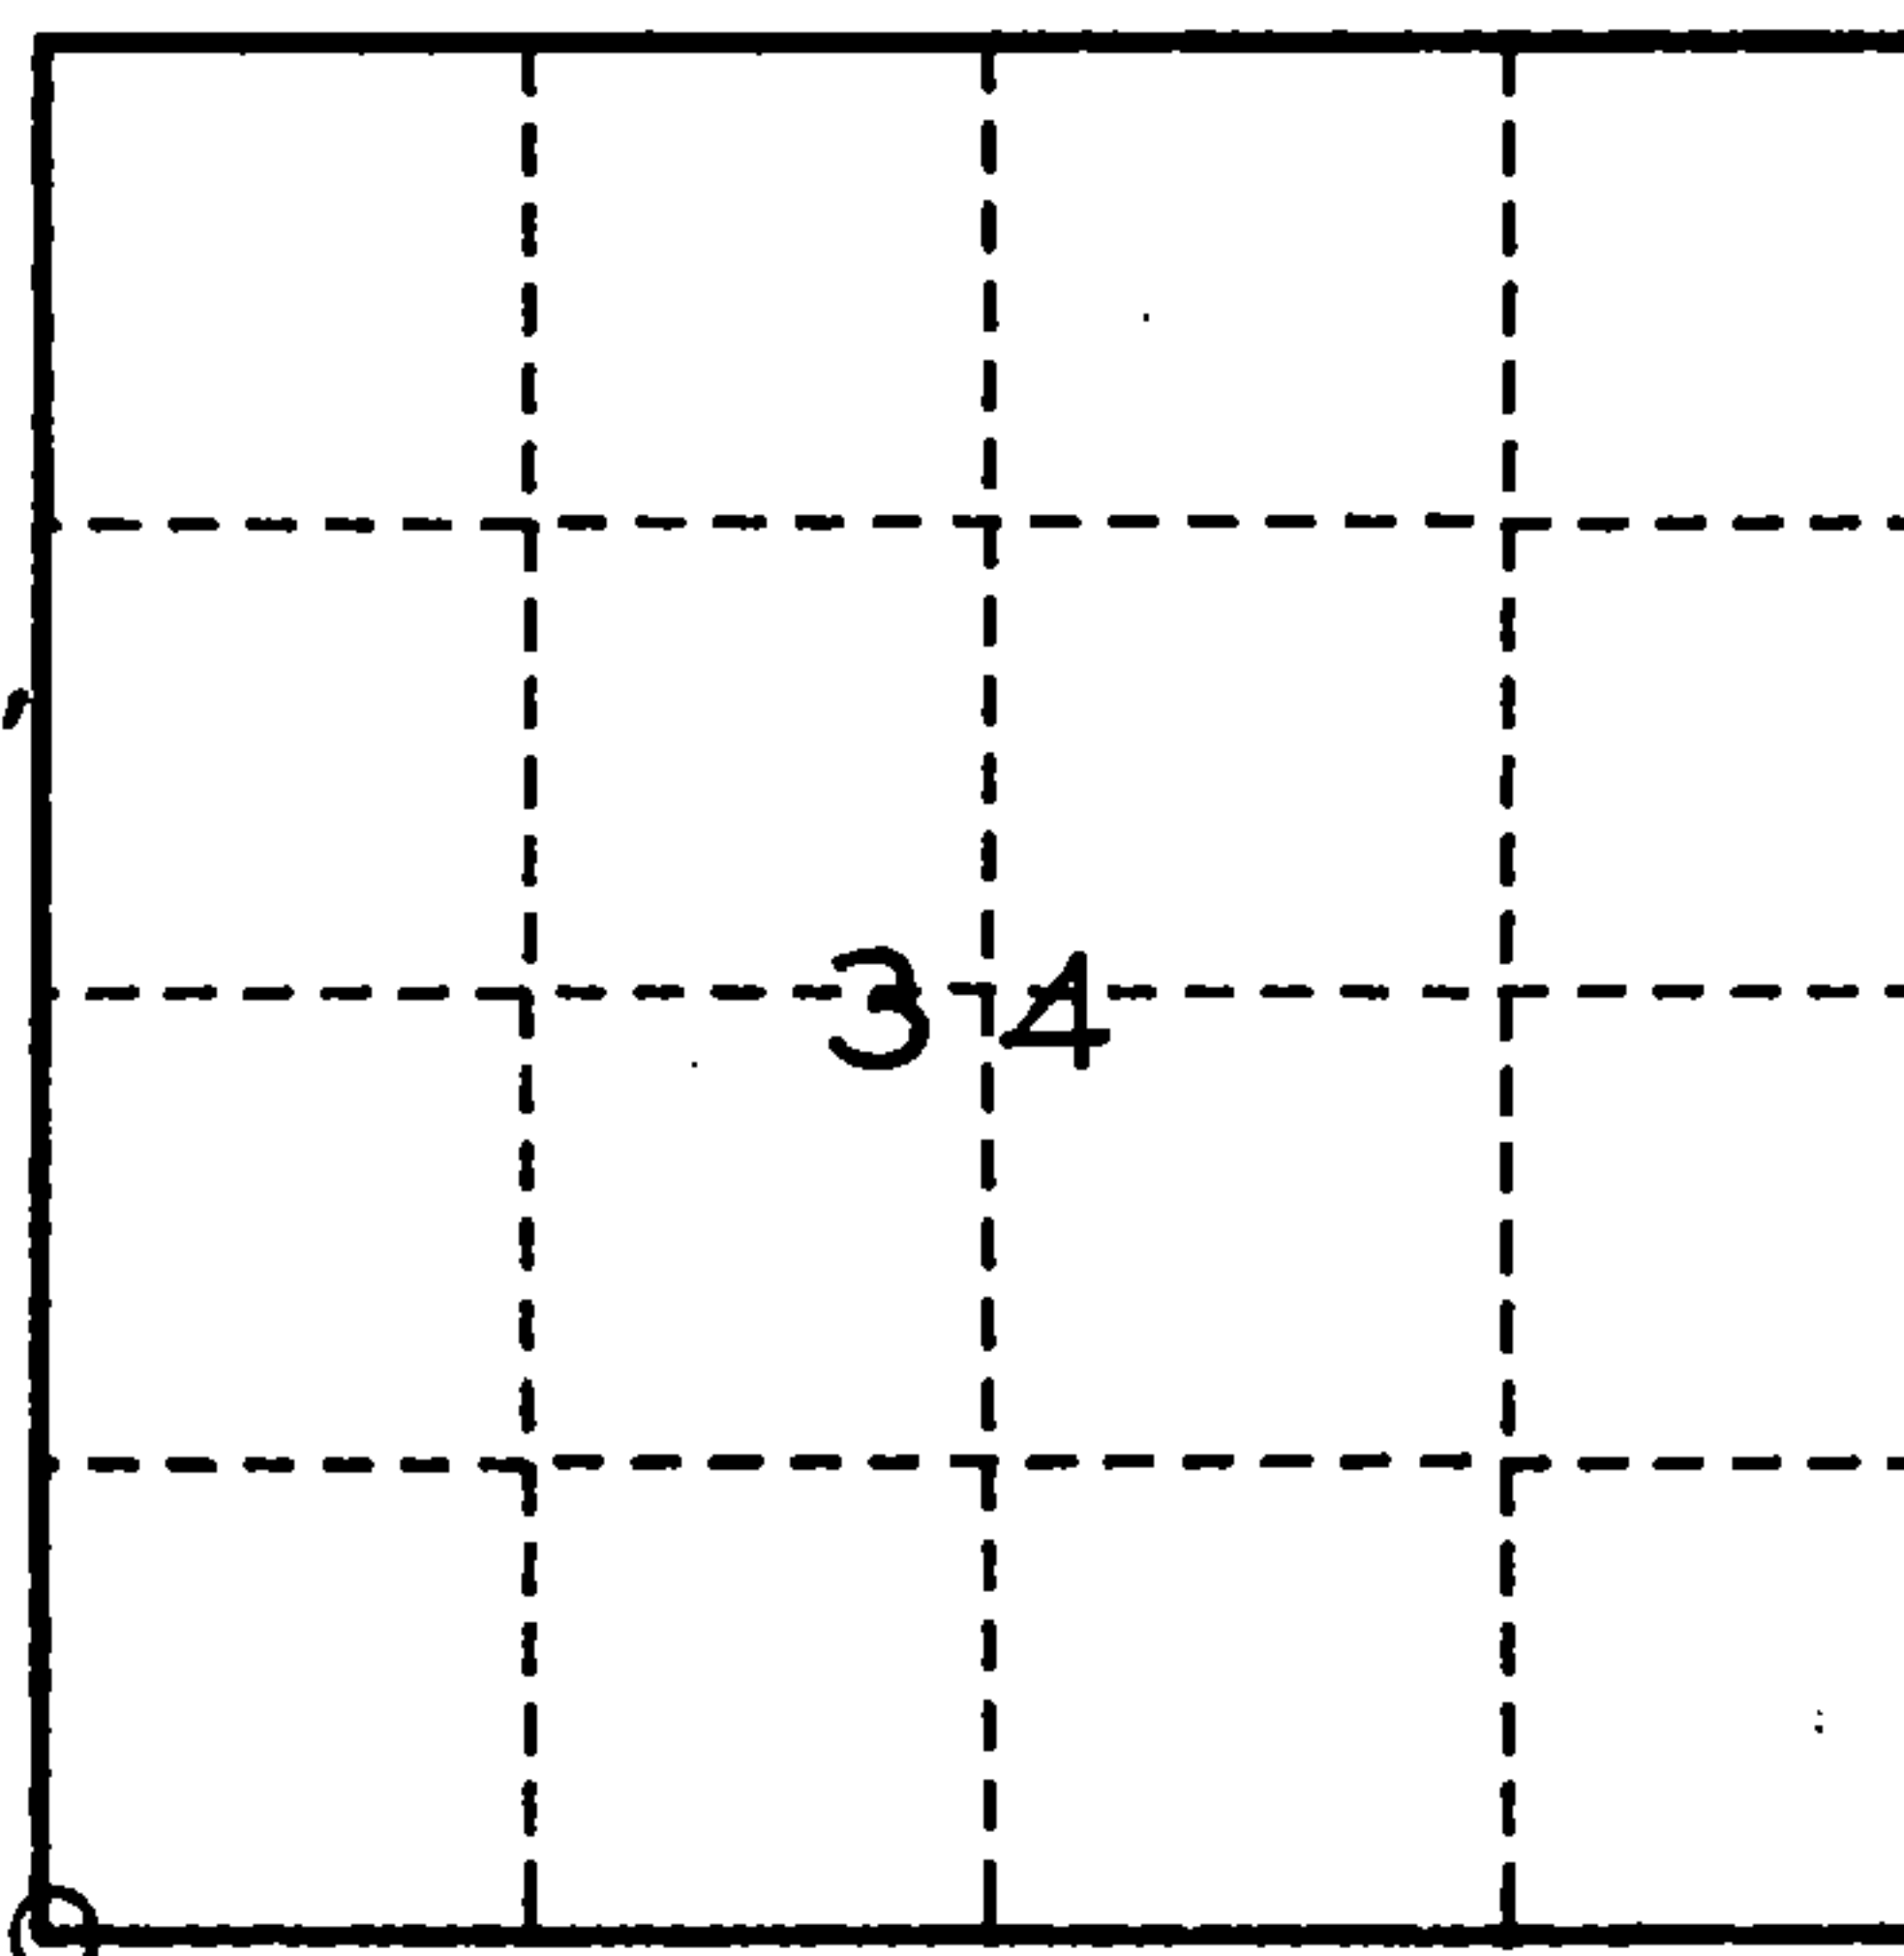
1993 - DOBRATZ, R.L.S. NO. S-973, FOUND MONUMENT, SIGN POST AND 2 OF THE ABOVE B.Ts STILL ALIVE - CEDAR 12" S.71° W. 14.18FT. AND HEMLOCK 8" N.70° W. 22.34FT., OTHERS ARE DEAD OR DOWN.
