U. S. PUBLIC LAND SURVEY MONUMENT RECORD

Section Corner to Sections 11, 12,
 13 & 14; T35N, R14E, 4th P.M.

CERTIFIED LAND CORNER RESTORATION

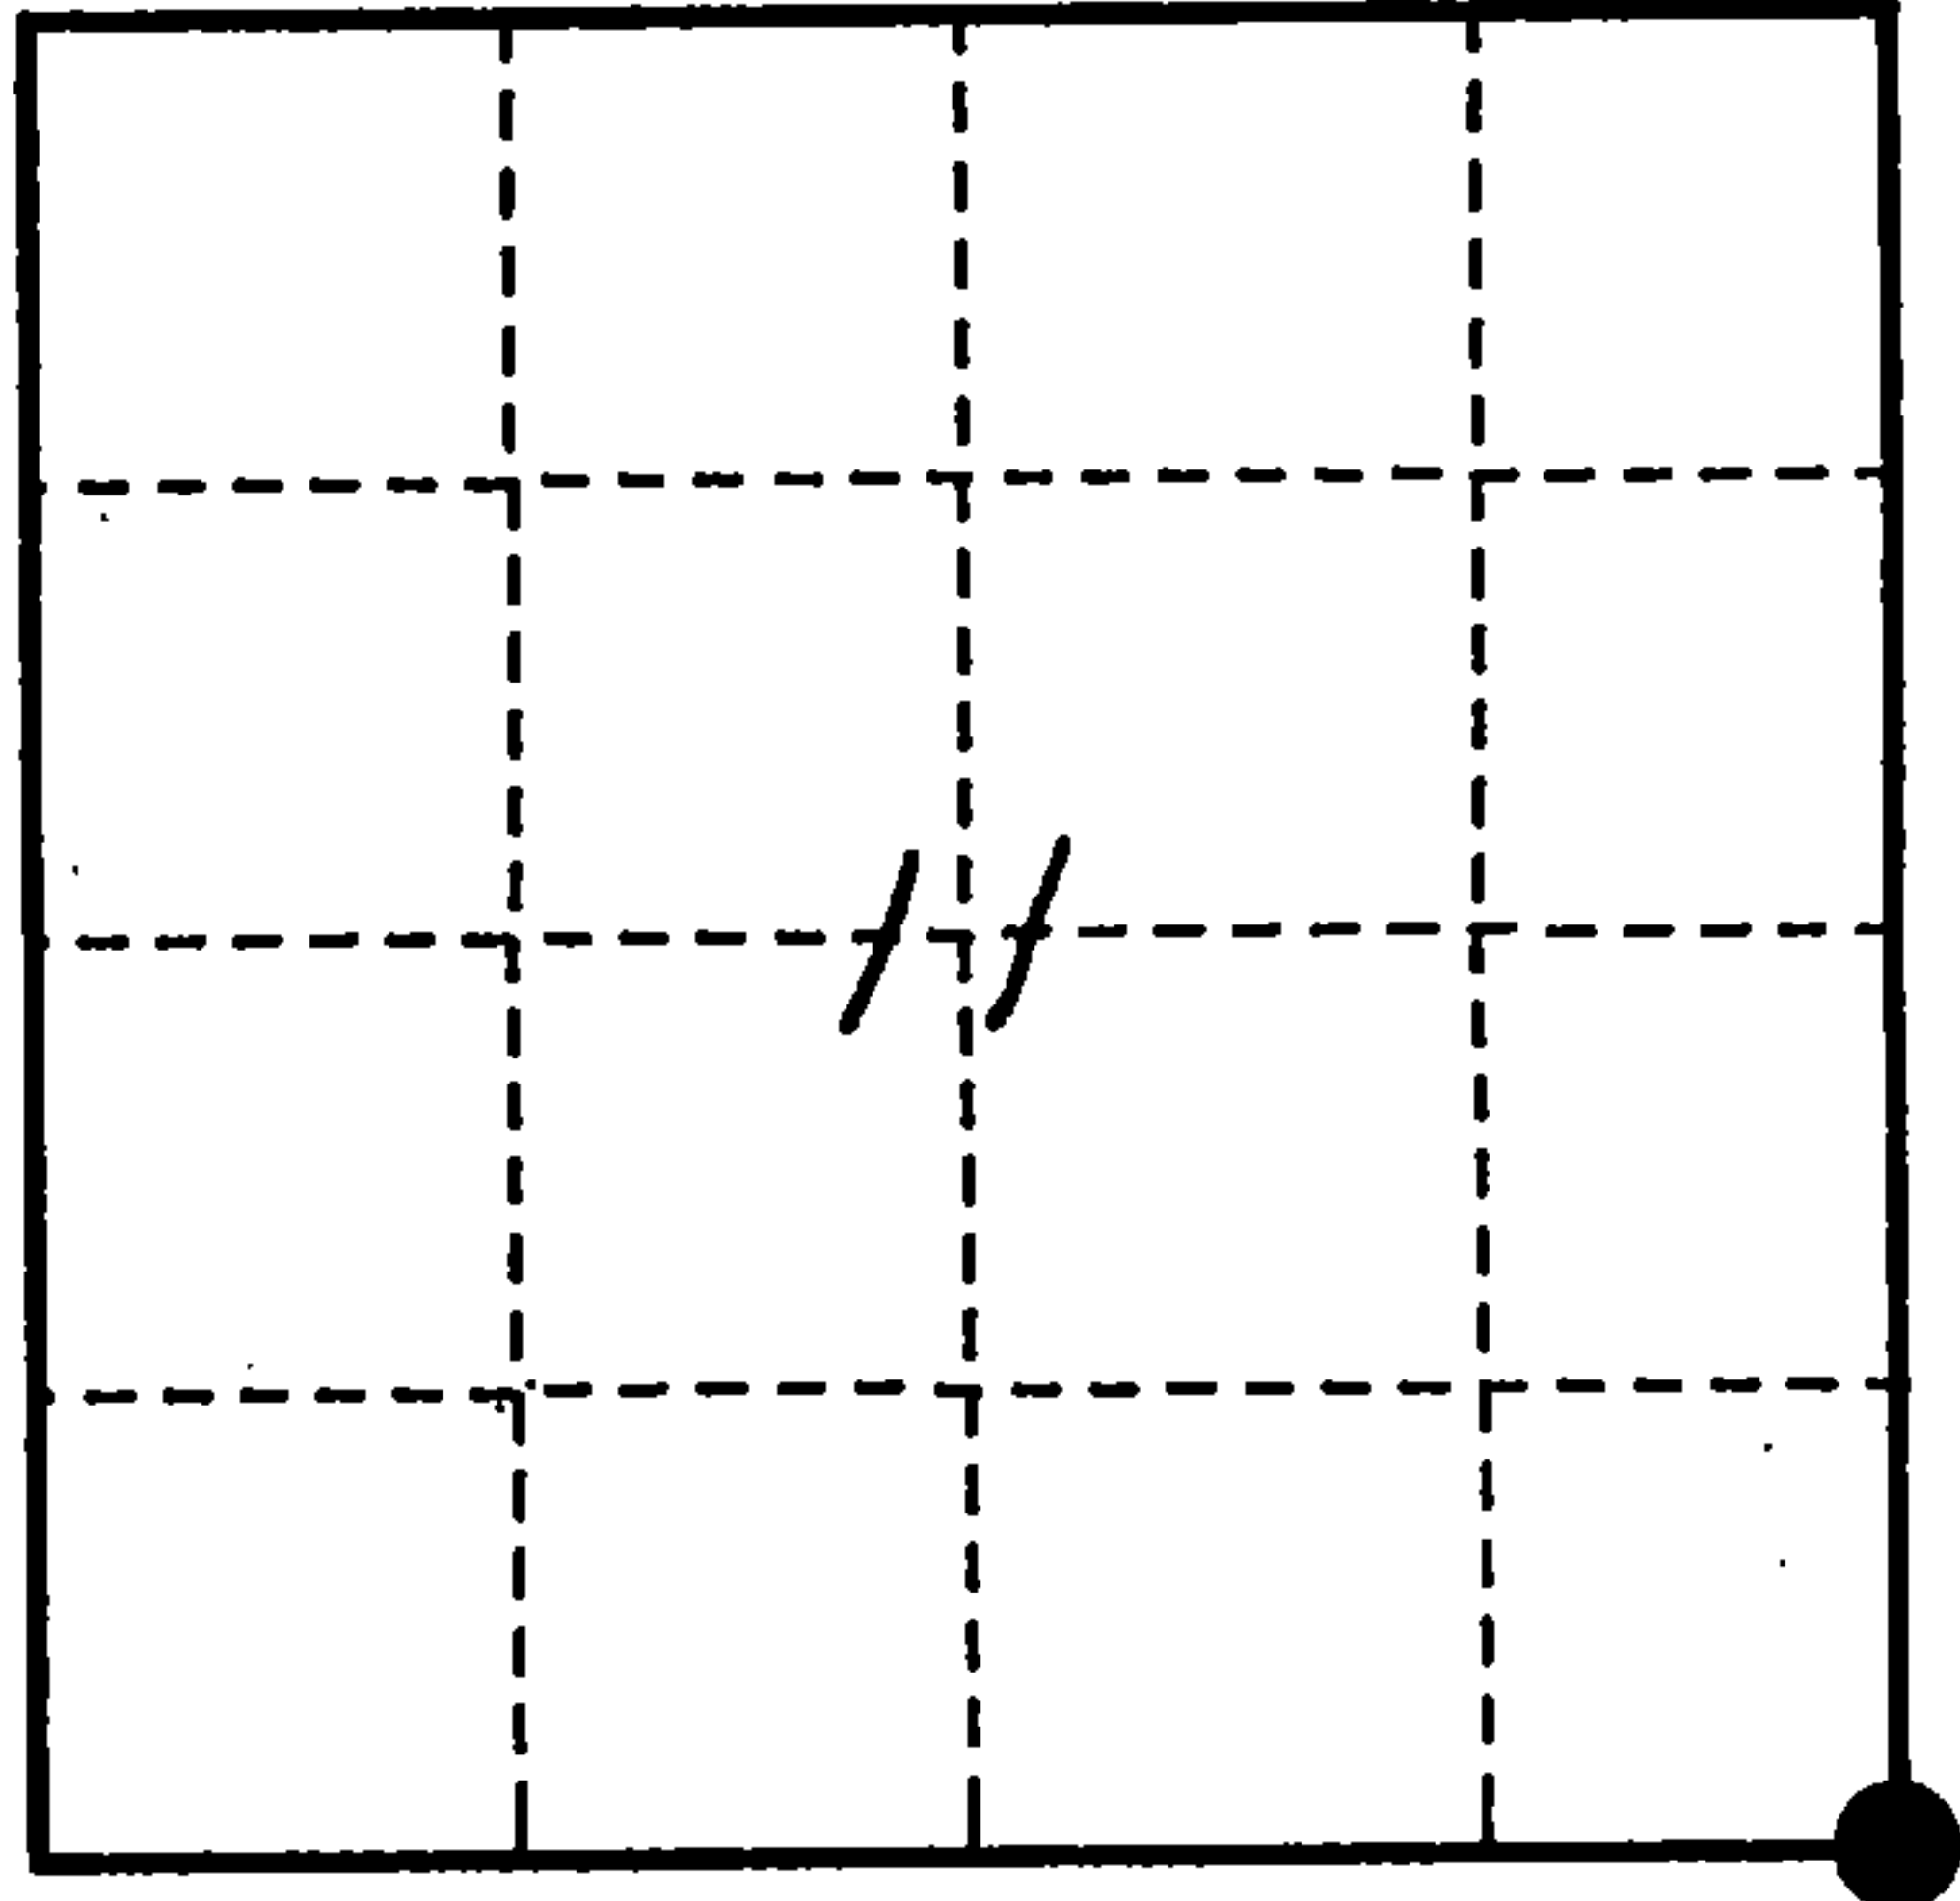
Found 2" iron pipe with brass cap as set by Resvick in 1974. Two BTs okay. Made two new BTs: White Spruce, 8", N31°E, 10.48'
 White Spruce, 6", S85°W, 11.98'

- 1) 2" iron pipe/brass cap
- 2) 8" White Spruce, N31°E, 10.48'
- 3) 4" White Spruce, N75°E, 1.68'
- 4) 9" White Spruce, S06°E, 13.61'
- 5) 6" White Spruce, S85°W, 11.98'
- 6) Steel sign post, SE, 1.0'

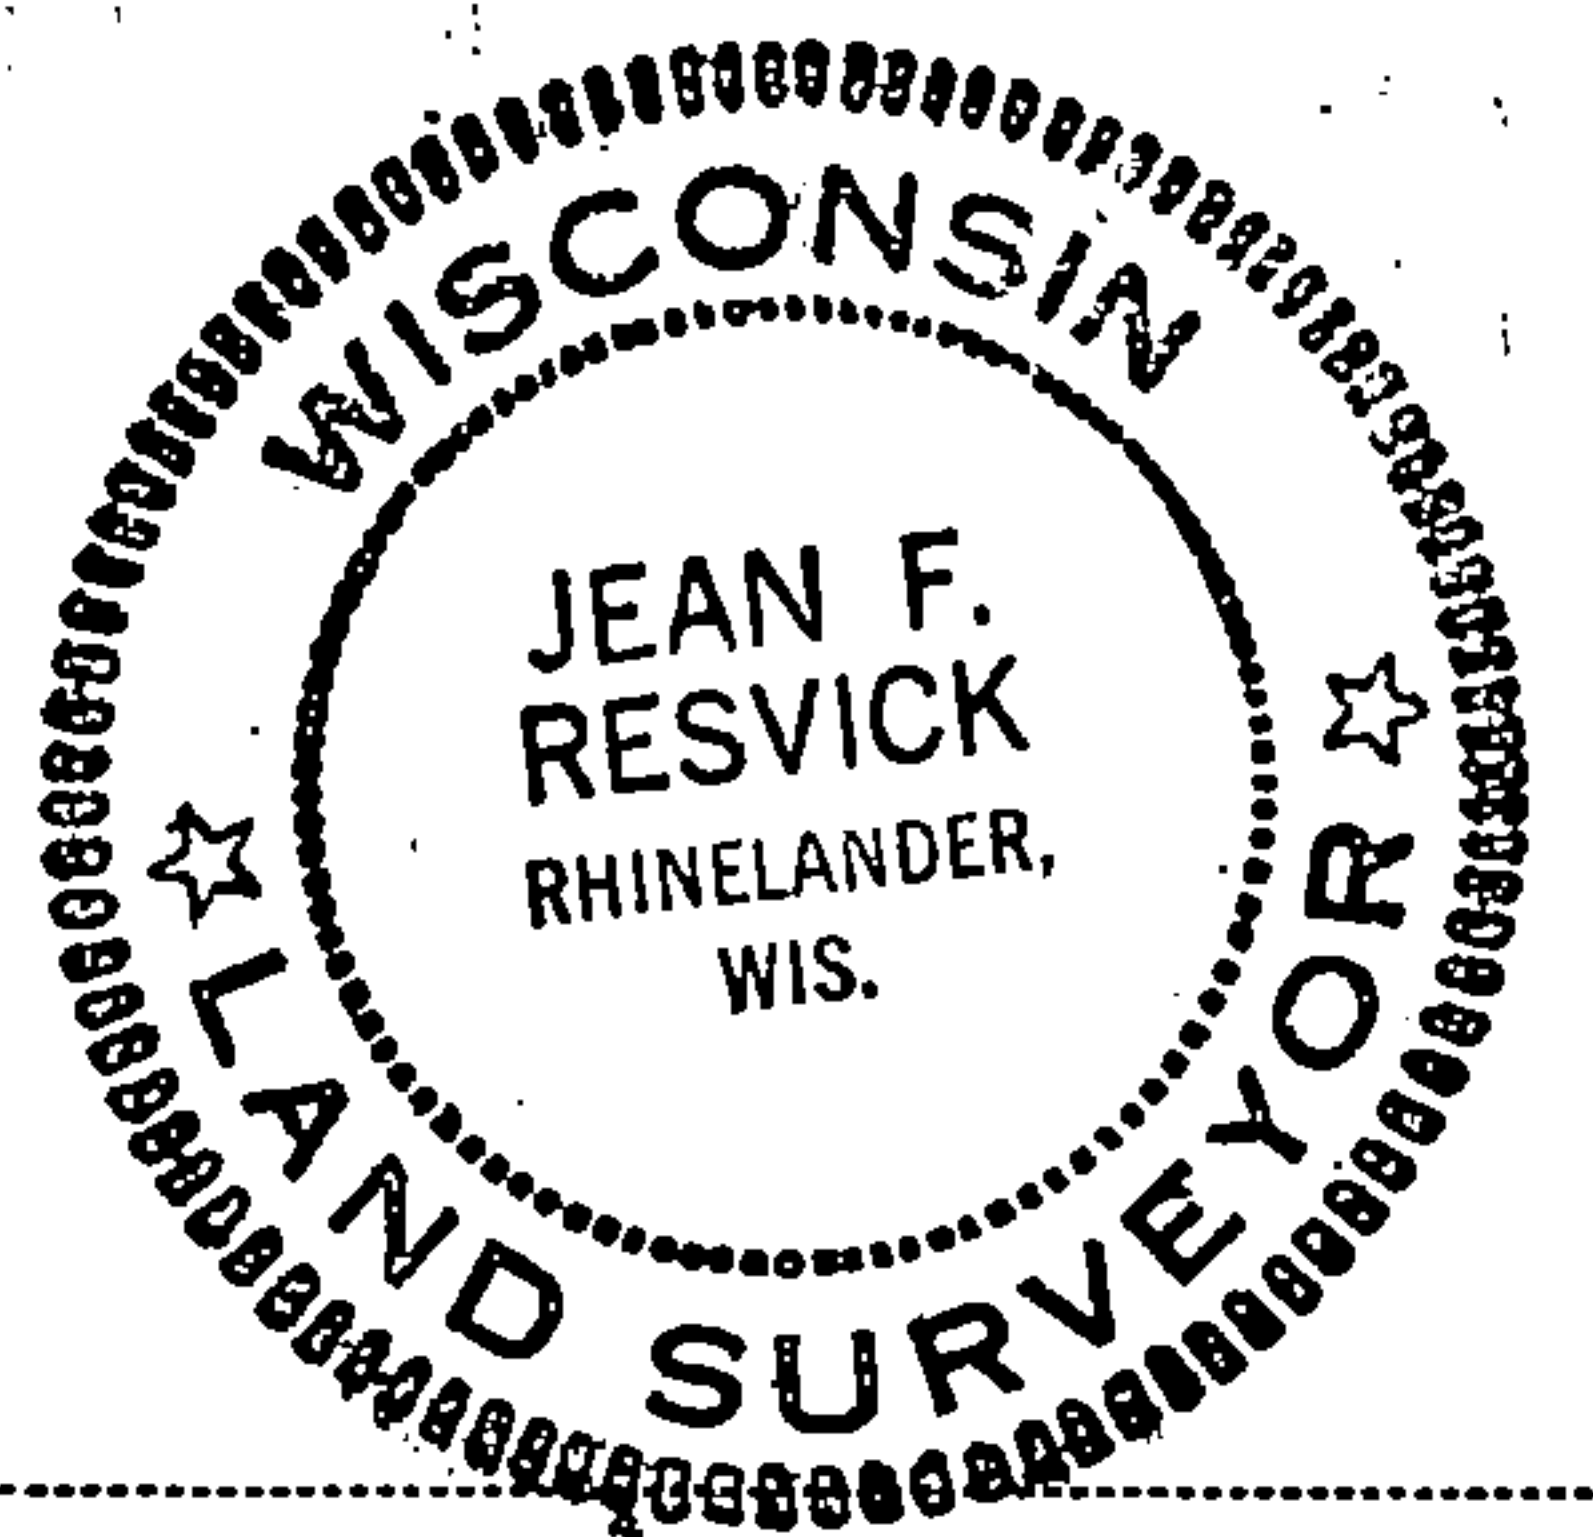
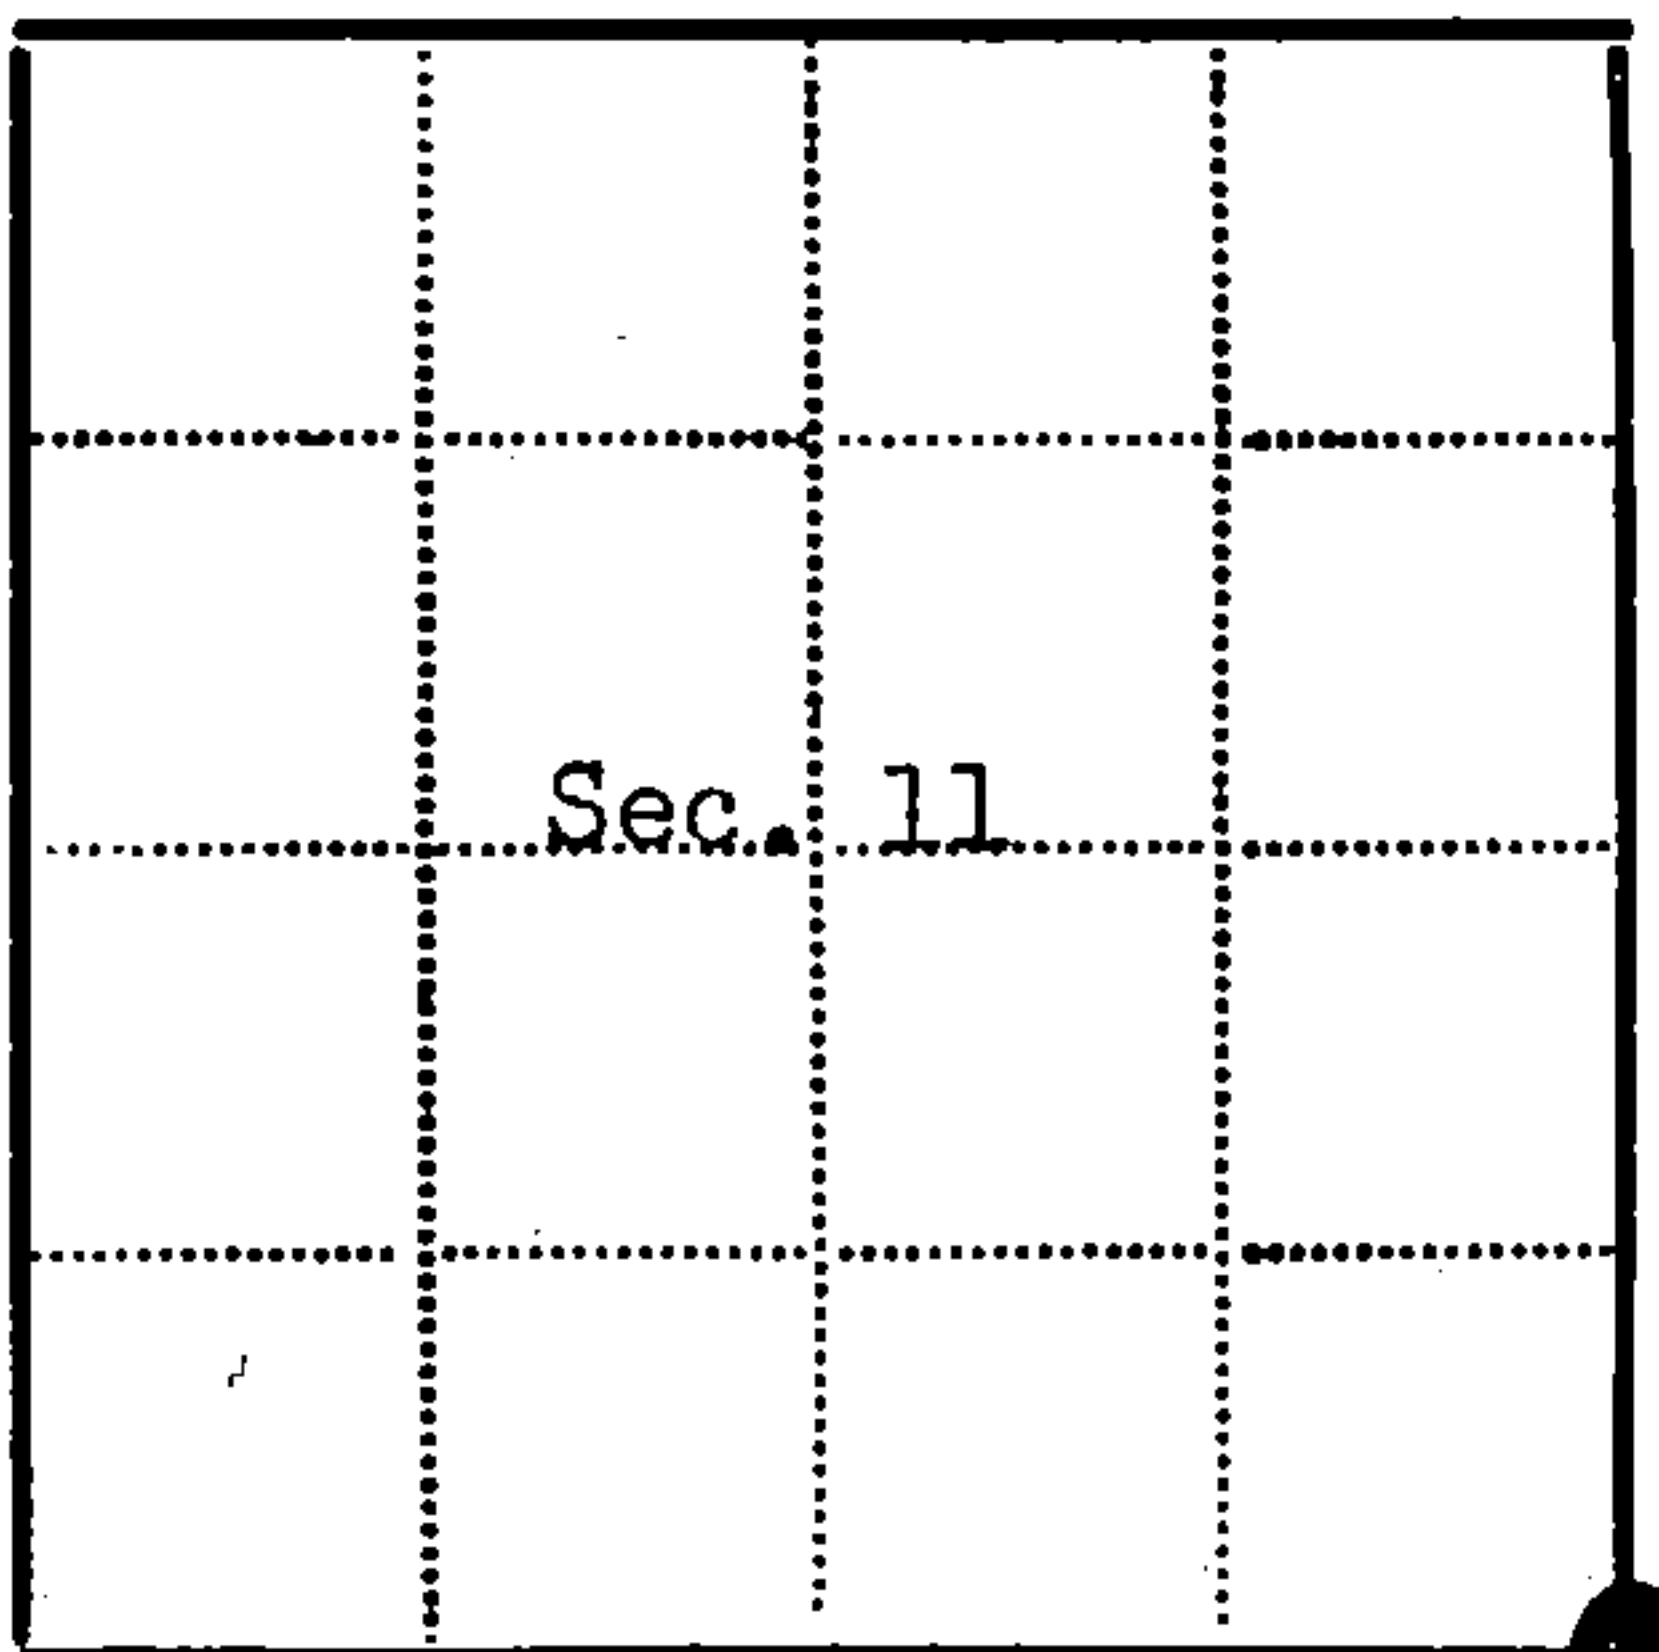
6x6 Cedar post rotted off in mound of rock
 Hemlock stump roots N25E, 28 lks
 Hemlock stump roots S26E, 34 lks.
 Hemlock stump roots S87W, 44 lks.
 8.30 ch. west, creek runs north

Replaced 6x6 cedar post with 2 inch inside diameter galvanized iron pipe, 3 feet long, filled with concrete, with brass cap stamped T35N, R14E, S11, S12, S14, S13, 1974, S-802
 Blazed and scribed the following new bearing trees
 Spruce 4, N75E, 1.68 feet
 Spruce 9, S6E, 13.61 Feet
 Steel sign post set 1 foot southeast of monument
