## U. S. PUBLIC LAND SURVEY MONUMENT RECORD

Section Corner to Sections 5, 6, 7 & 8,  
T35N, R15E, 4th P.M.

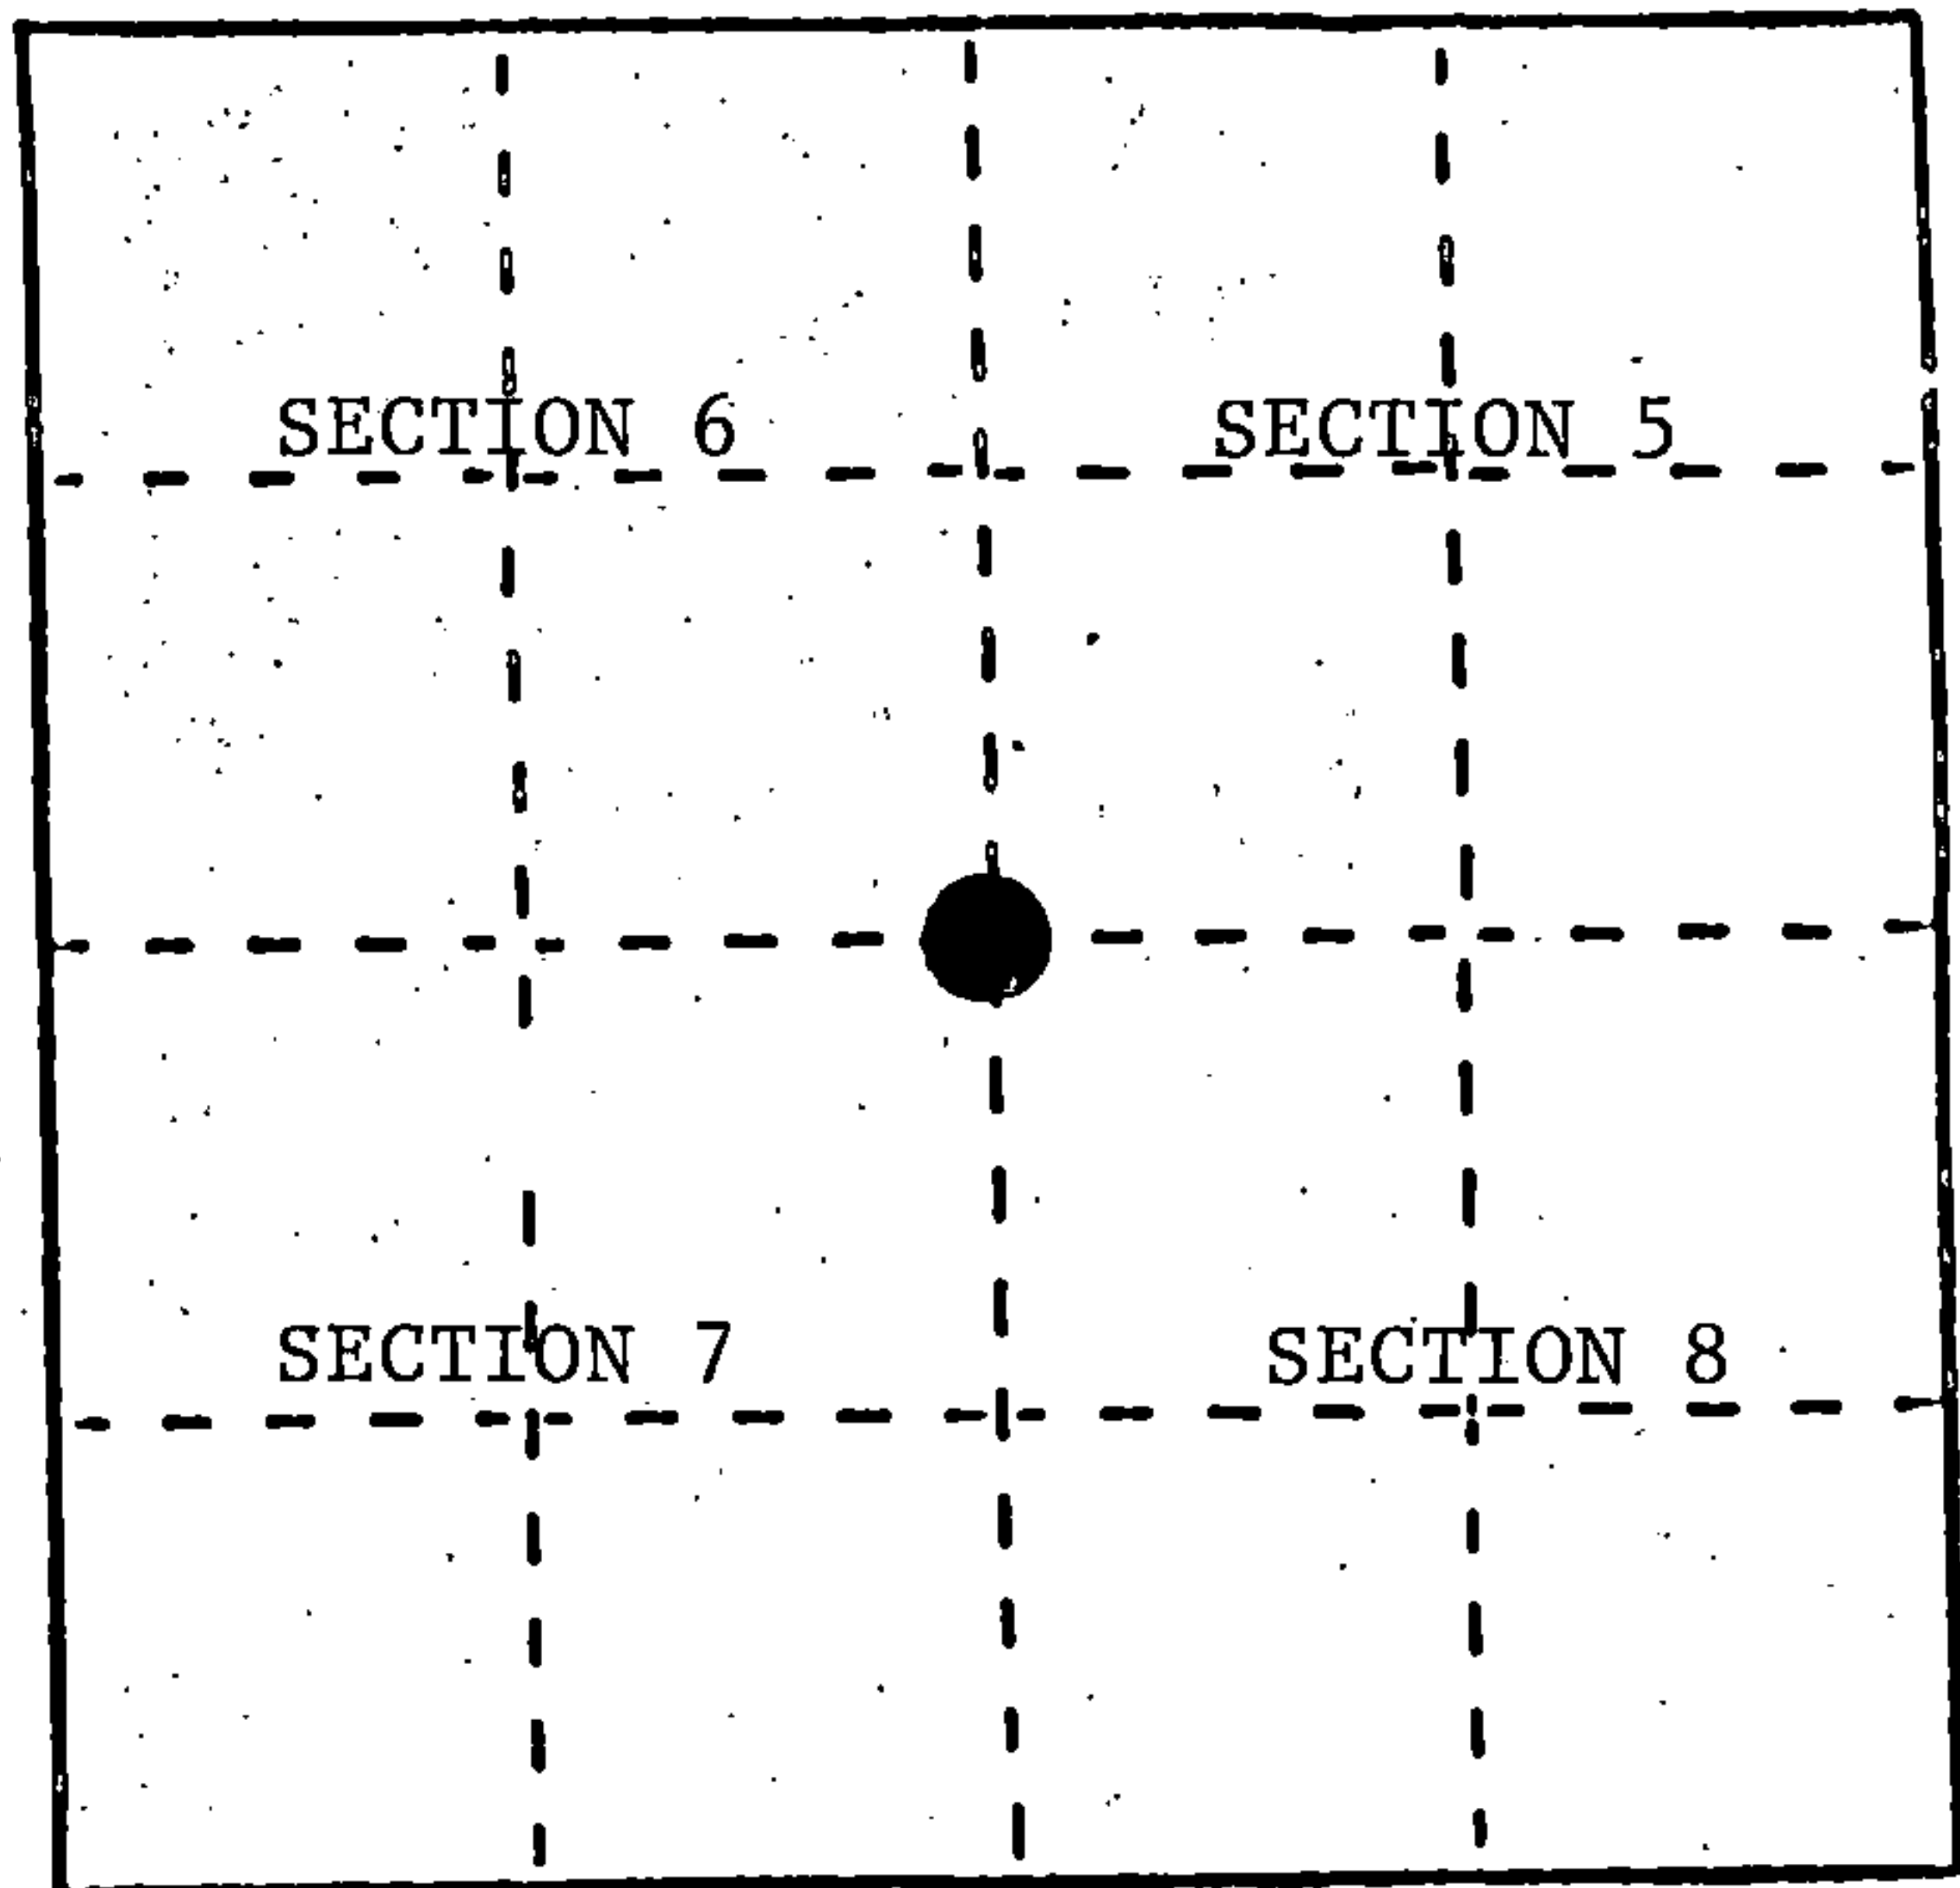
In 1859 James McBride established this corner and set a wood post with four BTs. As road construction has destroyed all evidence of the original corner, the BTs are no longer here.

An iron pipe 1" x 24" marks the accepted Section Corner position. It lies at the intersection of roads, in all four directions. This iron pipe was witnessed by two Forest Service references in 1965 when Jean Resvick worked Section 6. This same pipe was used by Thomas Arnott and John Fisher when Section 5 was subdivided in 1982.

6/28/89 I replaced the 1" x 24" iron pipe with a 2 1/2" x 36" aluminum monument. As Resvick's W.C. to the southeast was badly damaged, we also replaced it with a 1" x 36" drive type aluminum monument. We stamped both tablets, placed steel sign post at the W.C. and made two additional references.

- 1) 2 1/2" x 36" aluminum monument 2" below road surface.
- 2) 1" x 36" aluminum monument in mound of stone, SE, 49.90'
- 3) 6" x 60" concrete monument, SW, 38.00'
- 4) 18" White Spruce, N83°E, 127.00'
- 5) SE corner of cabin foundation, N55°W, 119.50'
- 6) Steel sign post, SE of RM to the SE, .77'
