CERTIFIED LAND CORNER RESTORATION

Index No. T-1

U.S. PUBLIC LAND SURVEY MONUMENT RECORD

Index No. T-25

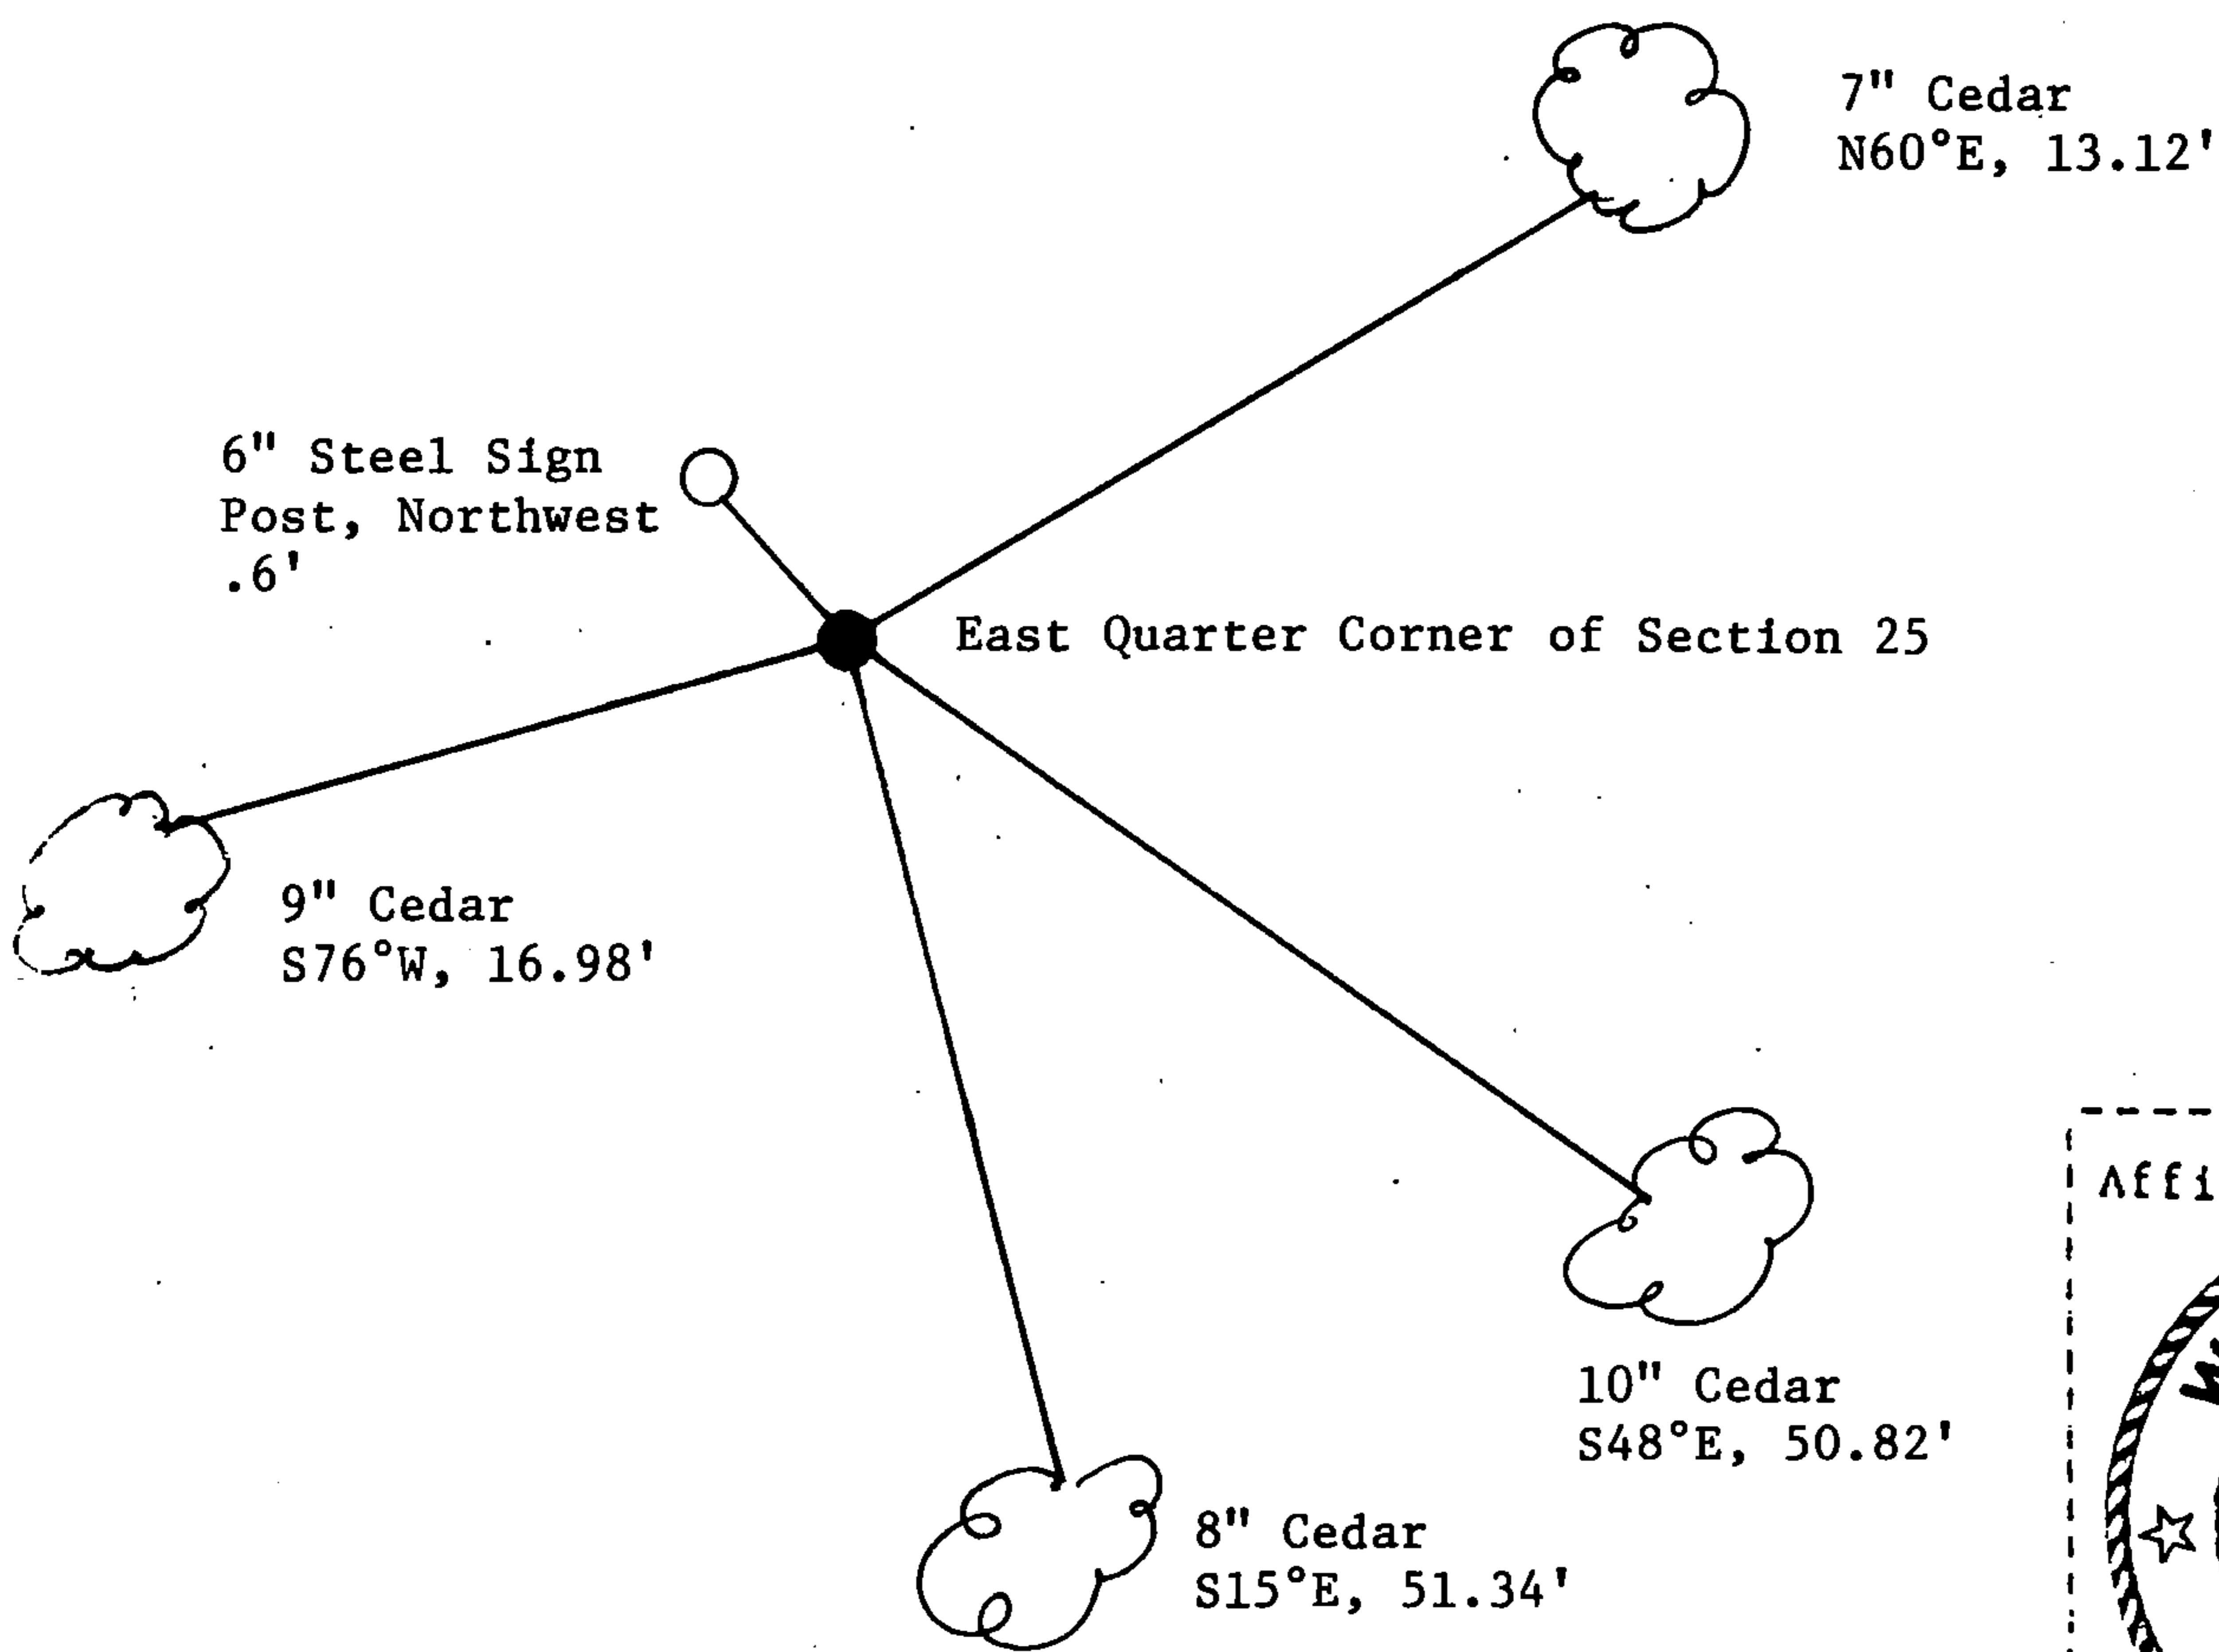
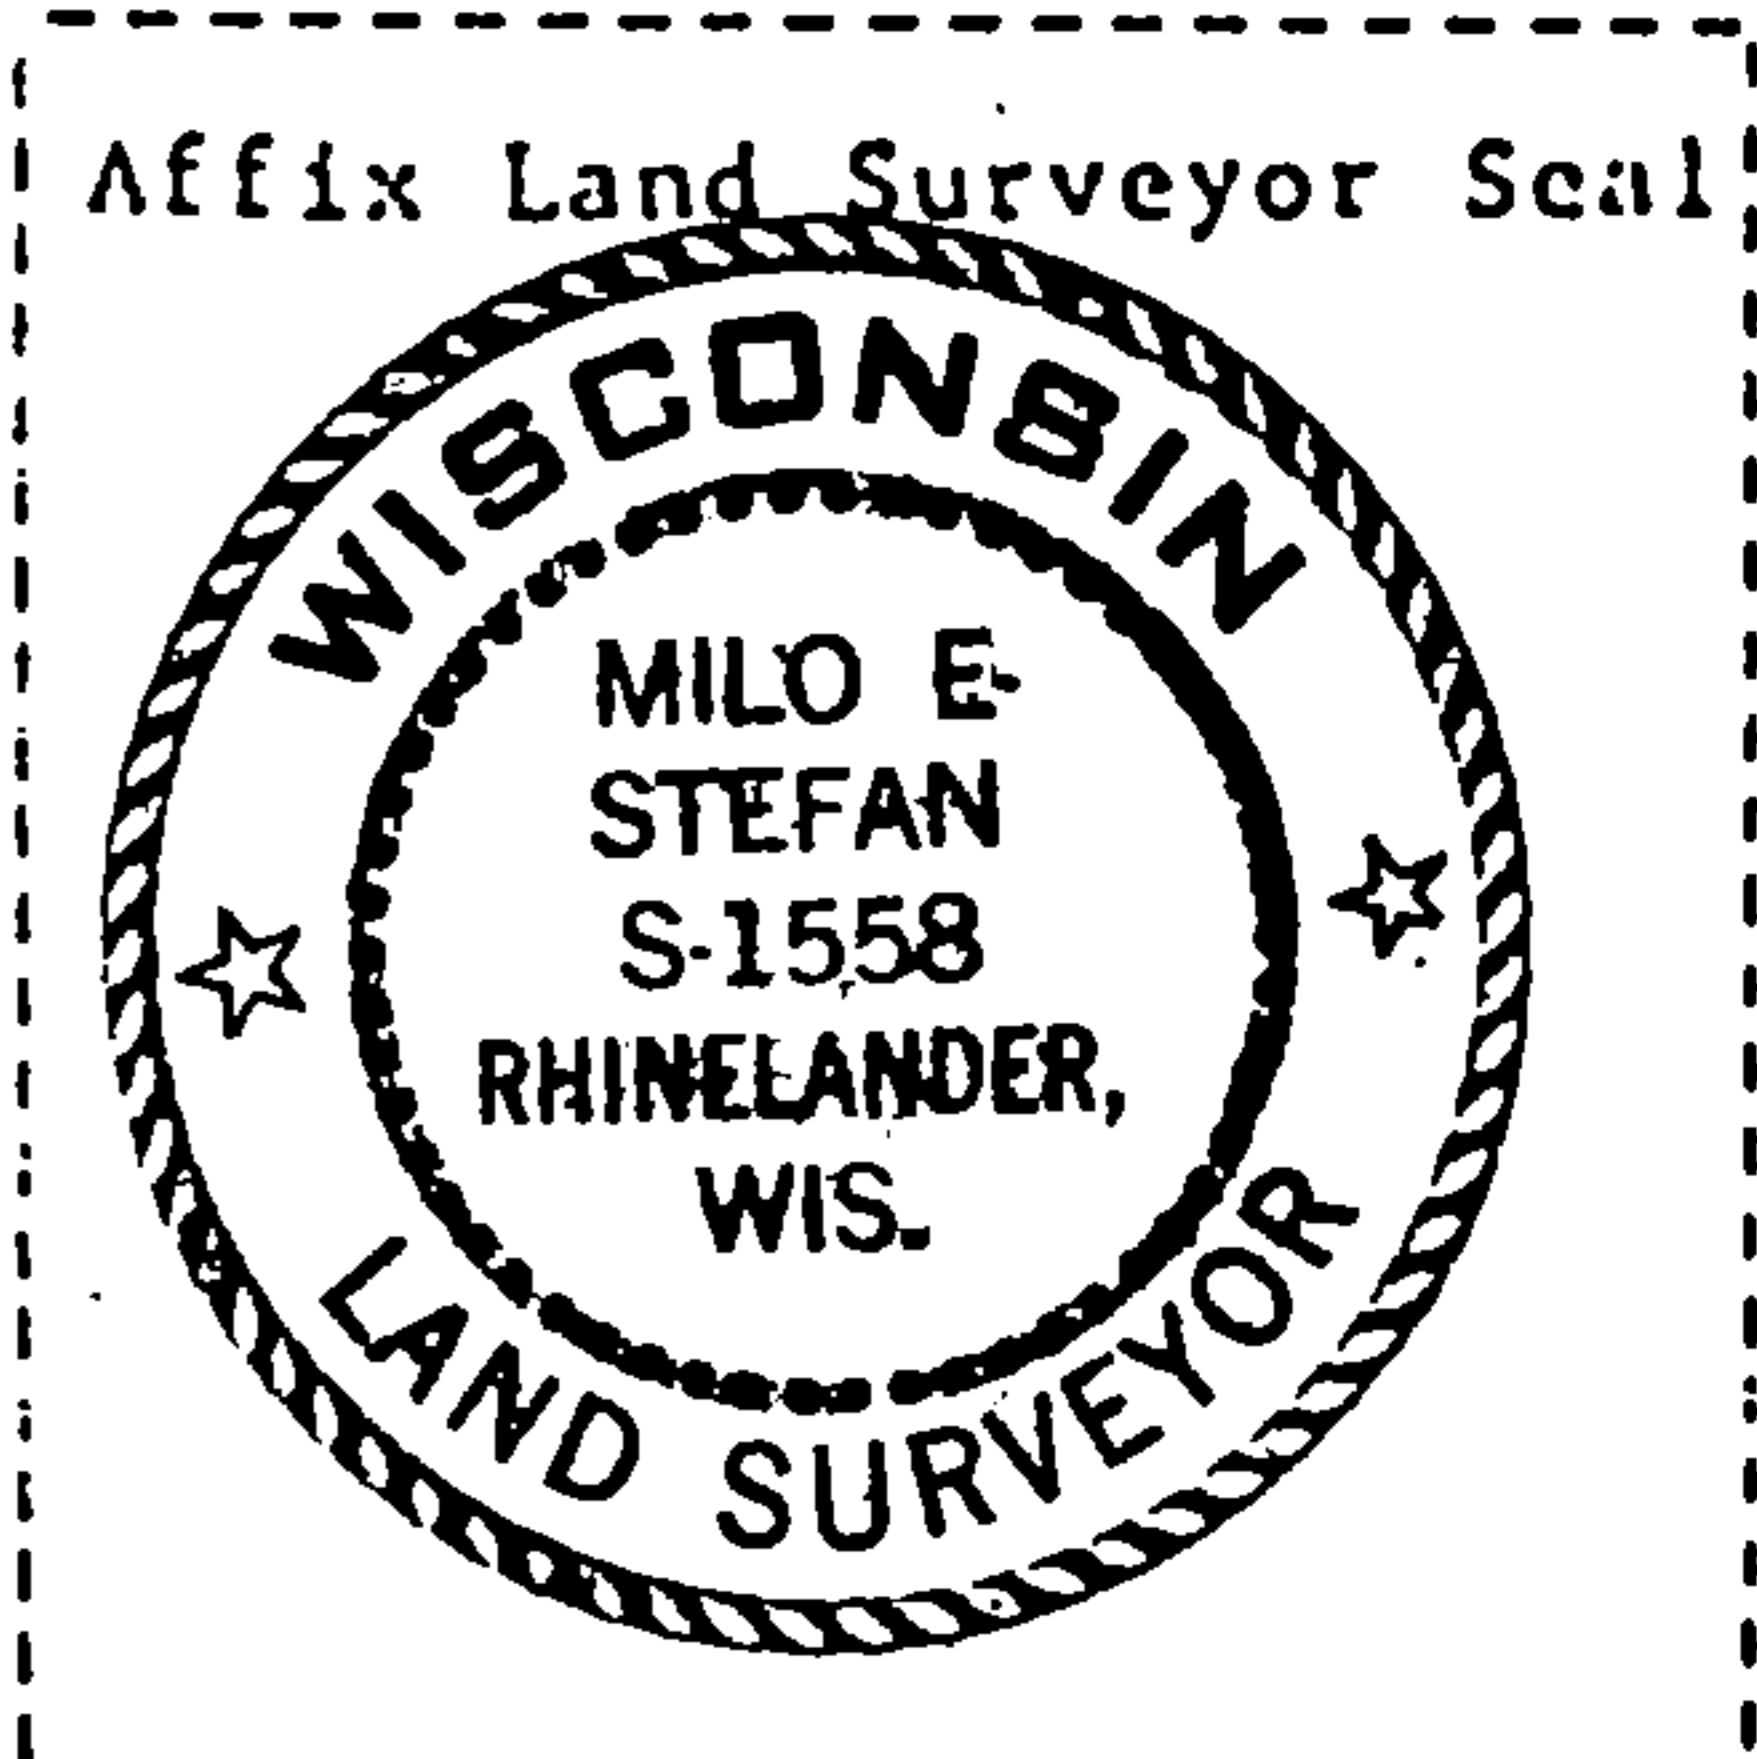
(f) Was the corner restored through acceptance of (1) an obliterated evidence location, or, (2) a found perpetuated location?

A found perpetuated location.
