U. S. PUBLIC LAND SURVEY MONUMENT RECORD

Quarter Corner to Sections 7 & 8,
T35N, R15E, 4th P.M.

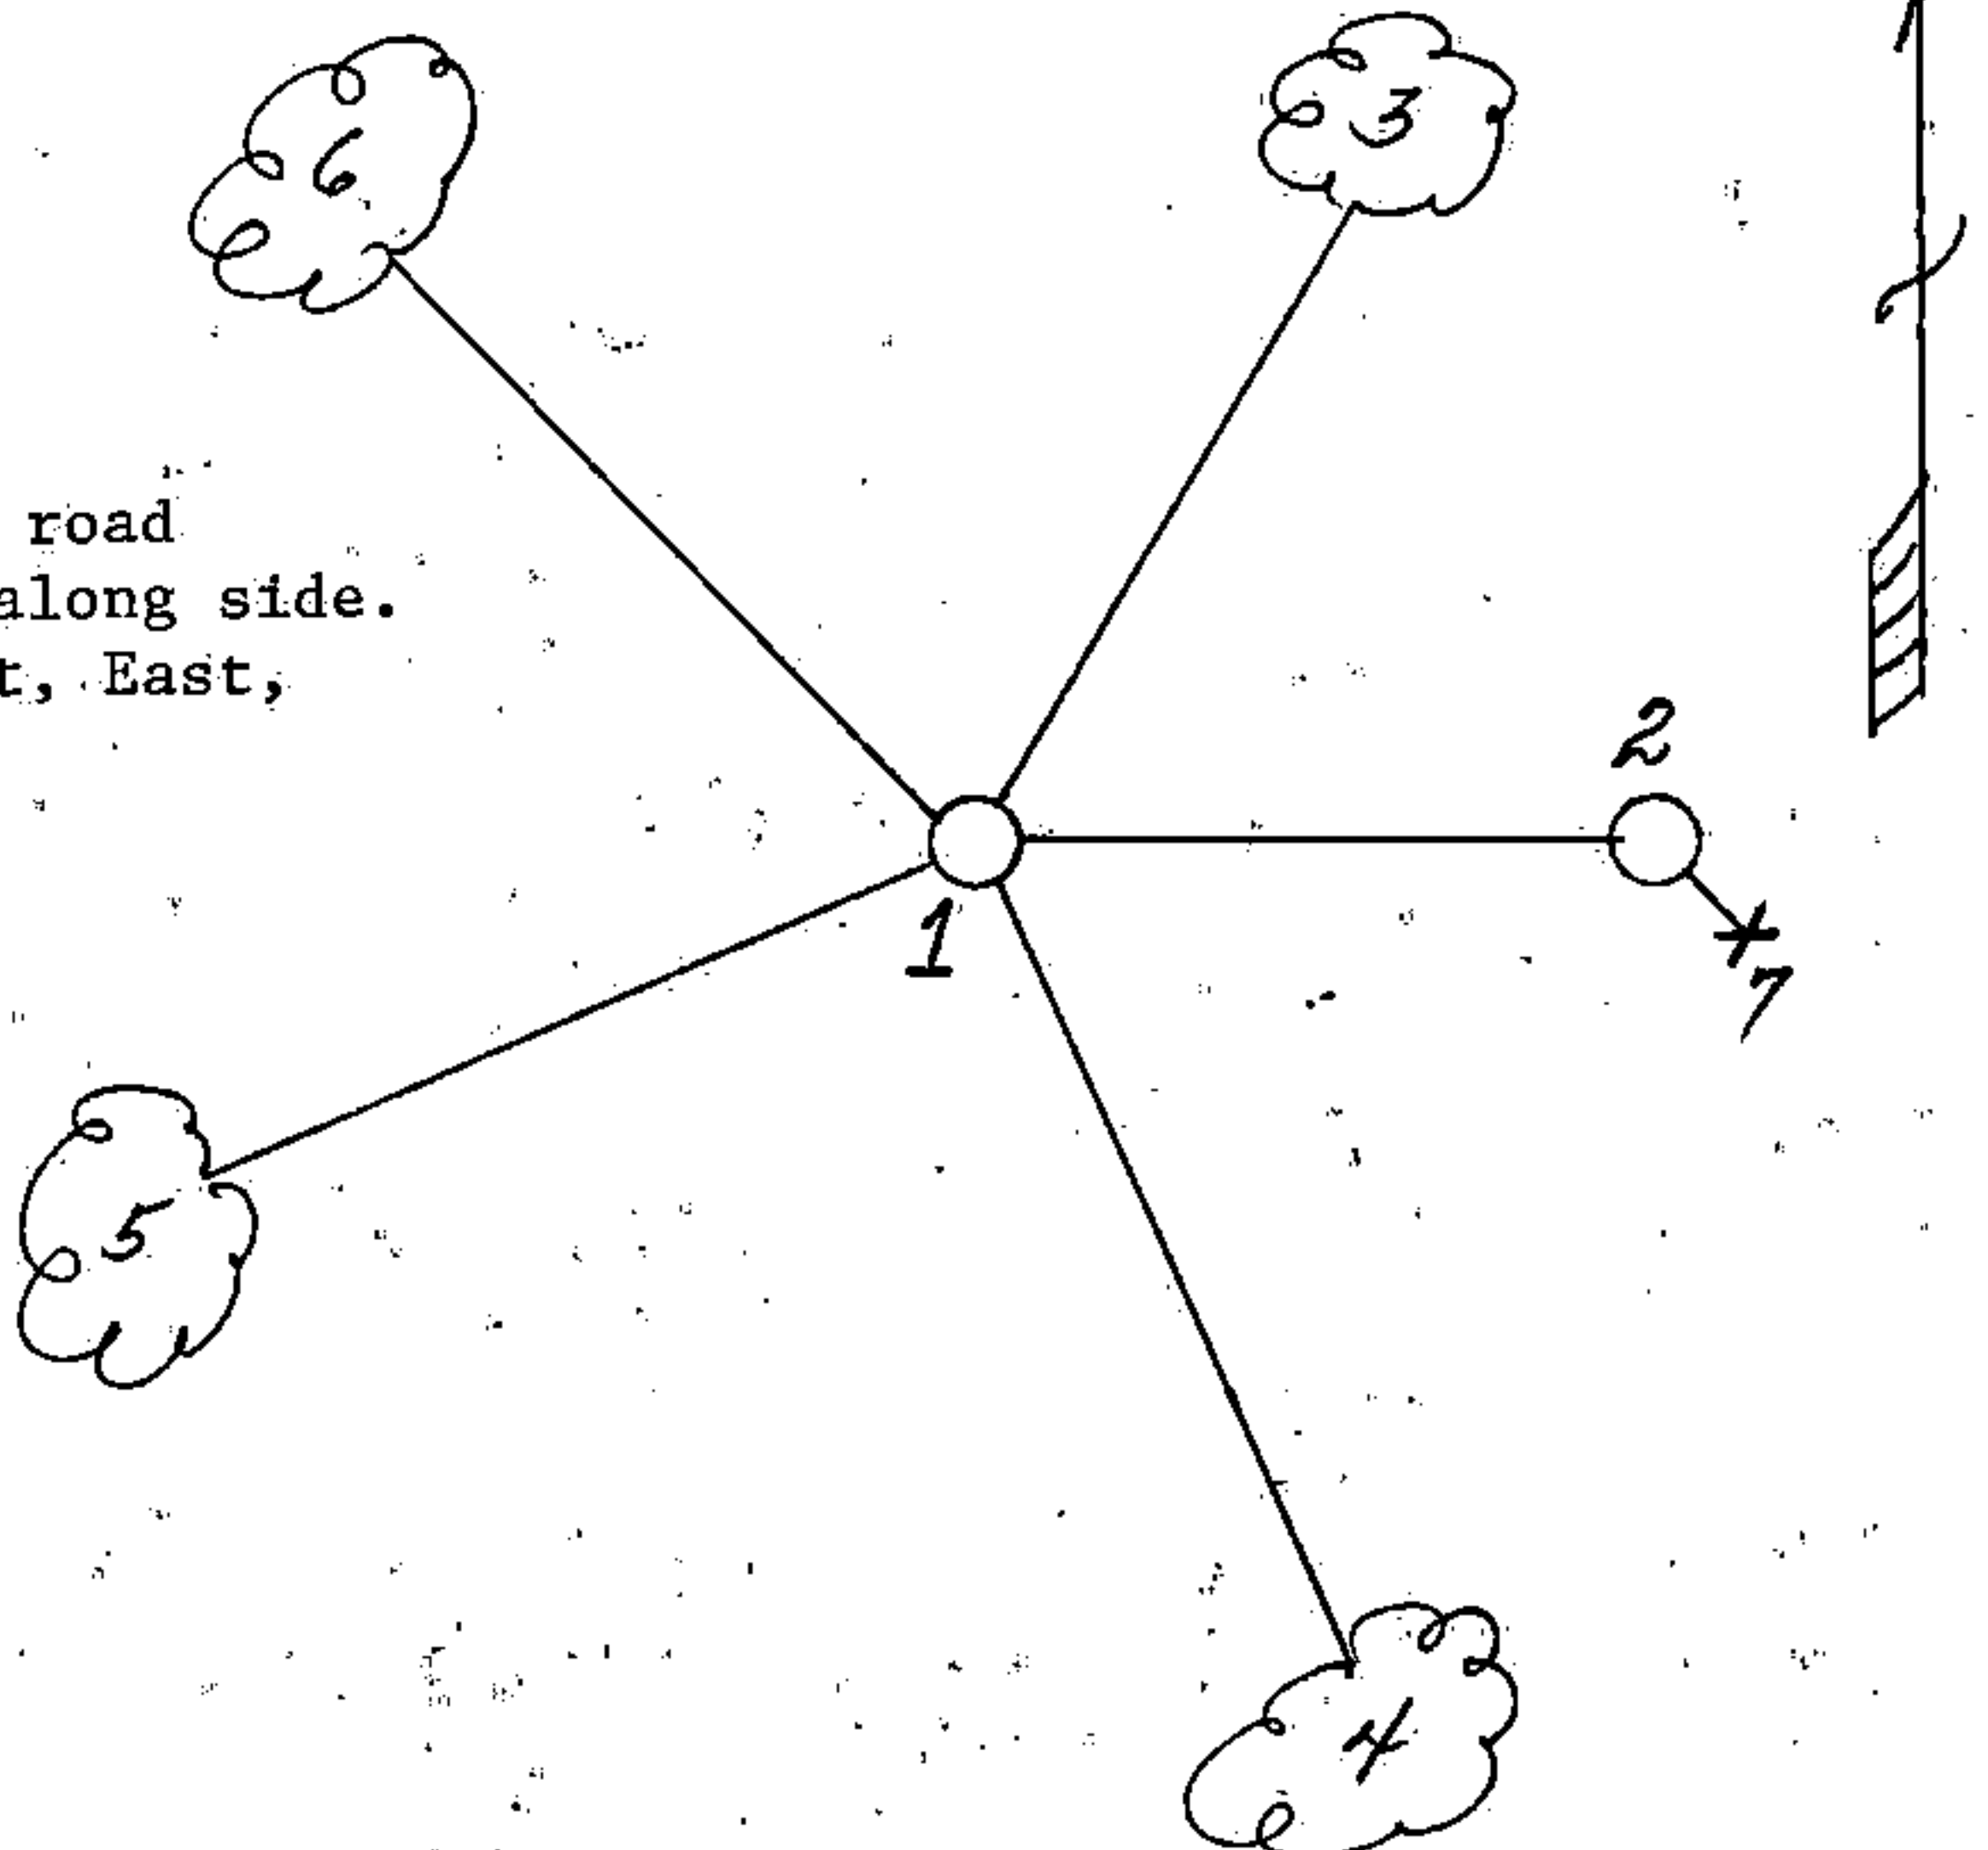
(d) Show a plan view drawing depicting the relevant monuments and reference ties which is sufficient in detail to enable accurate relocation of the corner monument if the corner monument is disturbed. Indicate north.

- 1) 3/4" x 24" iron rod, 8" below road surface with found iron pipe along side.
- 2) 2 1/2" x 36" aluminum monument, East, 25.00' as a Witness Corner.
- 3) 8" Cedar, N31°E, 47.70'
- 4) 4" Red Maple, S23°E, 39.06'
- 5) 12" Red Pine, S61°W, 65.83'
- 6) 10" Tamarack, N56°W, 75.00'
- 7) Steel Sign Post, East 24.00'
