CERTIFIED LAND CORNER RESTORATION

U. S. PUBLIC LAND SURVEY MONUMENT RECORD

Quarter Corner to Sections 25 and 30,
T35N, R16 - 17E.

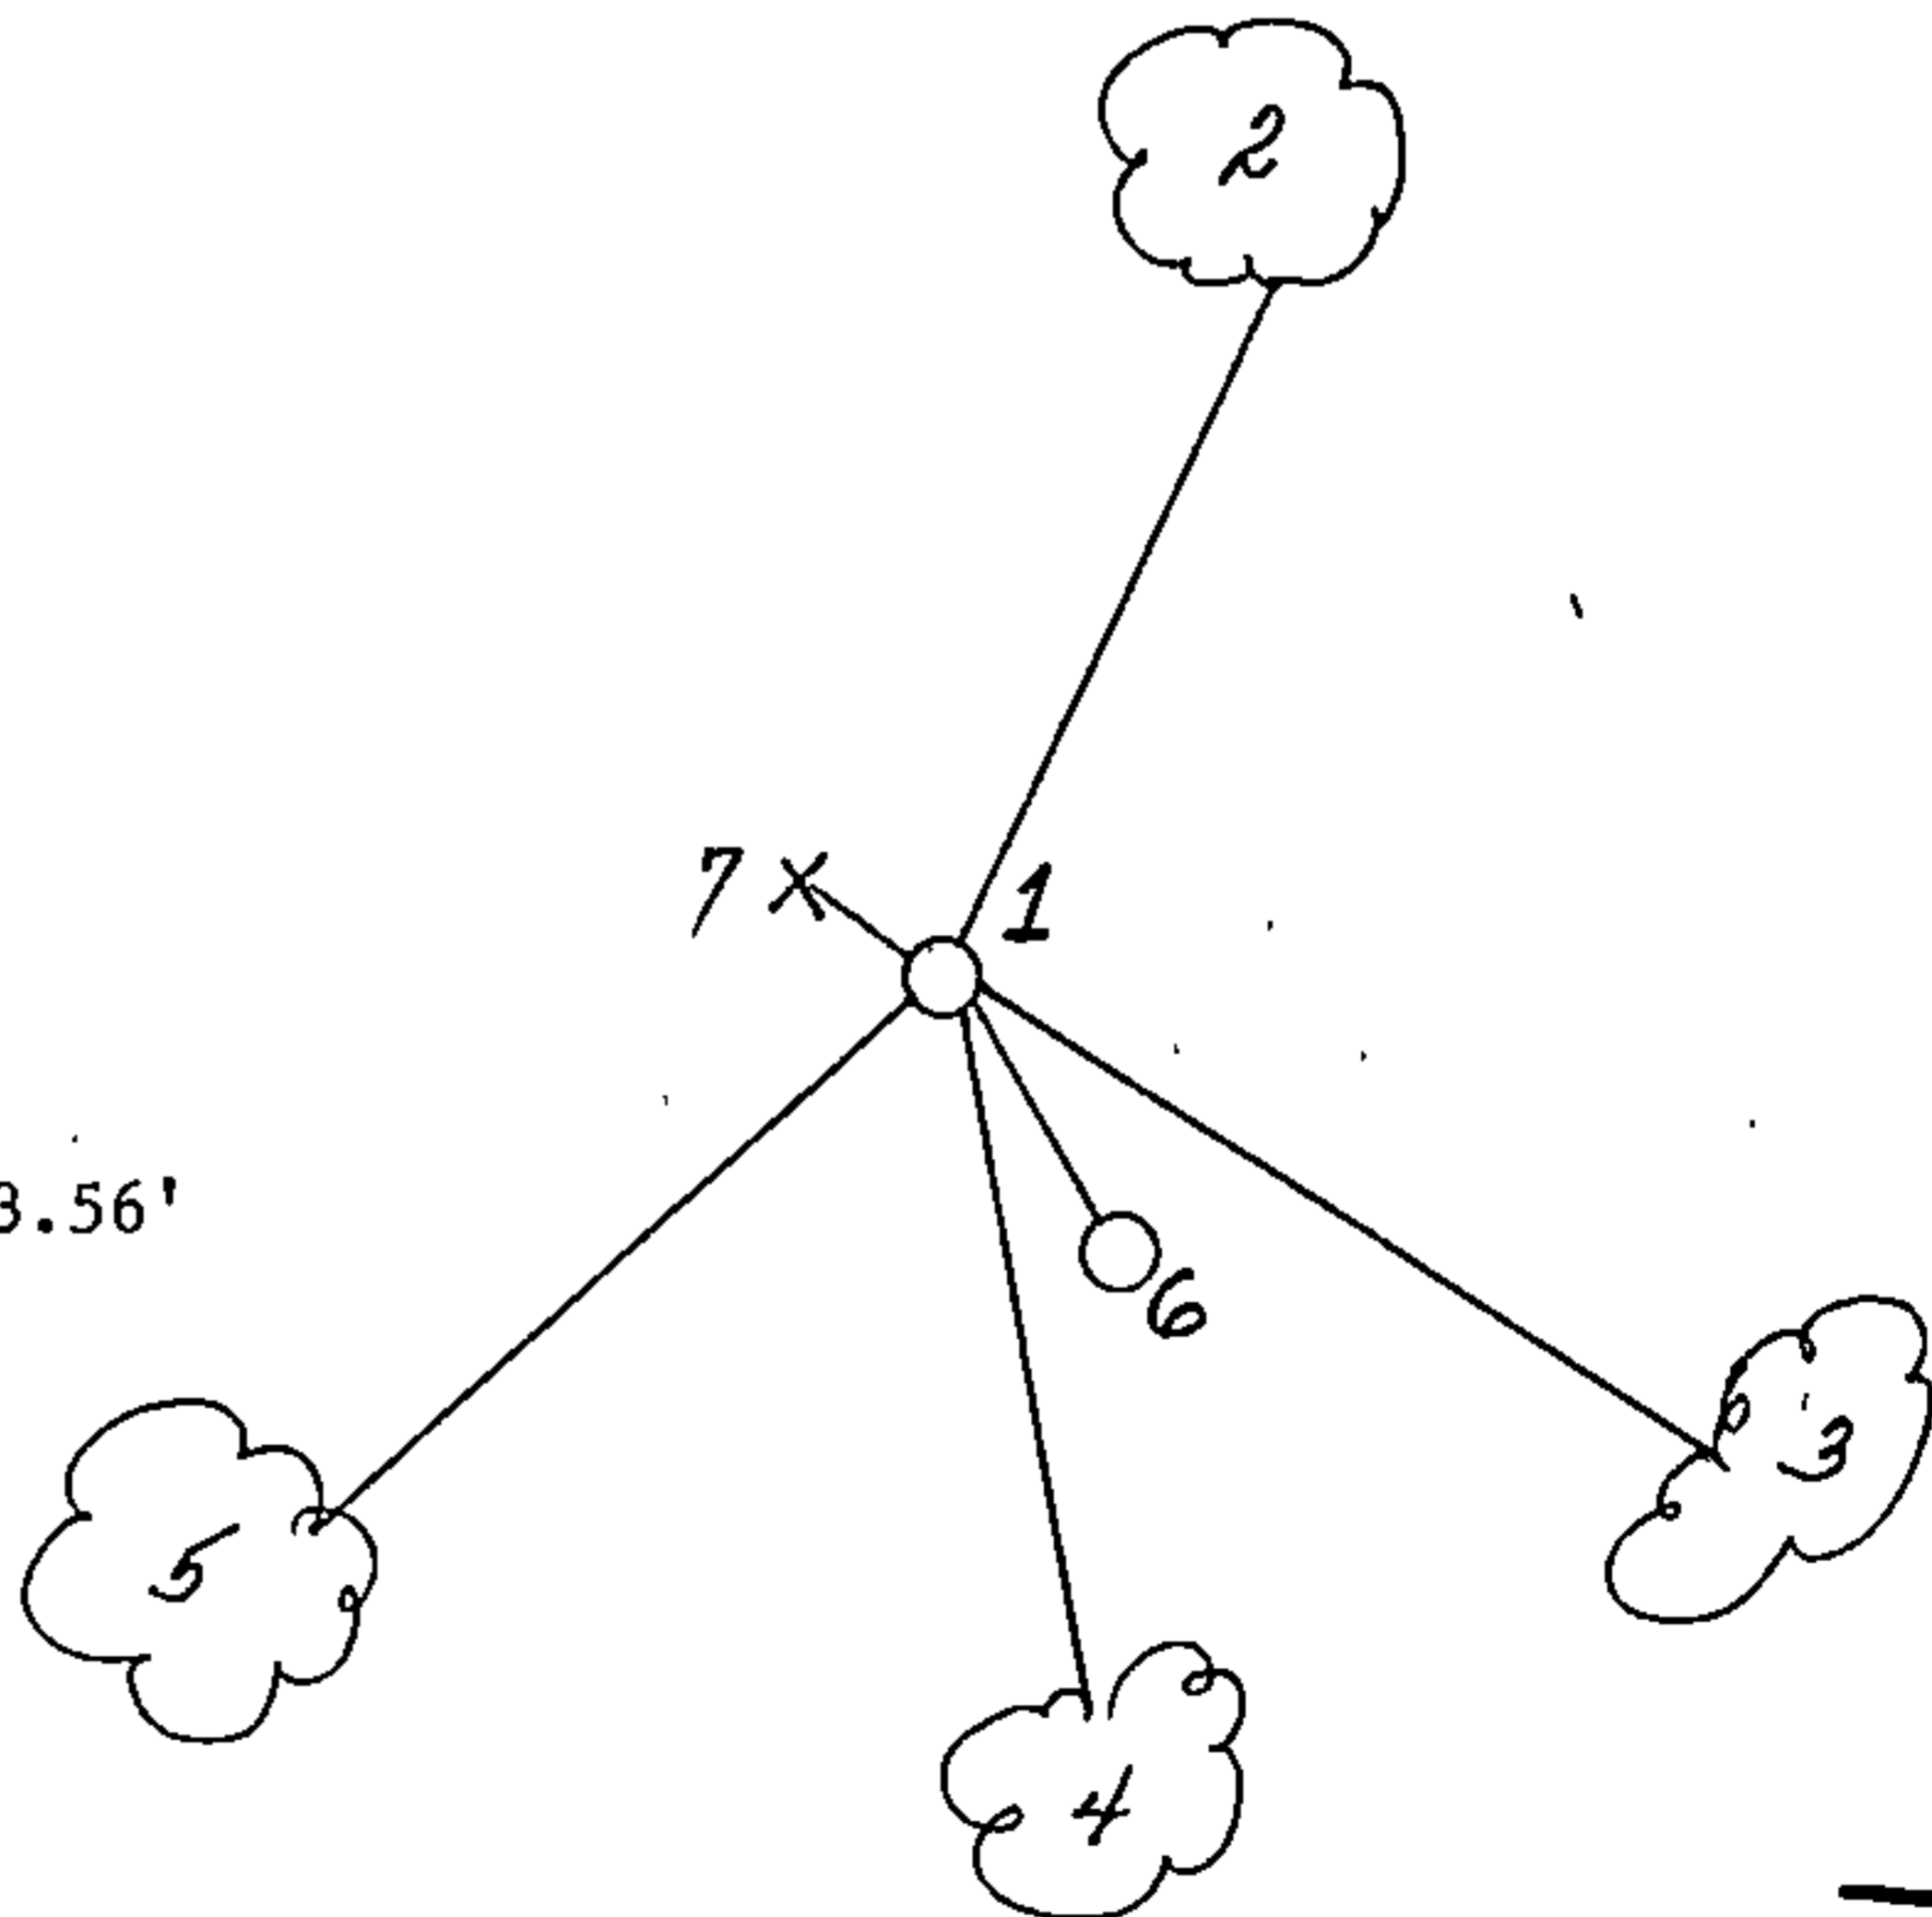
- (d) Show a plan view drawing depicting the relevant monuments and reference ties which is sufficient in detail to enable accurate relocation of the corner monument if the corner monument is disturbed. Indicate north.

- 1) 2½" x 36" aluminum monument in mound of stone
- 2) Sugar Maple, 8", N16°E, 30.65'
- 3) Sugar Maple, 8", S09°E, 32.69'
- 4) Sugar Maple, 8", S47°E, 51.54'
- 5) Sugar Maple, 8", S49°W, 41.76'
- 6) 4" x 36" iron pipe with brass cap buried to ground level, S13°-59.2'E, 3.56'
- 7) Steel Sign Post, Northwest, 1.4'

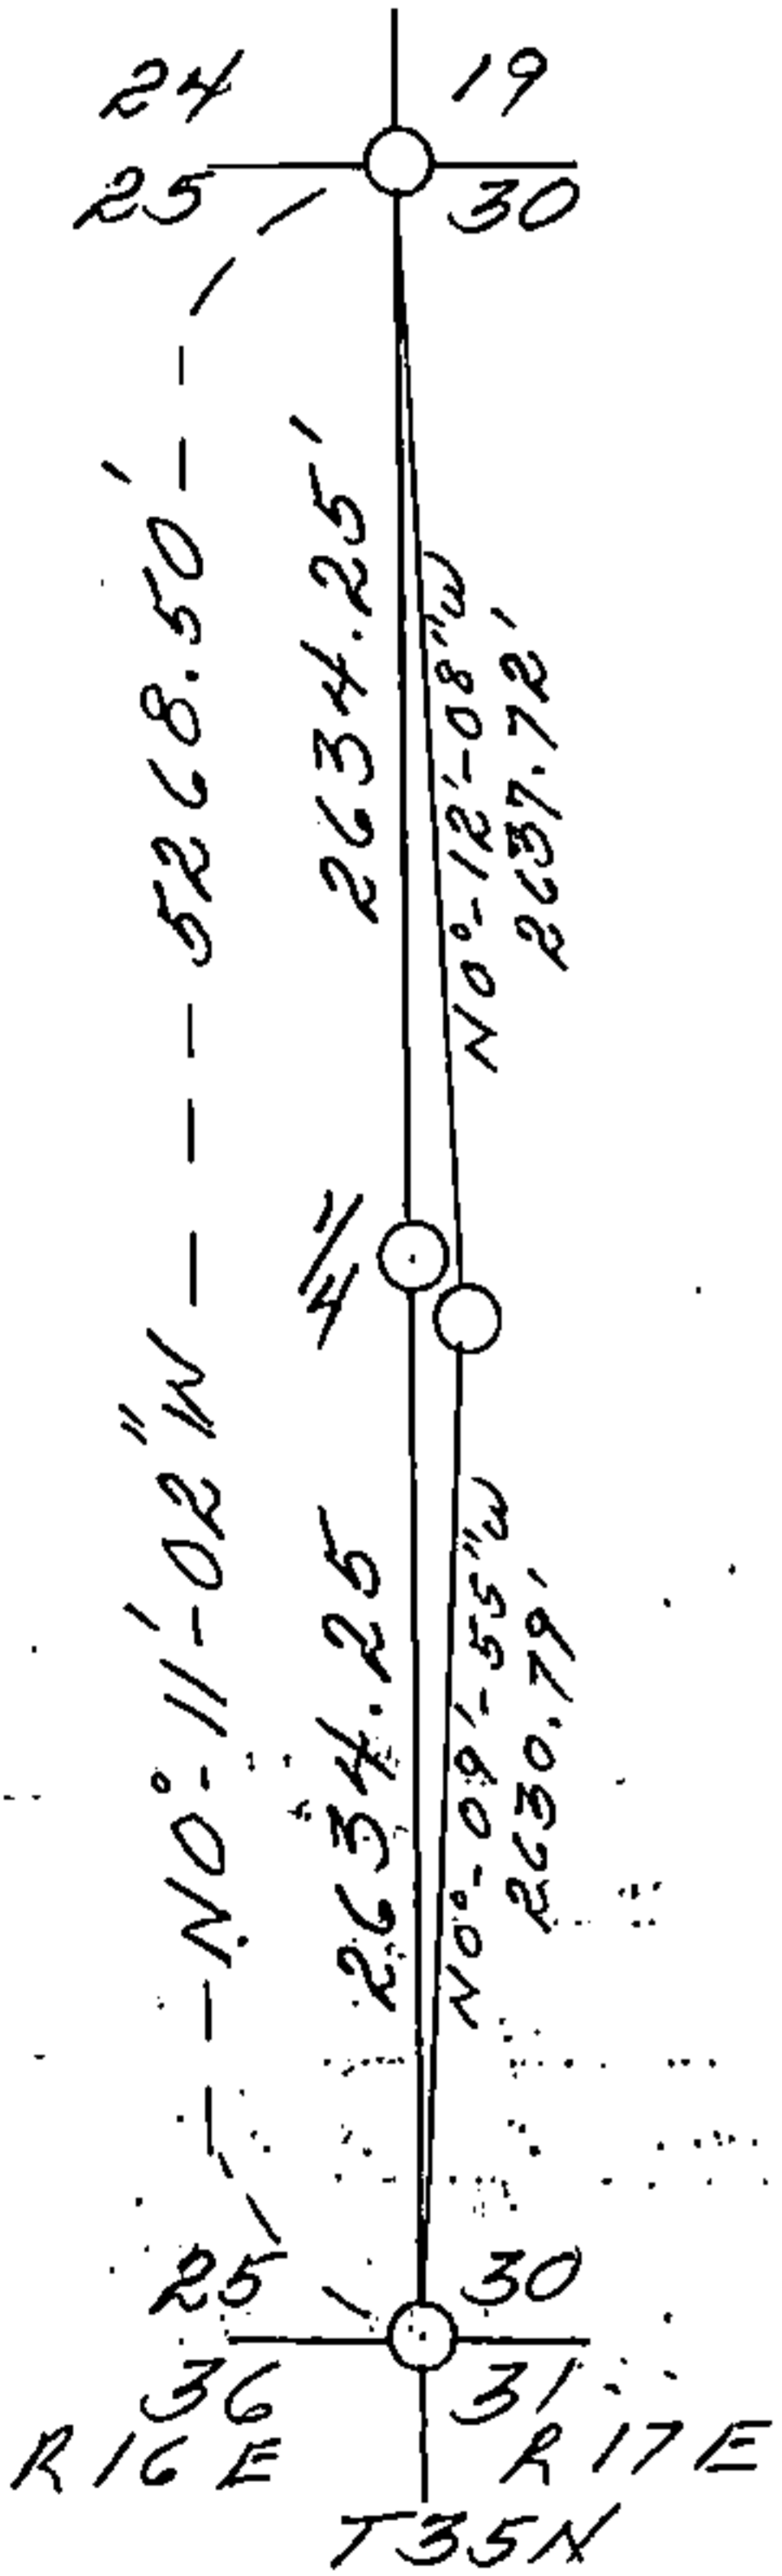
(g & h) Was the corner reestablished through lost corner proportionate methods? If so, show the method, including the directions and distances to other public land survey corners used as evidence or used for proportioning in determining the corner location?

See drawing under g and h.
