U. S. PUBLIC LAND SURVEY MONUMENT RECORD

1/4 Corner to Sections 24 and 25, T.36 N., R.14 E. of the 4th Principal Meridian, Wisconsin.

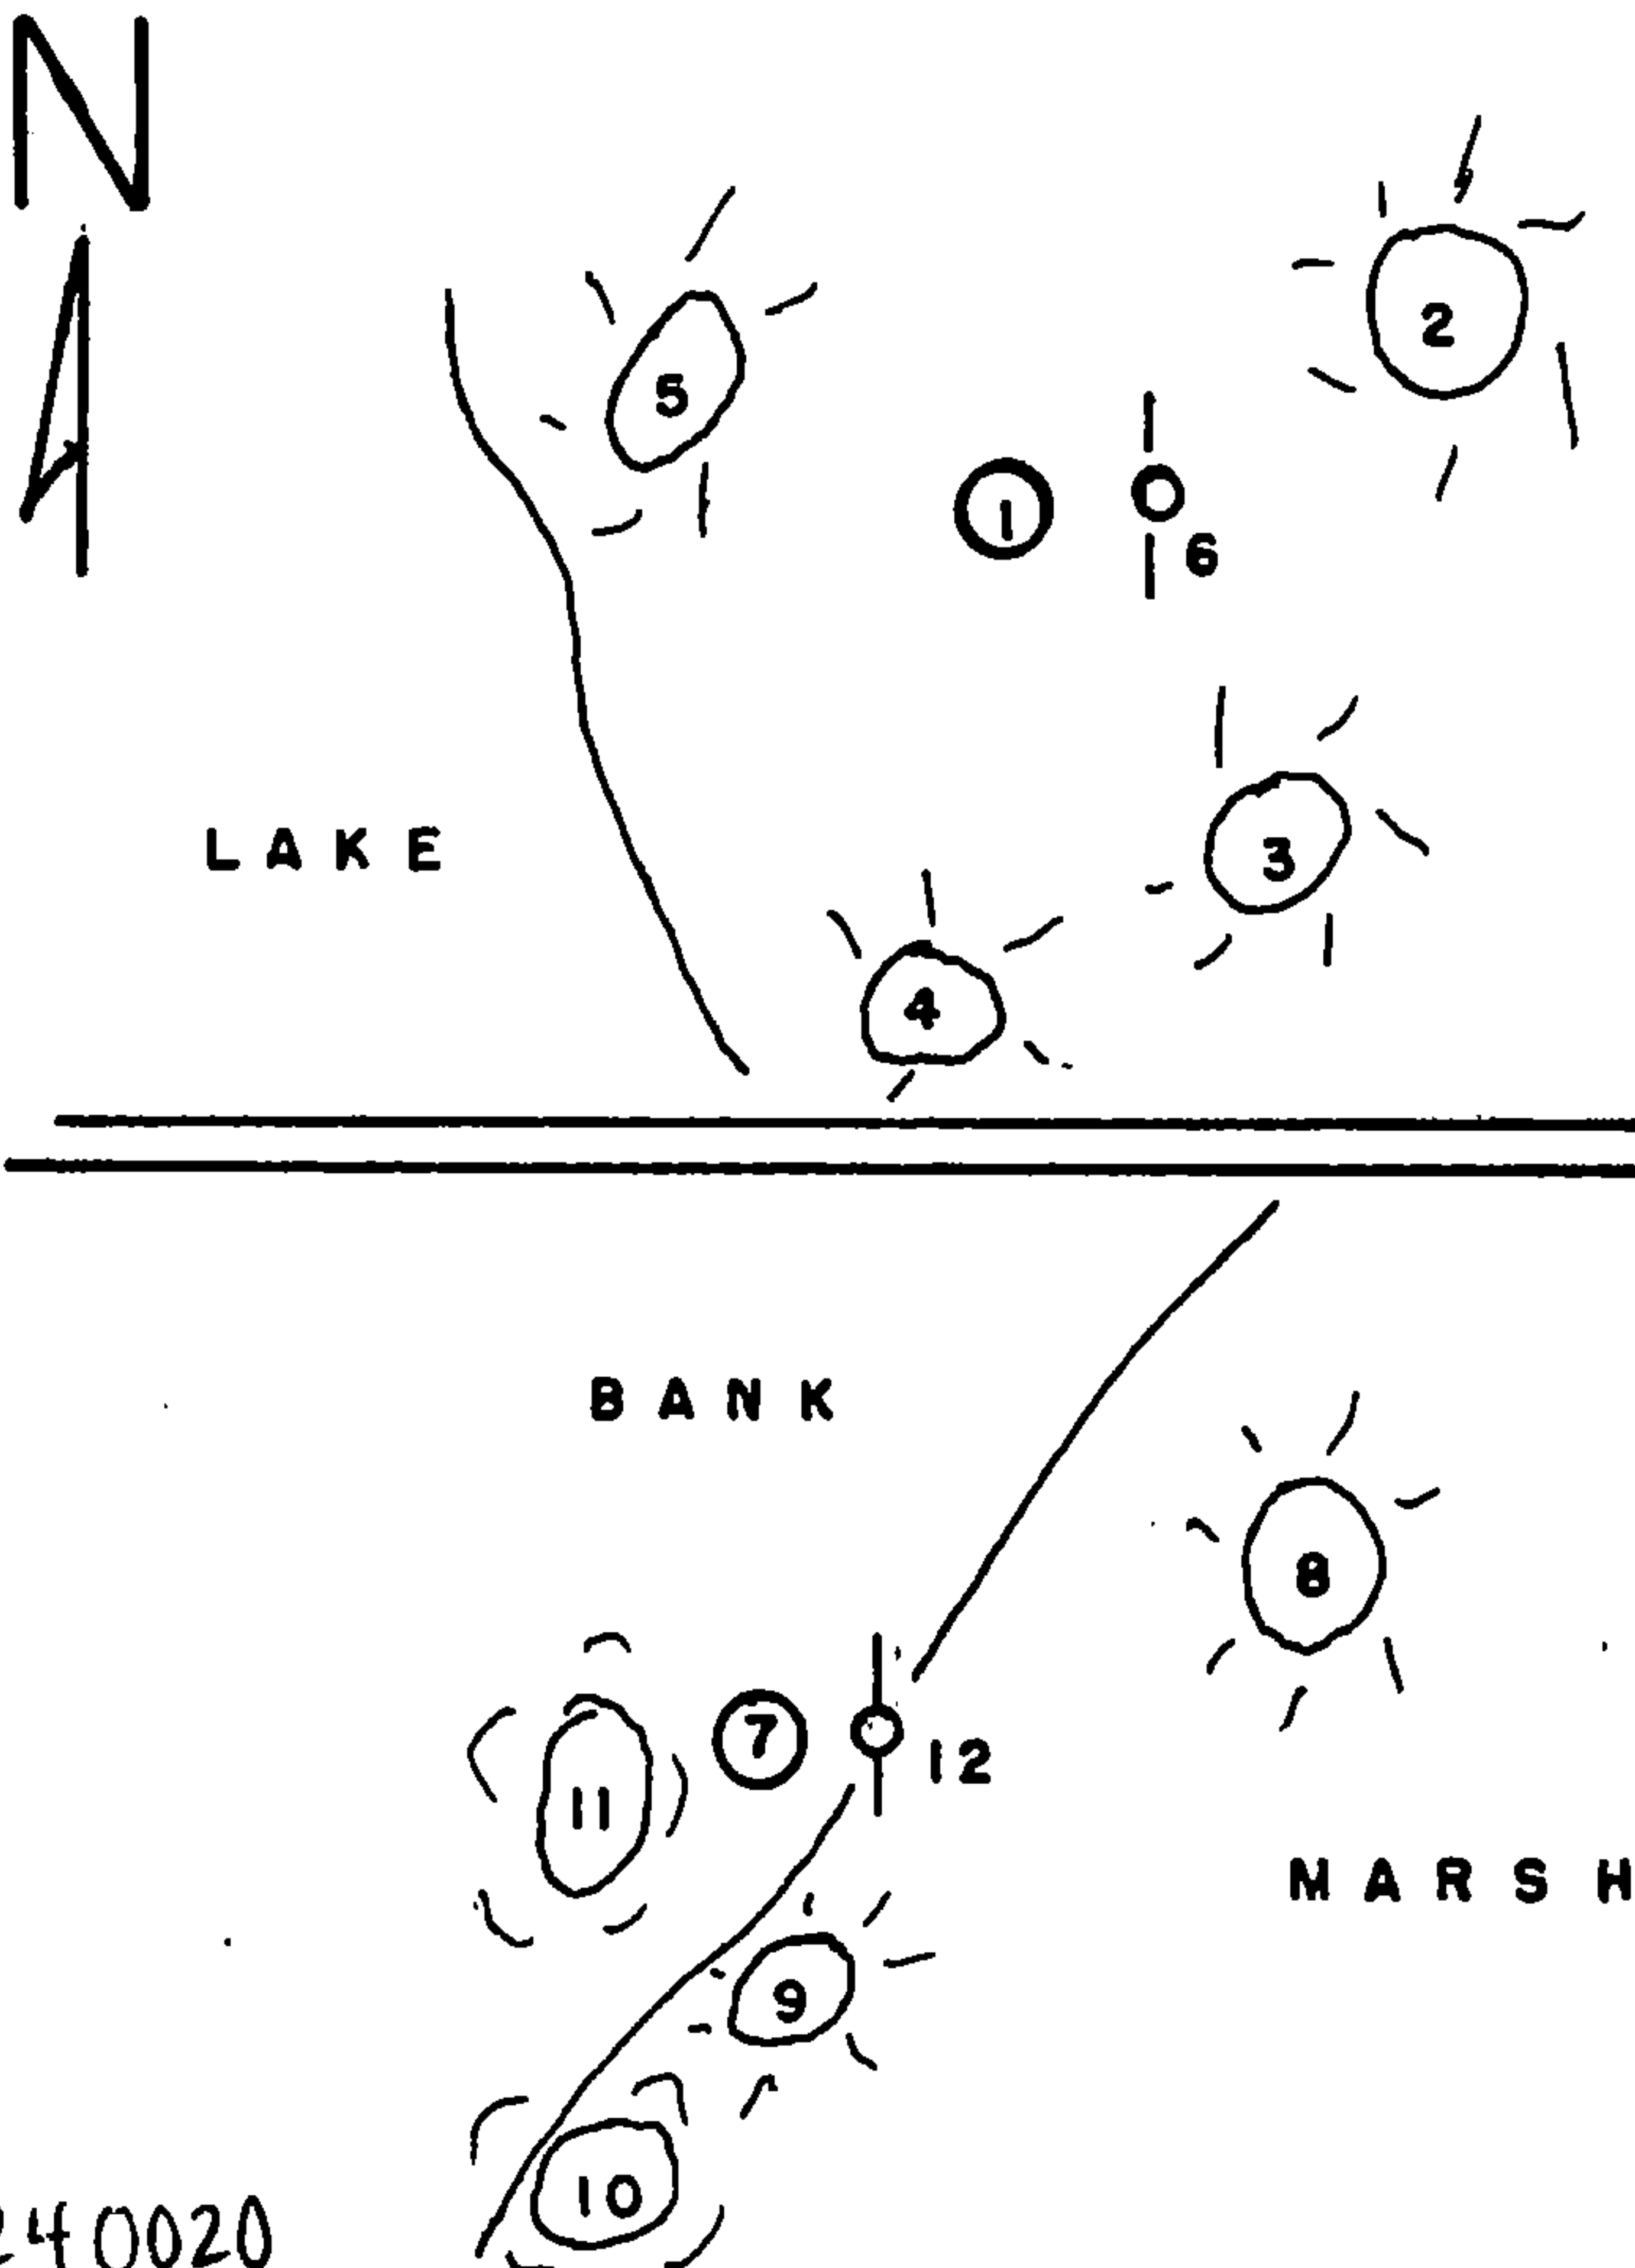
- (d) Show a plan view drawing depicting the relevant monuments and reference ties which is sufficient in detail to enable accurate relocation of the corner monument if the corner monument is disturbed. Indicate north.

1. W.C.EAST OF LAKE  
2. B.T. Hemlock 10" N.74 E. 18.1'  
3. B.T. Cedar 5" S.38 E. 14.5'  
4. B.T. Cedar 5" S.08 W. 19.25'  
5. B.T. Cedar 7" N.73 W. 10.55'  
6. Steel Sign Post EAST 1.3'

7. W.C.WEST OF LAKE  
8. B.T. Balsum 6" N.74 E. 11.65'  
9. B.T. Hemlock 20" SOUTH 12.7'  
10. B.T. Maple 10" S.30 W. 18.1'  
11. B.T. Maple 8" S.73 W. 4.4'  
12. Steel Sign Post EAST 1.3'

In 1986 I found the corner position marked by 1 1/4" iron pipe; found stumps of both original B.T.s which measure well from this monument; as this area is now flooded by lake, with water aprox. 4' deep, I set Witness Corners on section line as follow; a 2"x 36" Aluminum Pipe with cap bearing S.89-03.3 E. 327.7' and a 2"x 36" Aluminum Pipe with cap bearing S.87-07.9 W. 961.4'; I referenced the two W.C.s as shown below.
