U. S. PUBLIC LAND SURVEY MONUMENT RECORD

Quarter Corner Common to Sections 12 and 13, T36N-R16E

Index Number J-23 (T36N-R16E)

Forest County, Wisconsin

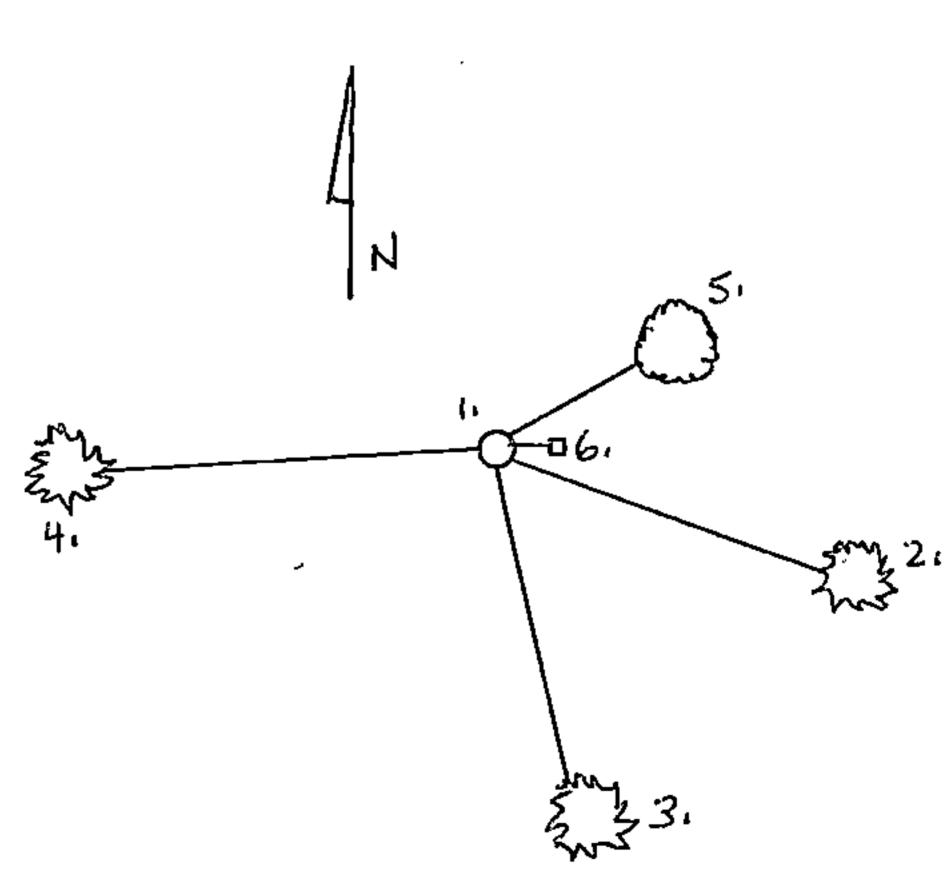
- (d) Show a plan view drawing depicting the relevant monuments and reference ties which is sufficient in detail to enable accurate relocation of the corner monument if the corner monument is disturbed. Indicate north.

- 1. 2" x 36" Aluminum monument with position stamped on cap.
- 2. W. Spruce 12" S79°E 41.03 feet.
- 3. W. Spruce 10" S09°E 64.30 feet.
- 4. W. Spruce 18" S85°W 68.19 feet.

- 5. Aspen 8" N50°E 10.77 feet.
- 6. Steel sign post East 1.4 feet.

- 1982 Pipe was recovered by M. Stefan, S-1558, per Forest Service records. Corner was restored with 2" x 36" aluminum monument witnessed by: W.Spruce 12" S79°E 41.03'; W.Spruce 10" S09°E 64.30'; W.Spruce 18" S85°W 68.19'; Steel sign post East 1.4'.
