## U. S. PUBLIC LAND SURVEY MONUMENT RECORD

Quarter corner to Sections 3 and 34, T.35-36N., R.16E., Fourth Principal Meridian, Forest County, Wisconsin.

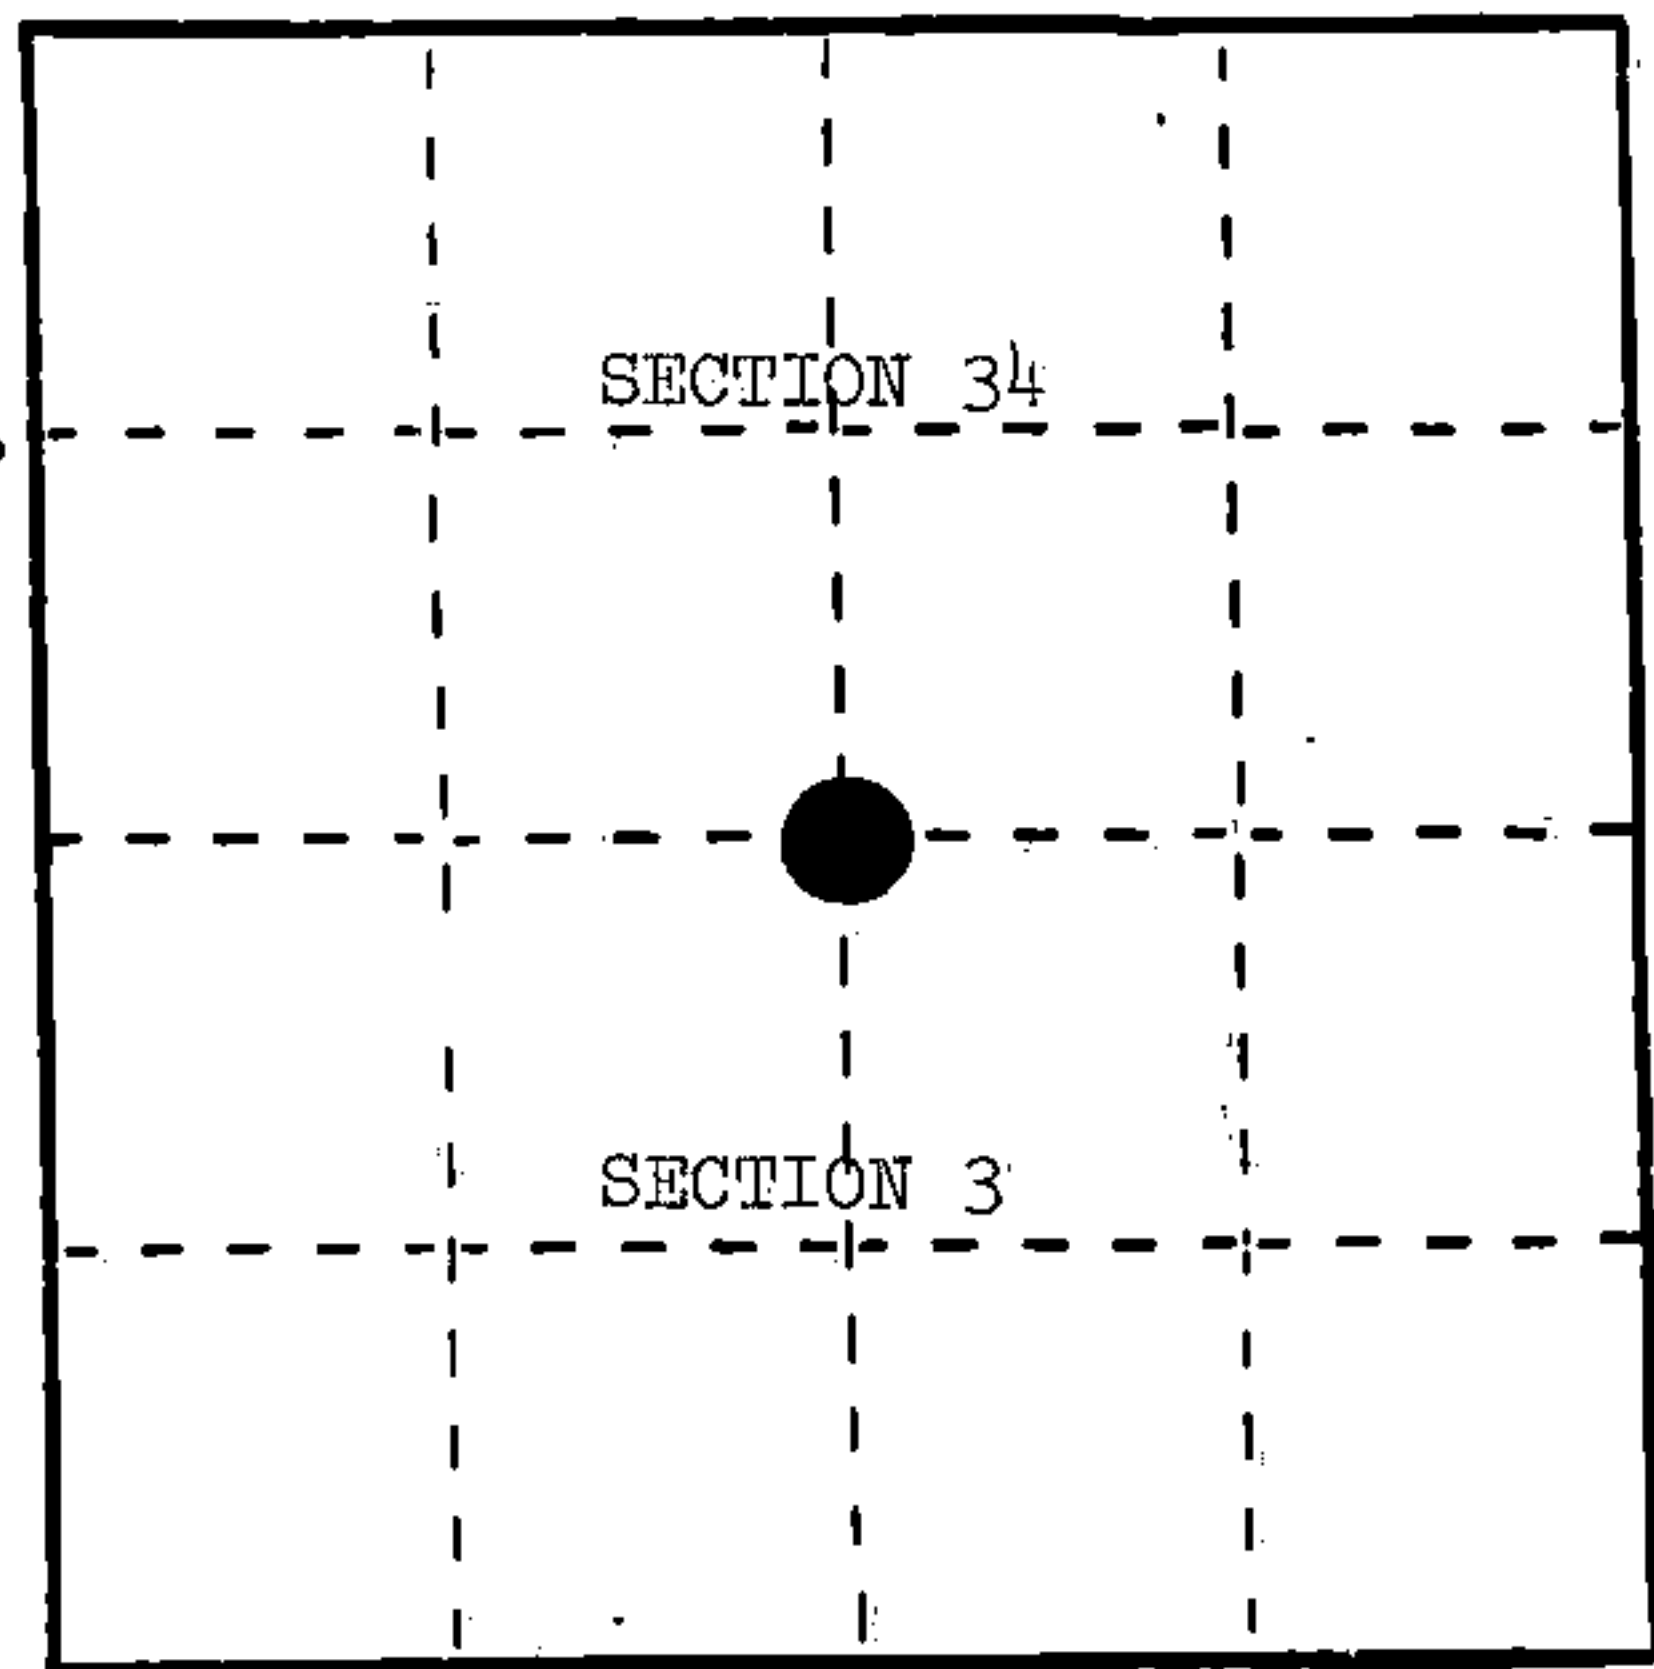
○ = Corner monument restored.

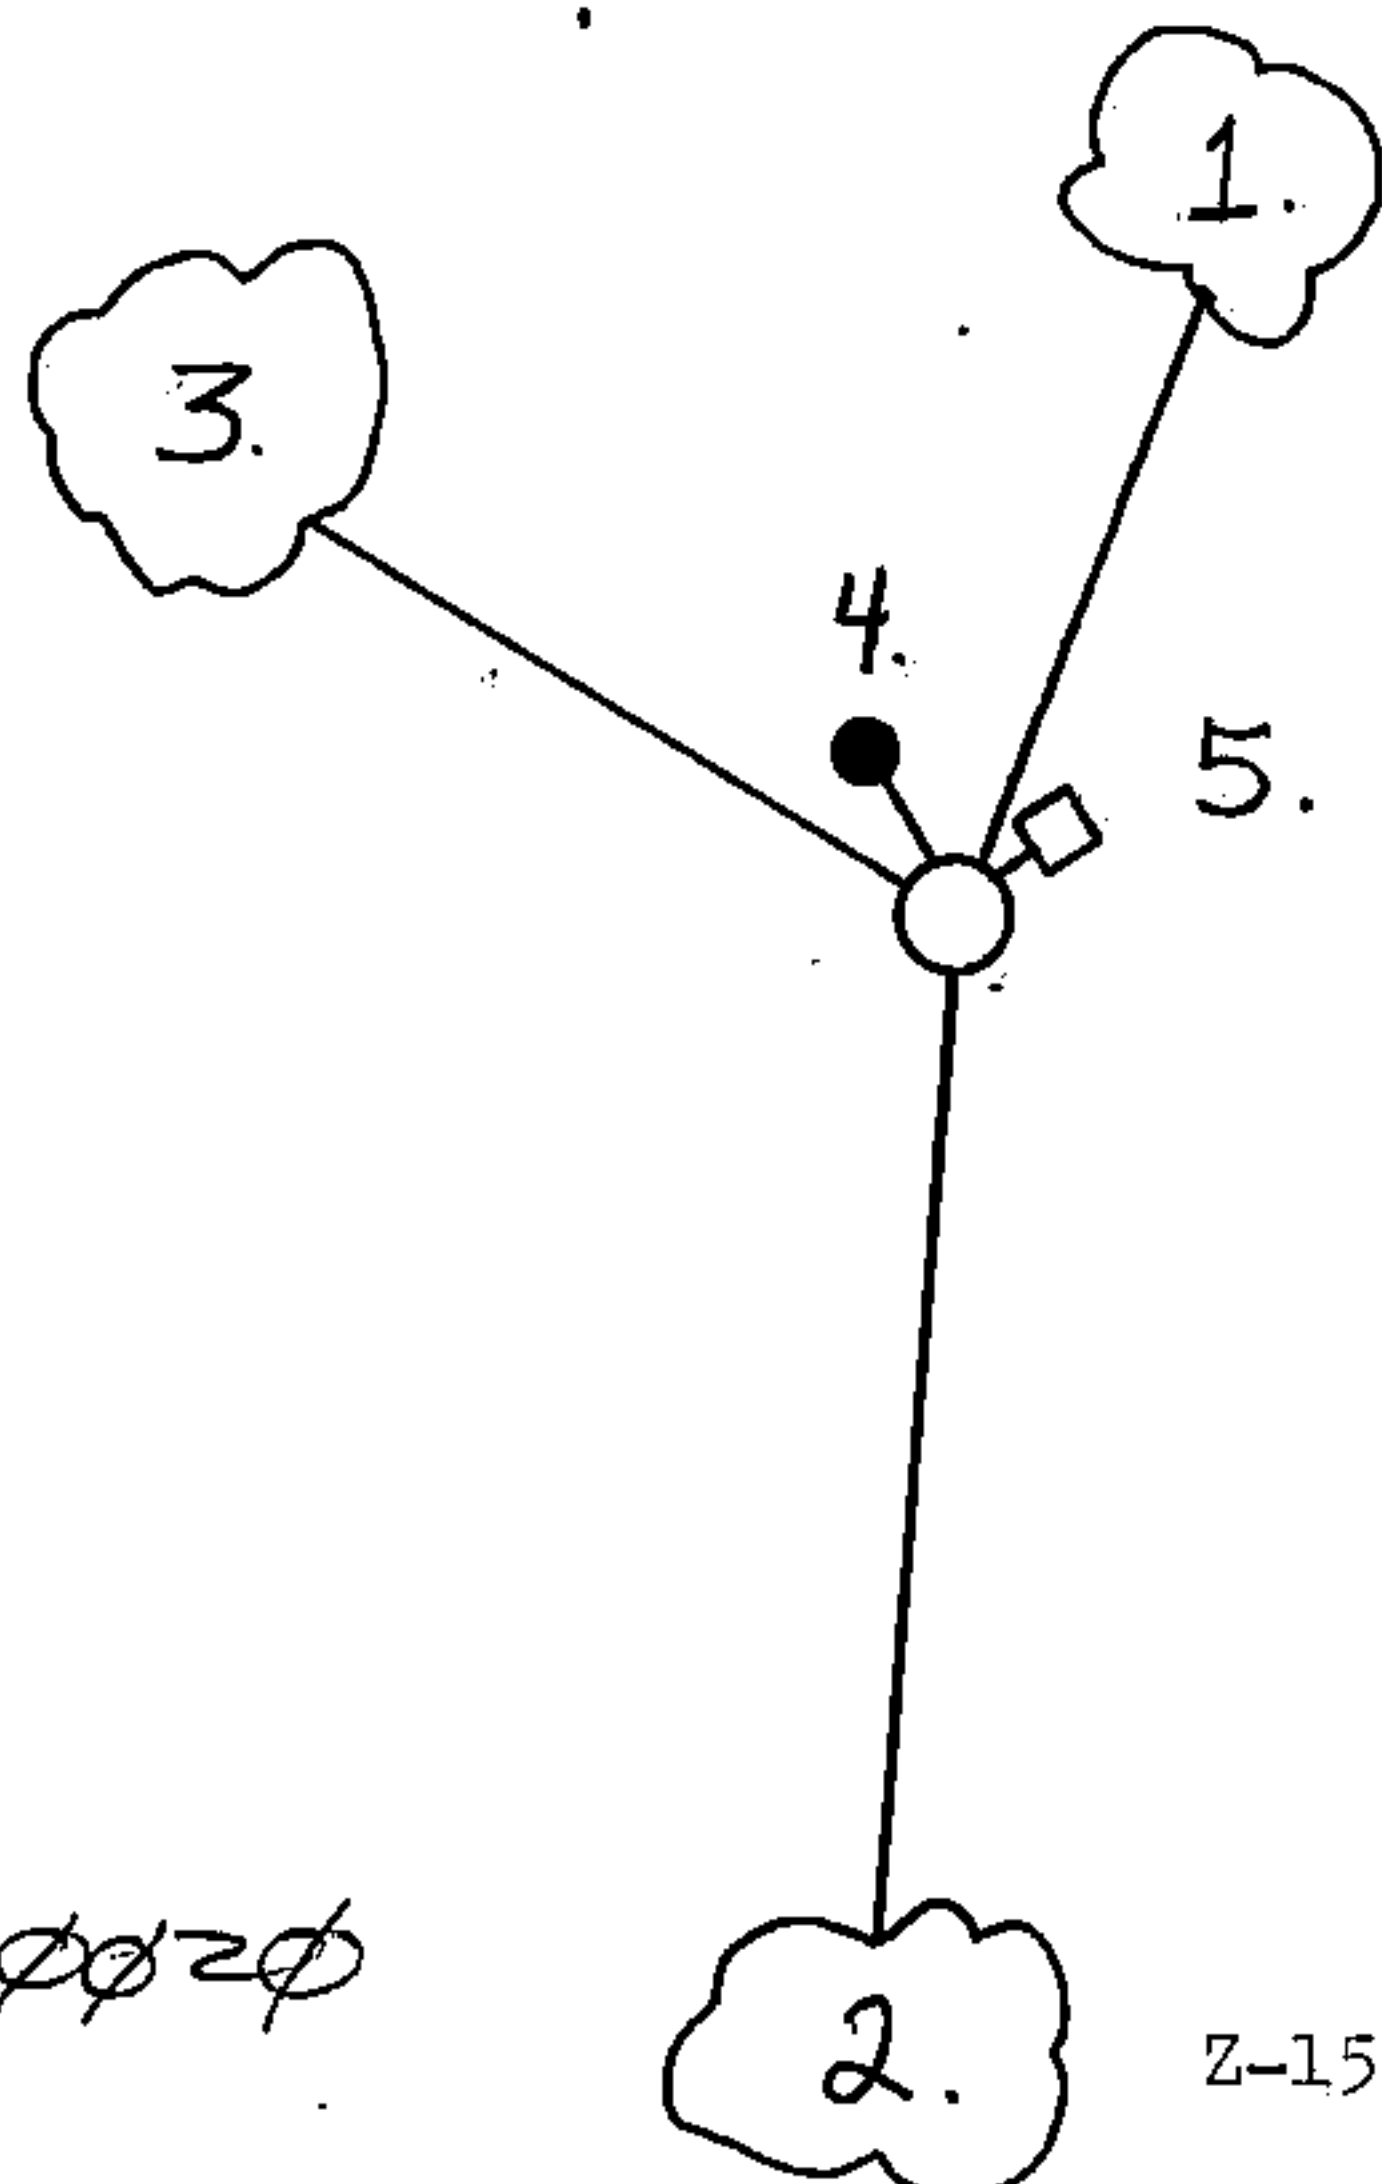
- (d) Show a plan view drawing depicting the relevant monuments and reference ties which is sufficient in detail to enable accurate relocation of the corner monument if the corner monument is disturbed. Indicate north.

1. Sugar Maple, 5", N.19°E., 22.79 feet
2. Sugar Maple, 10", S.06°W., 78.53 feet
3. Basswood, 9", N.51°W., 47.47 feet
4. 2" x 18" flue pipe, N.38°49'15"W., 7.00 feet
5. Steel Sign Post, 7', Northeast, 1.3 feet

Goodman's flue pipe was to be set at single proportion position--it was found to be N.38°49'15"W., 7.00 feet out of its proper position.

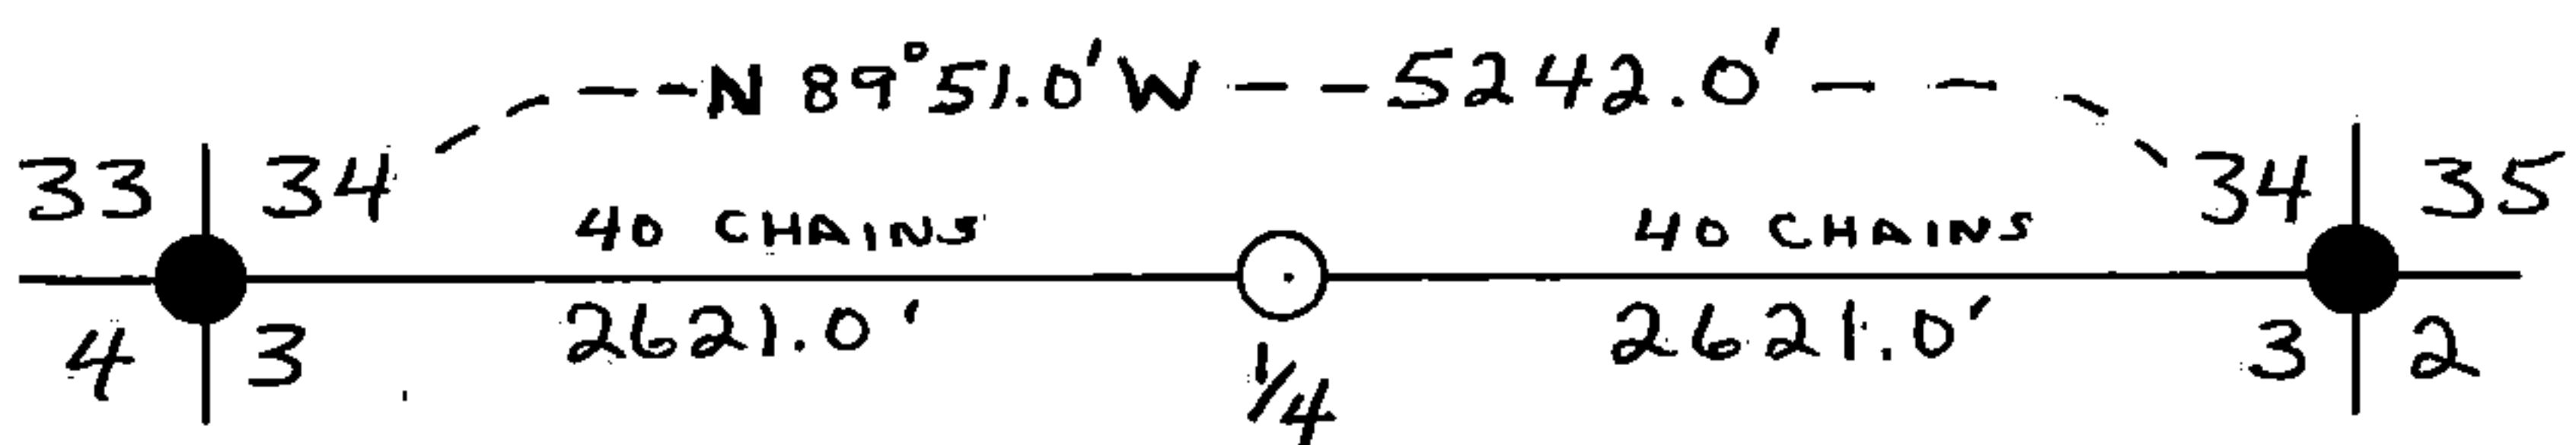
- (g&h) Was the corner reestablished through lost corner proportionate methods? If so, show the method, including the directions and distances to other public land survey corners used as evidence or used for proportioning in determining the corner location?

Single proportionate measure.
