CERTIFIED LAND CORNER RESTORATION

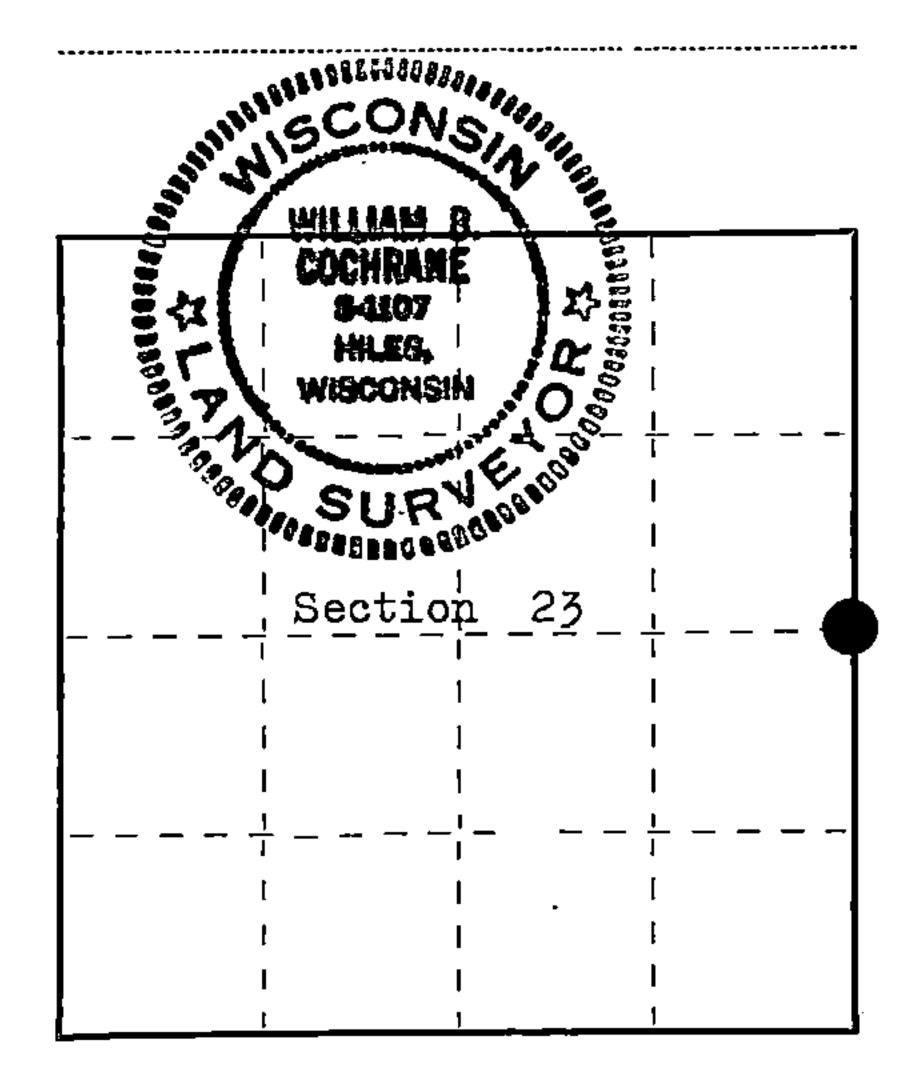
O = Corner monument restored.

No evidence of the corner was found. New road construction would have destroyed and corner evidence. Using the road center line for control in longitude, I set the corner at the midpoint between the Section Corners. This agrees with the original location of the road before construction.

Description of monument and accessories I established to perpetuate the original location of this corner.								
At the corner position, I set a 1" inside diameter, galvanized								
pipe, 30 inches long, 4 inches below the road surface. I set								
a 2½" Berntsen, A-1 Federal monument S 86° 08' 37" W, 100.00 feet,								
with cap stamped:

T37N R12E, 14, S23, S24, 1977, S-1107, REFERENCE CORNER 100FT From the iron pipe: A Maple, 12", Bears S 53° E, 76.00 feet N 00° 53' 07" W, 2675.02 to the Northeast Section Corner of Section 23

S 00° 41' 24" E, 2675.02 to the Southeast Section Corner of Section 23
