Sheet 1 of 6

# PLAT OF SURVEY FOR CERTIFIED LAND CORNER RESTORATION AND ESTABLISHMENT

BEING THE CORNERS FOR THE NI/2 OF THE NWI/4, THE NE I/4, THE NW I/4 OF THE SE I/4, THE SI/2 OF THE SE I/4 AND THE SWI/4, SECTION 18, T40N RIJE, FOURTH PRINCIPAL MERIDIAN

COUNTY OF FOREST, STATE OF WISCONSIN

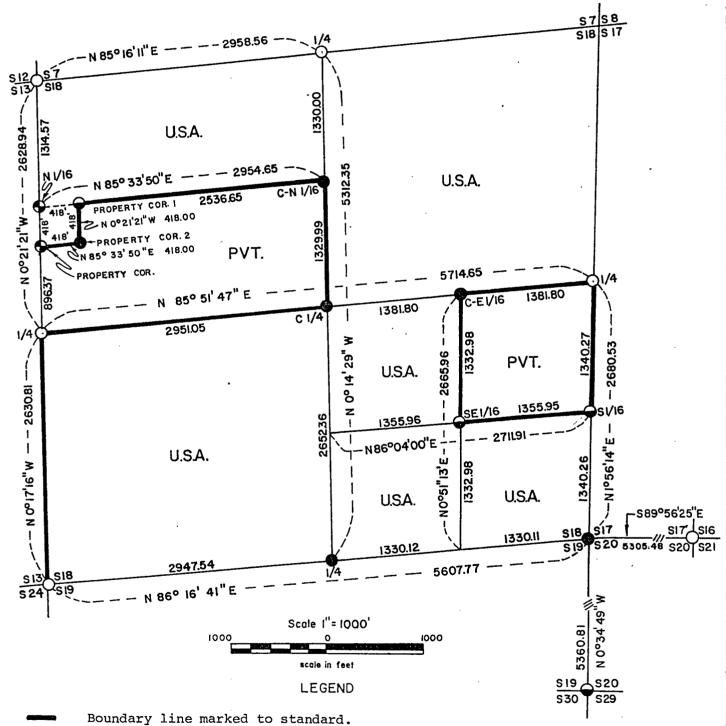
- boundary rine marked to standard.
- 2½ inch diameter aluminum pipe monument, 36 inches long with an aluminum cap stamped to identify the corner.
- 2½ inch diameter aluminum pipe monument, 60 inches long with an aluminum cap stamped to identify the corner.
- O General Land Office Dependent Resurvey Monuments.
- 2 inch diameter aluminum pipe monument, 36 inches long with an aluminum cap stamped to identify the corner.

NOTE: Bearings are referenced to solar observations.

The bearings between corner positions are true bearings as determined by reference to solar observations. The accuracy of this survey exceeds the State requirements of 1 in 3000.
