U. S. PUBLIC LAND SURVEY MONUMENT RECORD

CENTER EAST 1/16 CORNER TO SECTION 12,
TWP. 34 N., R.14 E.

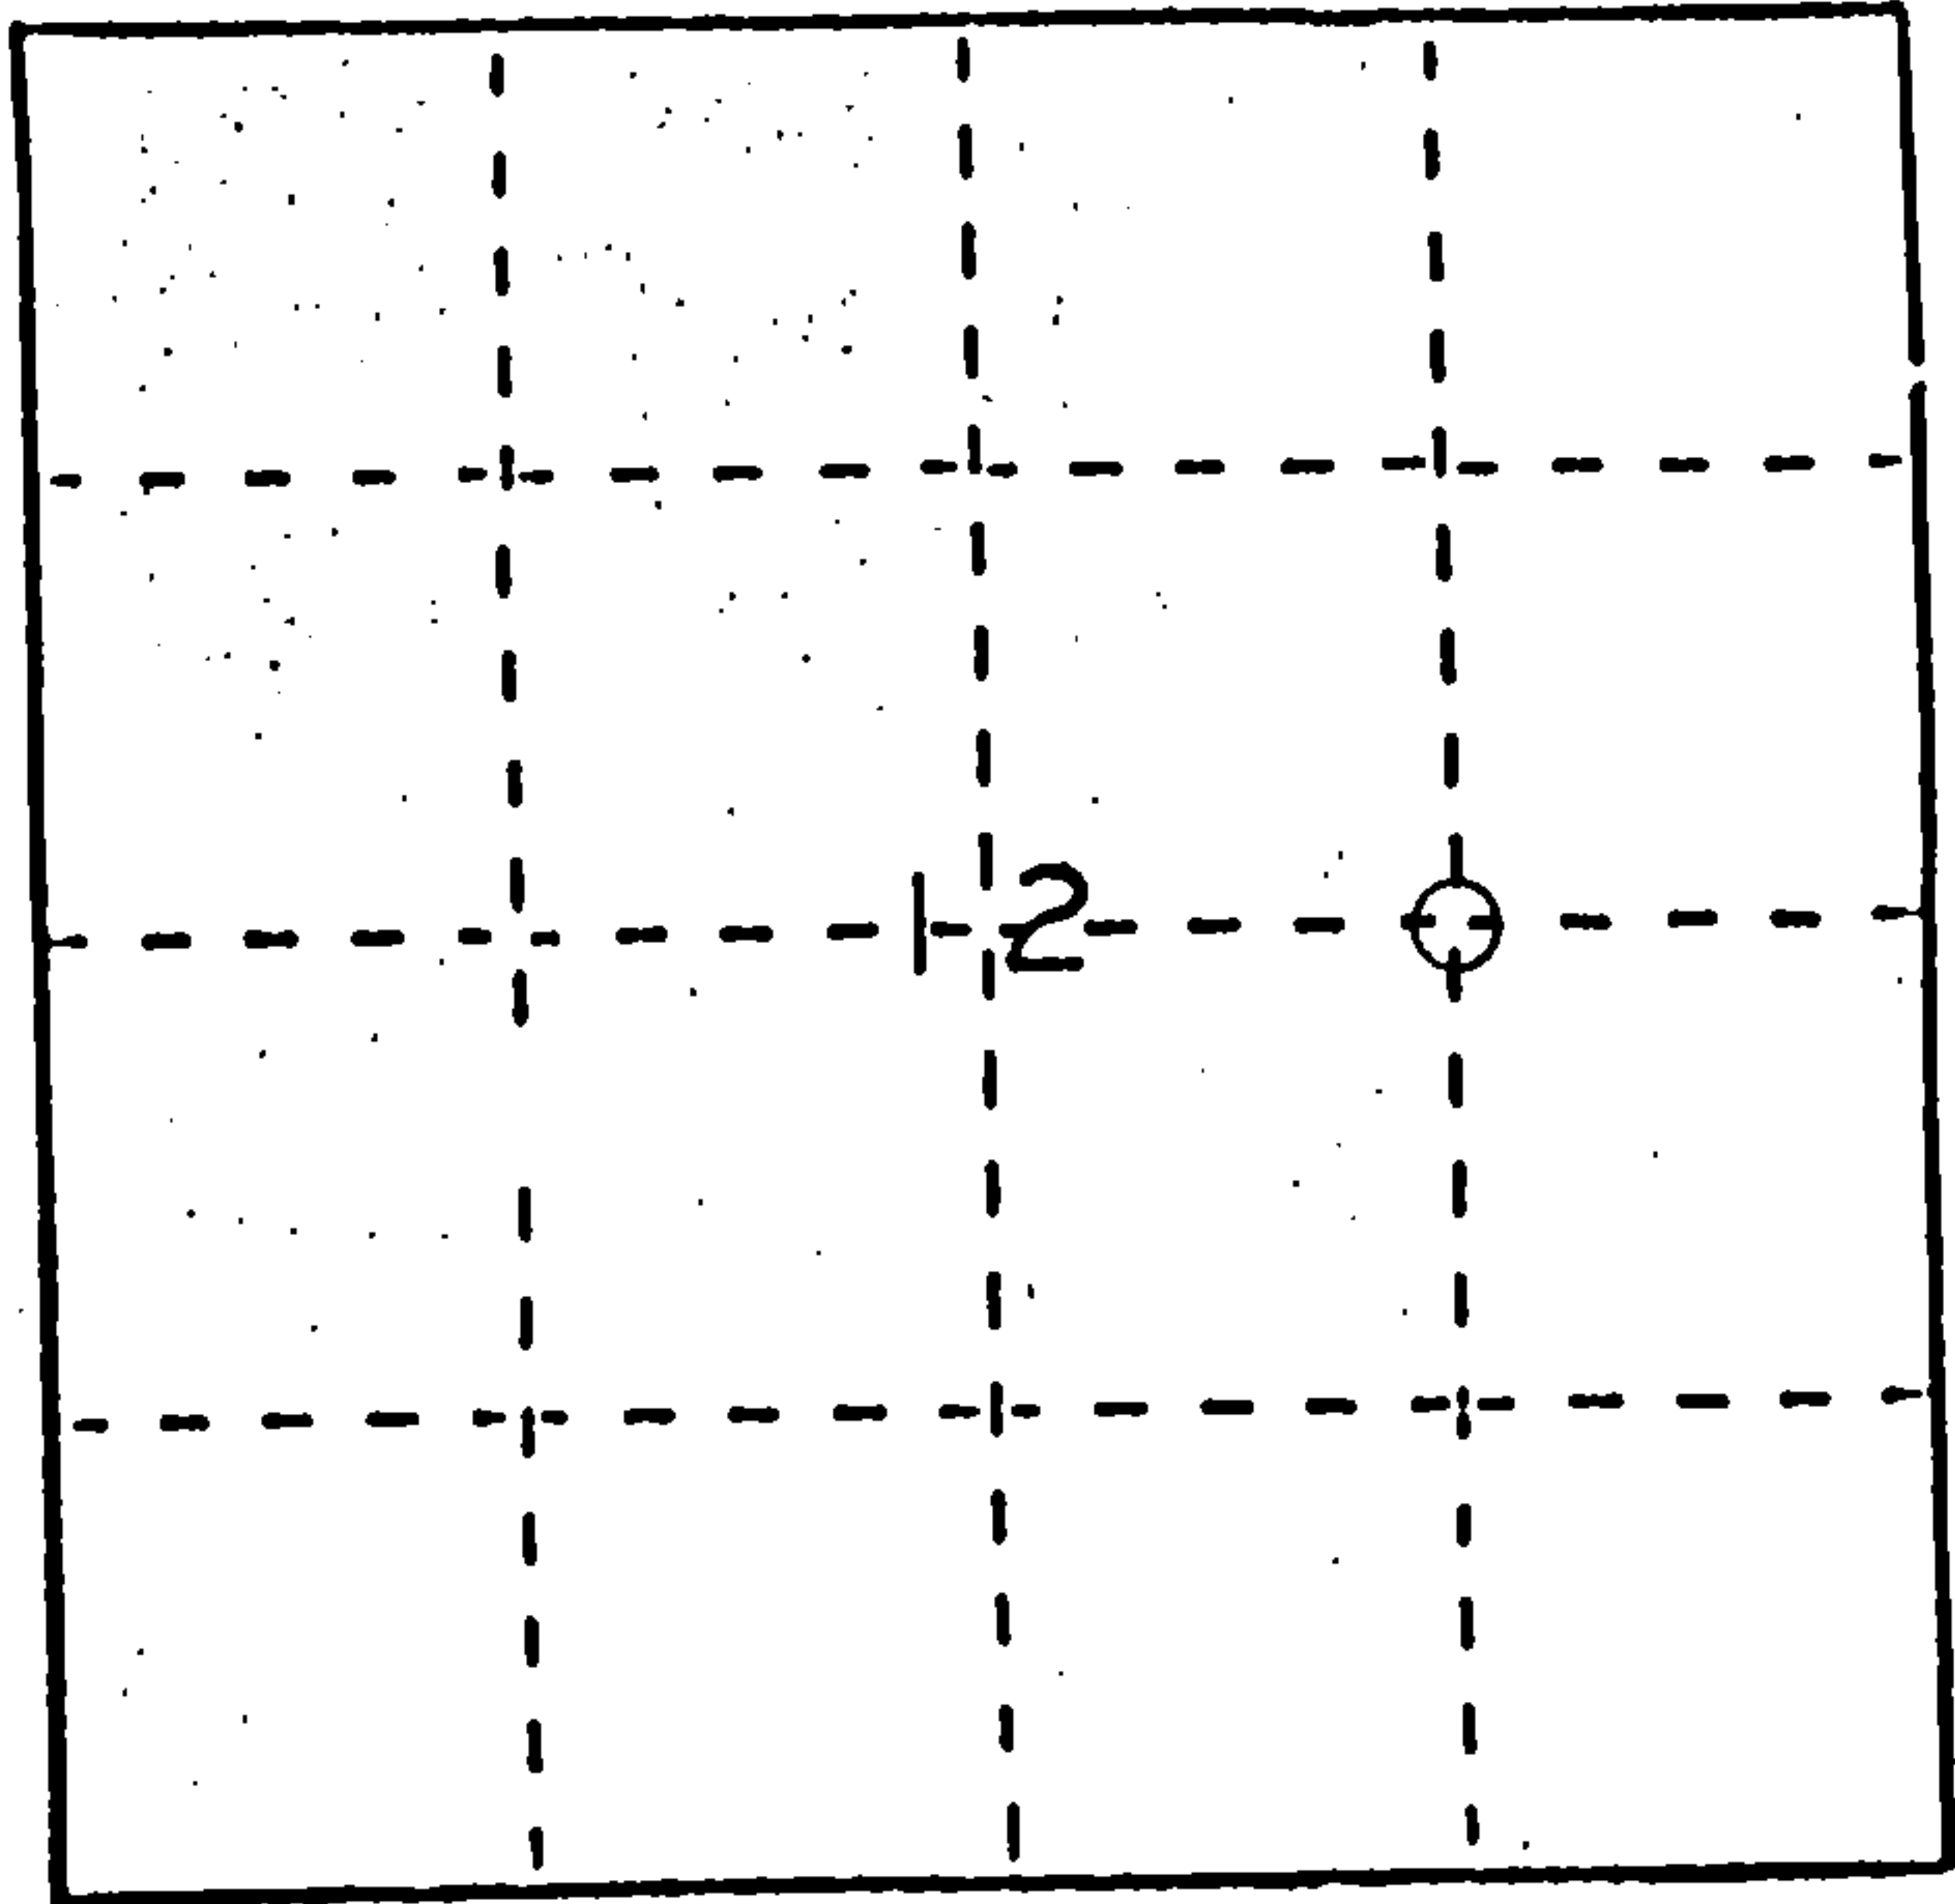
- (a) Identify the corner by reference to the U.S. public land survey system.
○ = Corner monument restored.

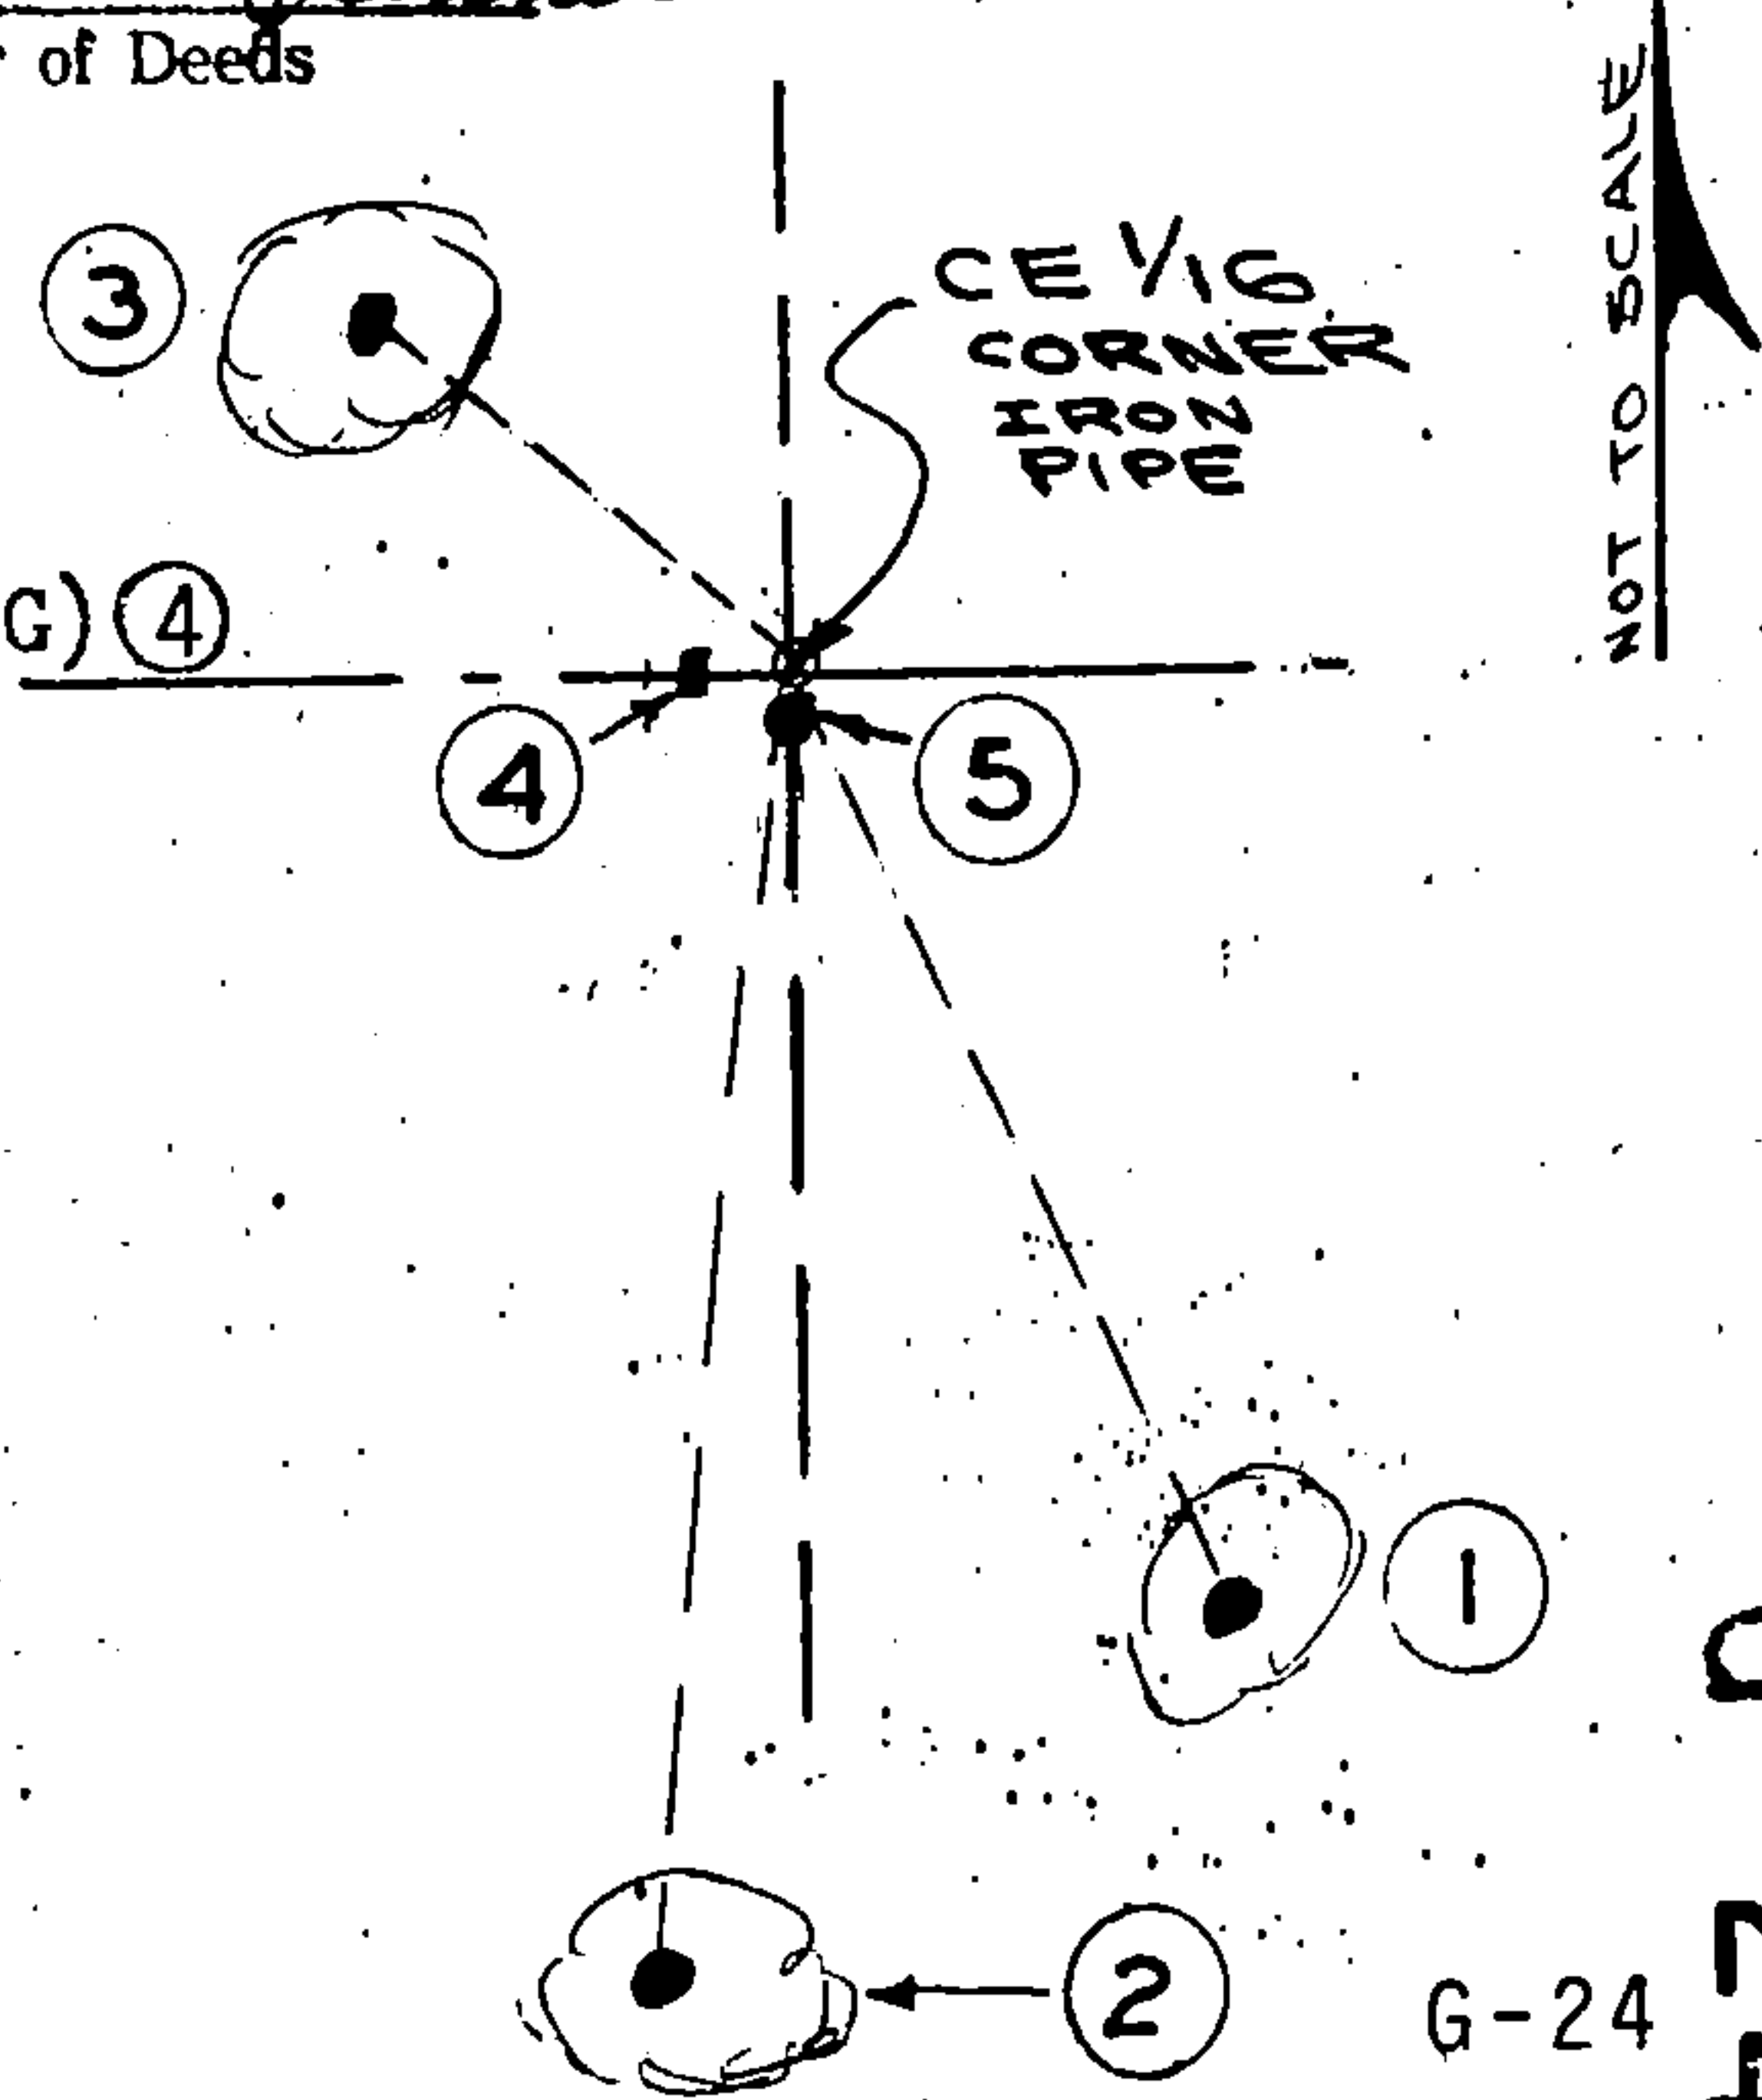
- (d) Show a plan view drawing depicting the relevant monuments and reference ties which is sufficient in detail to enable accurate relocation of the corner monument if the corner monument is disturbed. Indicate north.

- B.T.s SUGAR MAPLE 9" S.25° E. 33.57FT. (EXISTING) ①
SUGAR MAPLE 9" S.9° W. 52.6 FT. (EXISTING) ②
SUGAR MAPLE 7" N.51° W. 17.25 FT. (EXISTING) ③
WITNESS MONUMENTS STEEL SIGN POST WEST 4.32 FT. (EXISTING) ④
1" X 36" ALUMINUM MONUMENT 1.28 FT. ⑤
SOUTH OF CENTER EAST 1/16 CORNER,
STAMPED TO IDENTIFY CORNER

NOTE! UNABLE TO SET MONUMENT AT TRUE CORNER
DUE TO BOULDER 10" BELOW SURFACE!
SET 1" DIAMETER IRON PIPE IN ROCK
PILE OVER BOULDER AT TRUE CORNER.

1857 & 1859 ORIGINAL SURVEY OF SECTION 12
1982 SUBDIVISION OF SECTION 12, BY STEFAN R.L.S. NO. S-1558,
SET 2" DIA. ALUMINUM MONUMENT AT CENTER EAST 1/16 CORNER
B.T.s SUGAR MAPLE 9" S.25° E. 33.57FT., SUGAR MAPLE 9" S.9° W.
52.6 FT., SUGAR MAPLE 7" N.51° W. 17.25 FT.
WITNESS STEEL SIGN POST WEST 4.32 FT.
1989 DOBBRATZ R.L.S. NO. S-973. FOUND B.T.s AND POST AS NOTED BY STEFAN
IN 1982, NO MONUMENT FOUND!
