U. S. PUBLIC LAND SURVEY MONUMENT RECORD

Quarter Corner common to Section 3, T36N-R16E,
 and Section 34, T37N-R16E

Index Number A-15 (T36N-R16E)

Forest County, Wisconsin

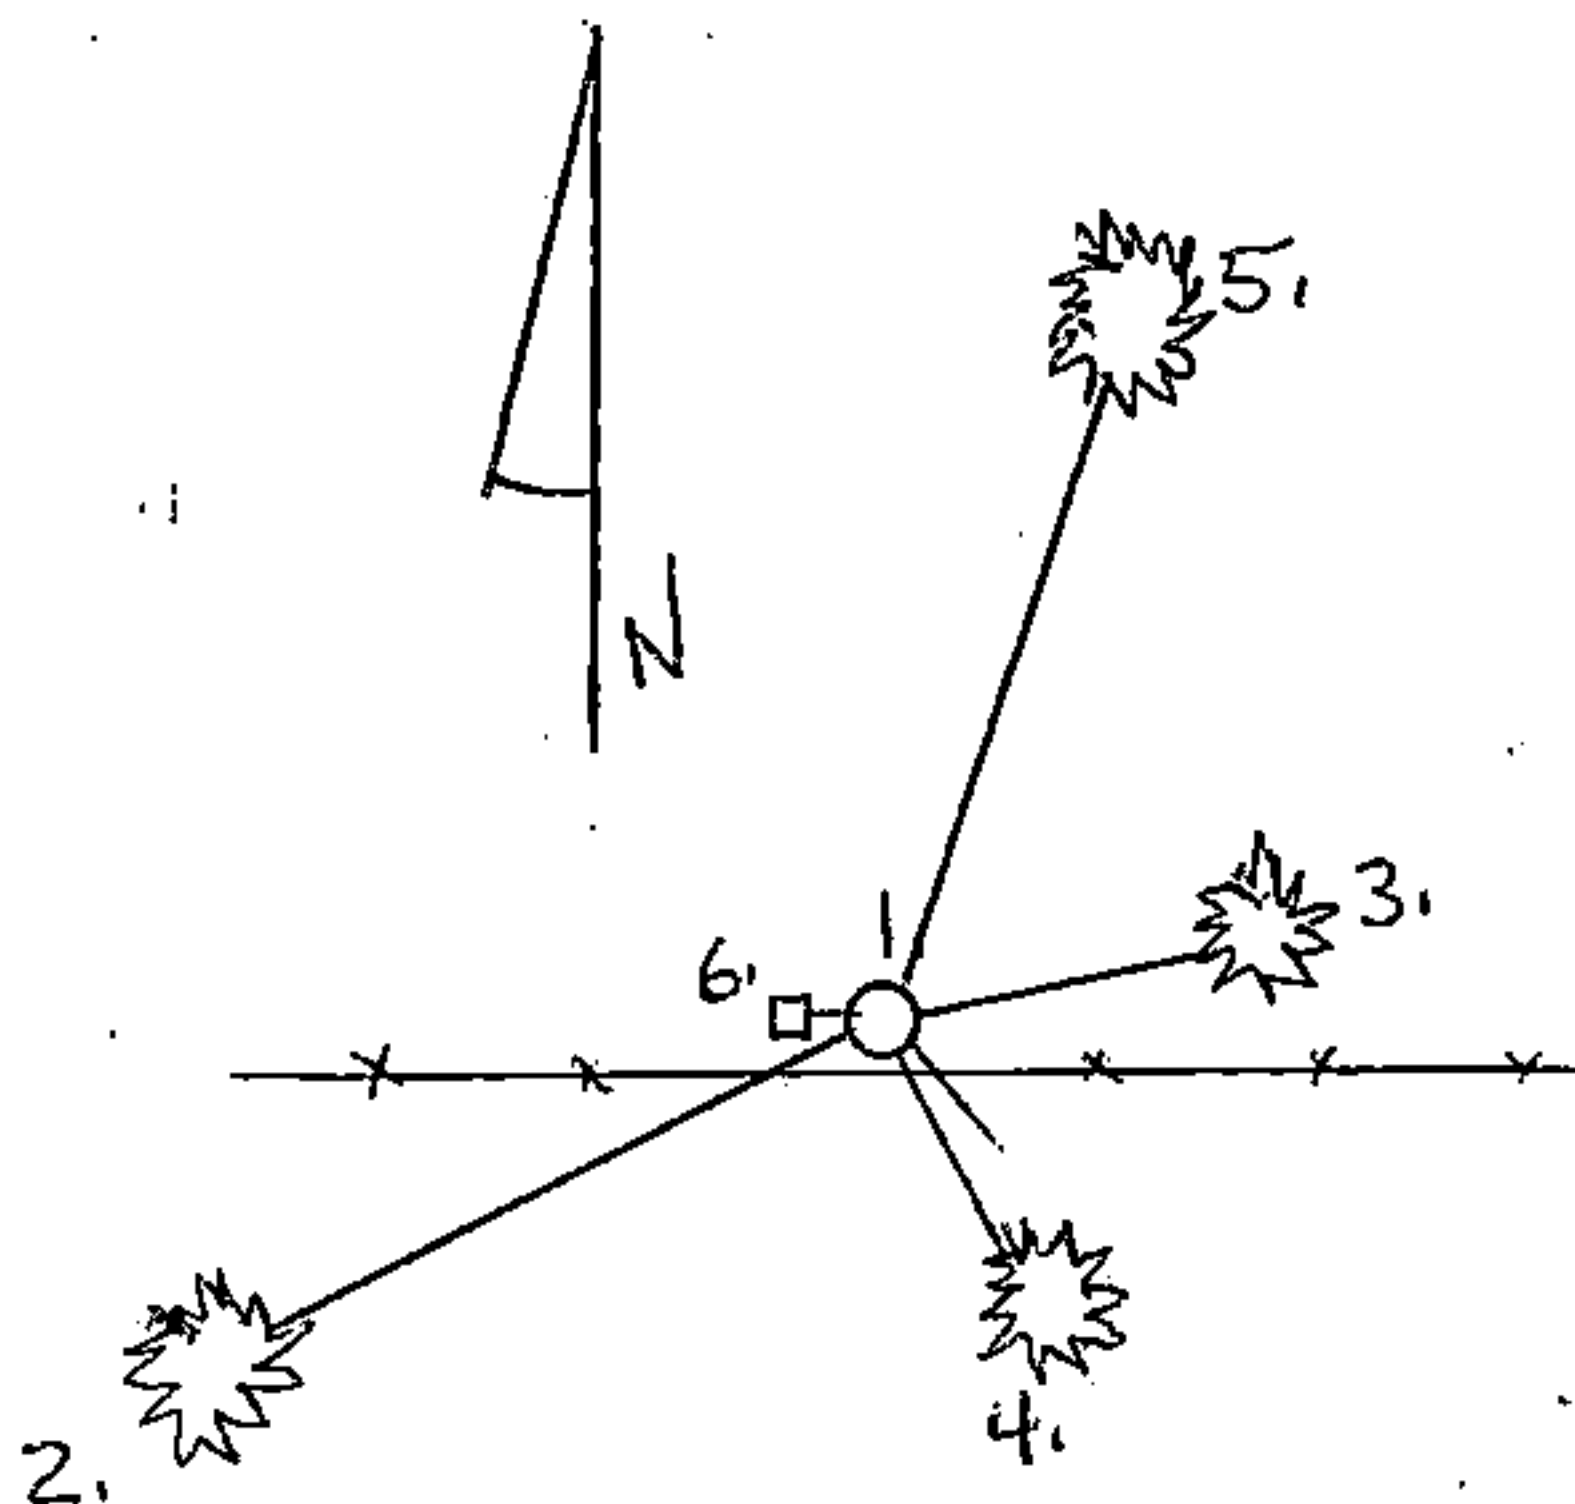
- (d) Show a plan view drawing depicting the relevant monuments and reference ties which is sufficient in detail to enable accurate relocation of the corner monument if the corner monument is disturbed. Indicate north.

- 2½" x 36" Aluminum monument with location stamped on cap.
- Black Spruce 5" S54°W 41.15 feet.
- Black Spruce 6" N83°E 10.70 feet.
- Black Spruce 6" S28°E 12.49 feet.
- Black Spruce 5" N34°E 52.26 feet.
- Steel sign post West 1.52 feet.

(a) Describe any material discrepancy between the location of the corner as restored or reestablished and the location of that corner as previously restored or reestablished by distance and direction. Show the discrepancy on the plan view drawing under (d), above. Show the distances between the corner as previously restored or reestablished and (1) the corner as restored or reestablished, and (2) to at least 2 of the witness monuments shown on the drawing in (d), above.
