Stock No. 26273

PLAT OF SURVEY FOR CERTIFIED LAND CORNER
RESTORATION AND ESTABLISHMENT
BEING THE CORNERS FOR THE SE1/4, SW1/4, NW1/4, SE1/4-NE1/4, AND
W1/2-NE1/4 OF SECTION 21, T.37N. R.15E., FOURTH PRINCIPAL MERIDIAN
COUNTY OF FOREST, STATE OF WISCONSIN

Sheet 1 of 5

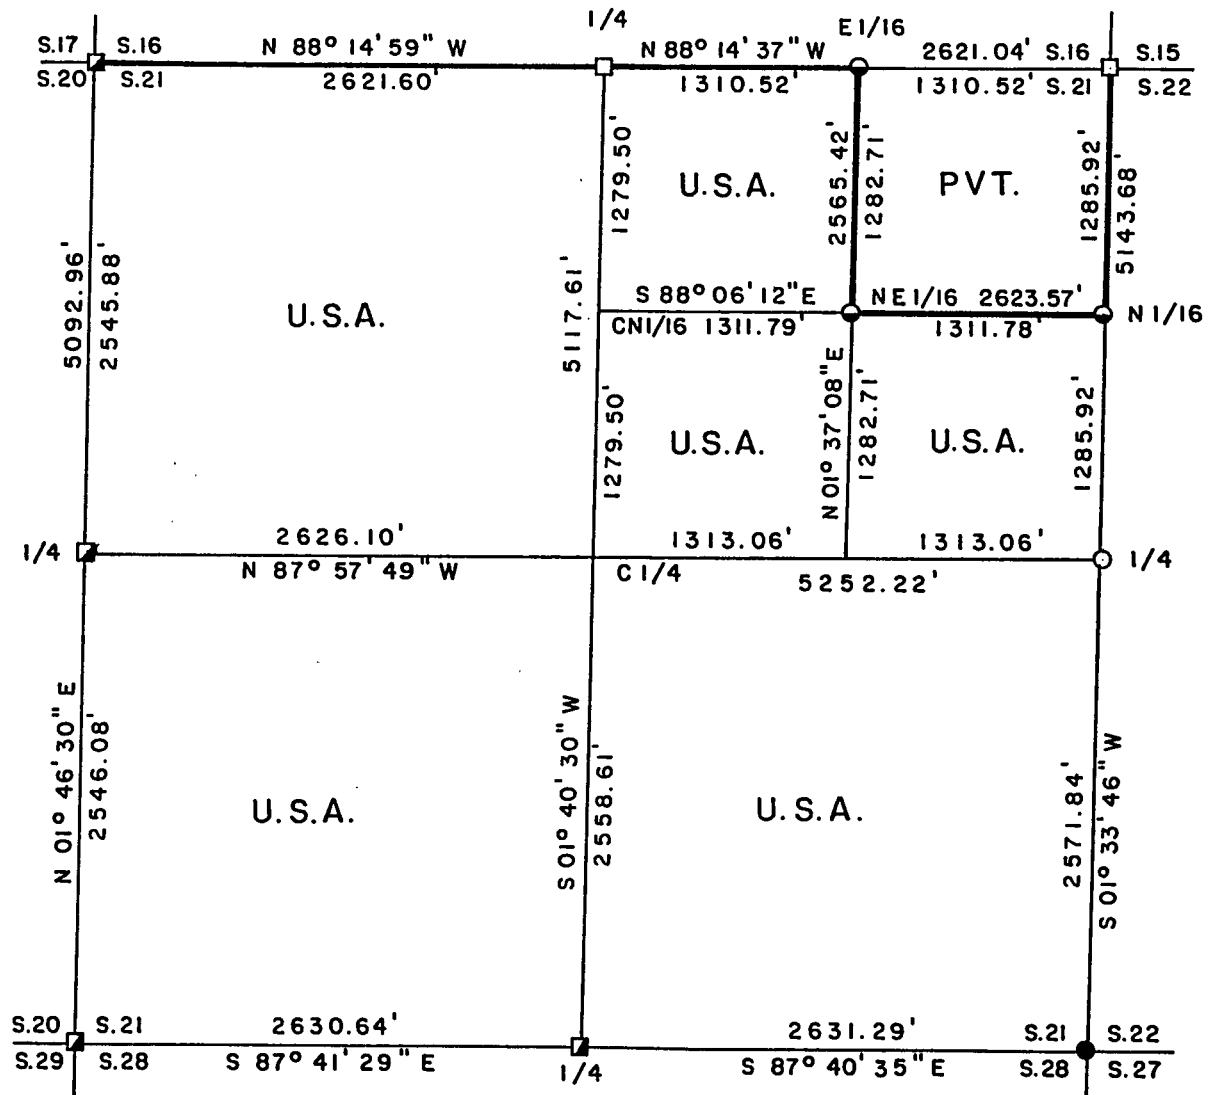
SCALE 1" = 1000'

This survey was made by Gary L. Pisoni, a Registered Land Surveyor in the State of Wisconsin, for the U.S.D.A., Forest Service, for the purpose of recovering, restoring, establishing, marking, and perpetuating the corners and boundary lines of U.S. Government Land on the perimeter and within Section 21, Township 37 North, Range 15 East, Fourth Principal Meridian, Forest County, State of Wisconsin, as shown on the plat map herewith.
