PLAT OF SURVEY FOR CERTIFIED LAND CORNER

RESTORATION AND ESTABLISHMENT

BEING THE CORNERS FOR THE NE 1/4 OF THE NE 1/4,  
THE SE 1/4 OF THE SE 1/4, THE EAST 1/2 OF THE SW 1/4  
AND THE CORNERS ON THE PERIMETER OF THE SECTION.

SECTION 14, TOWNSHIP 40 NORTH, RANGE 13 EAST.

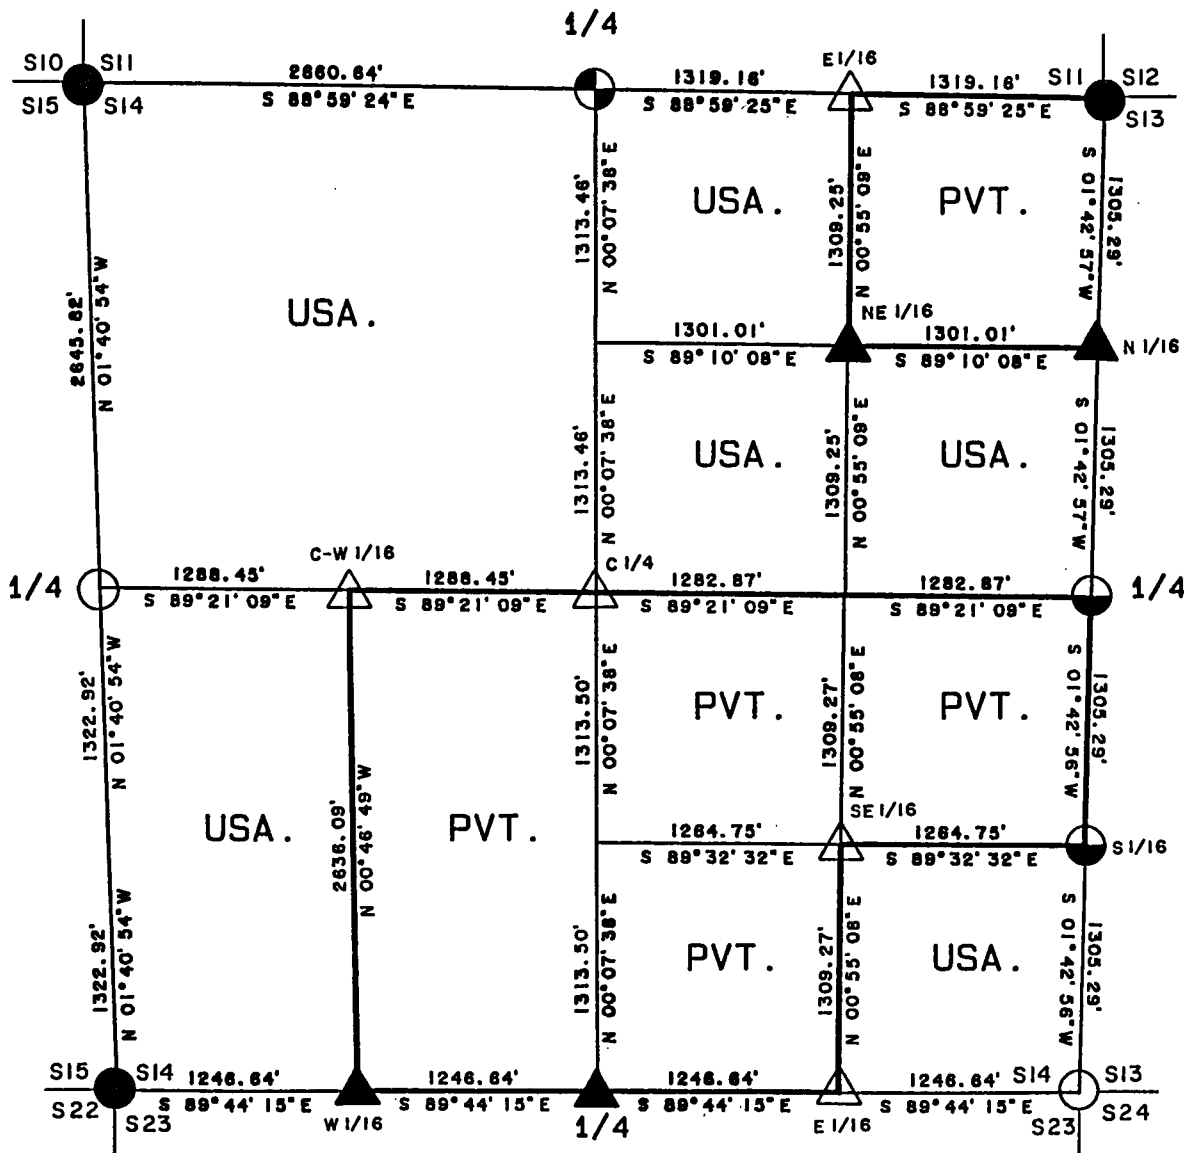
COUNTY OF FOREST, STATE OF WISCONSIN.

This survey was made by the U.S. Department of Agriculture, Forest Service for the purpose of recovering, restoring, establishing, marking, and perpetuating the corners and boundary line of U.S. Government land on the perimeter and within Section 14, Township 40 North, Range 13 East, Fourth Principal Meridian, Forest County, State of Wisconsin as shown on the plat map herewith.

The bearings between corner positions are referenced to the East line of Section 25 as previously surveyed. No curvature corrections have been applied to the bearings in Section 14. The accuracy of this survey exceeds the State of Wisconsin requirement for closure of 1 part in 3000. Corners recovered or established by this survey are marked as described in the map legend. Each monumented corner is referenced to blazed, scribed, painted and tagged bearing trees. Tie bearings to the bearing trees are magnetic and are not corrected for declination.
