U. S. PUBLIC LAND SURVEY MONUMENT RECORD

Quarter Corner to Sections 23 and 24, T.34 N., R.14 E.

REGISTER'S OFFICE
Forest County, Wis.

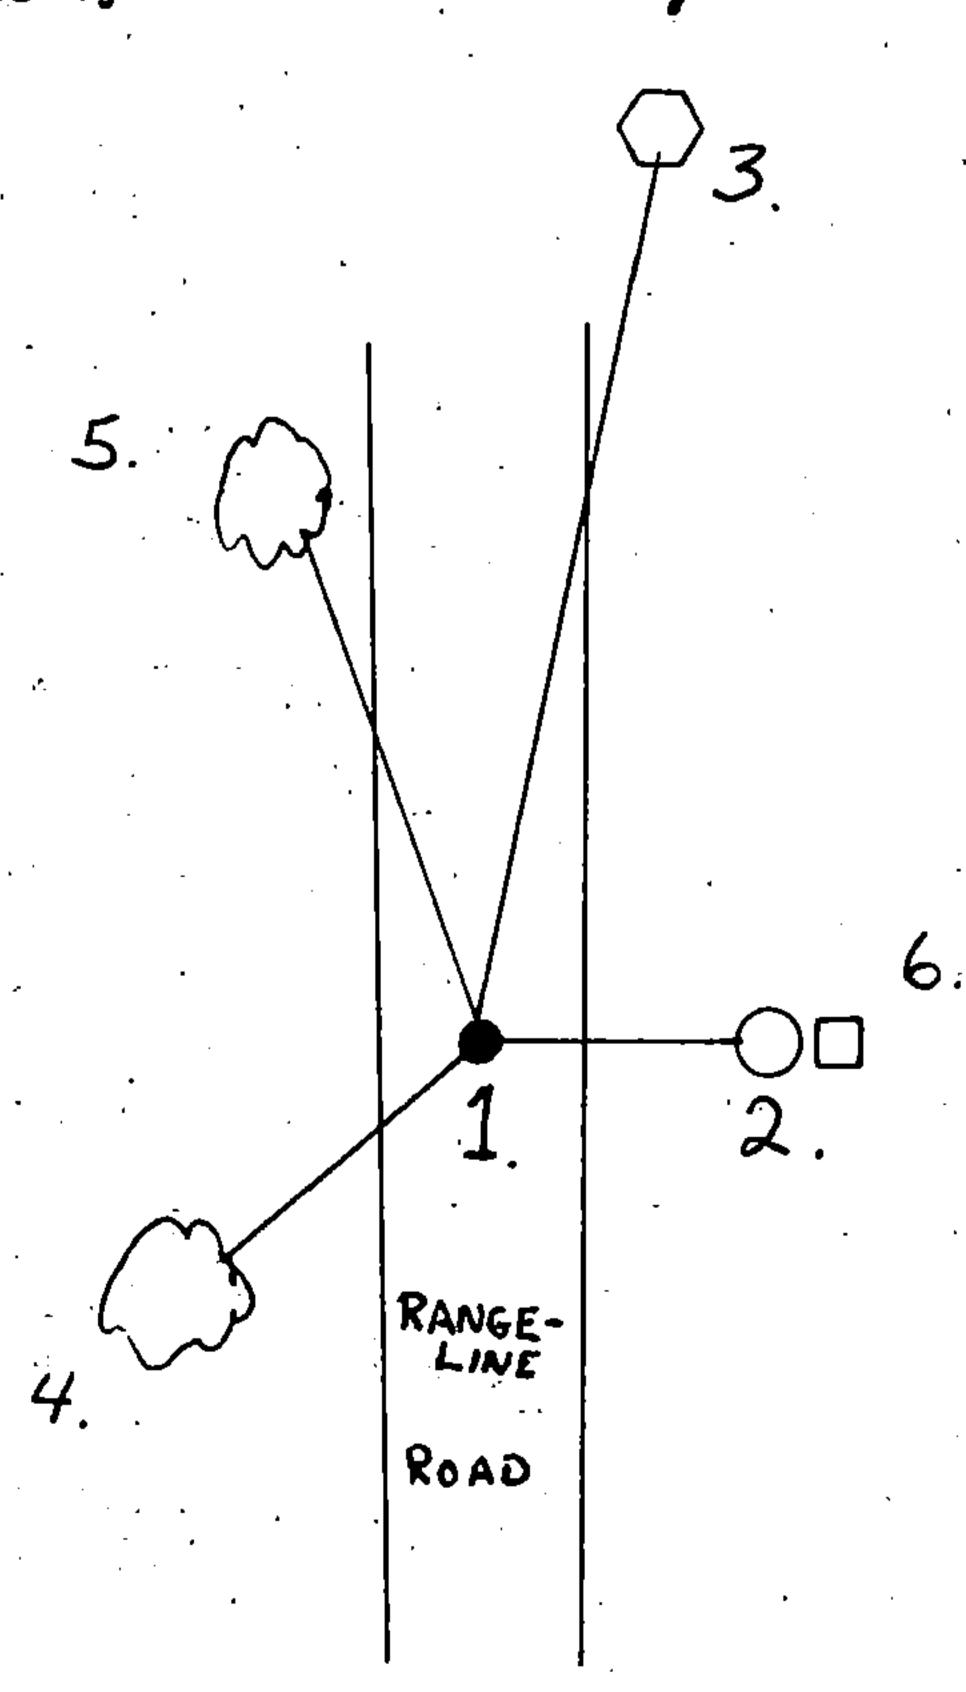
Describe witness monuments.
- (d) Show a plan view drawing depicting the relevant monuments and reference ties which is sufficient in detail to enable accurate relocation of the corner monument if the corner monument is disturbed; Indicate north.
 - 1. R.R. Spike in road surface as corner position.
 - 2. $2\frac{1}{2}$ ' x 36" aluminum monument stamped as witness corner. East, 26.10 feet.
 - 3. Power Pole (3414-24W5), N11E, 205.13 feet.
 - 4. Aspen.; 5" S47W, 29.79 feet.
 - 5. Aspen, 7" NO8W, 87.49 feet.
 - 6. Steel Sign Post, 6', East, 26.94 feet.
