U. S. PUBLIC LAND SURVEY MONUMENT RECORD

Quarter corner to Sections 11 and 14, T.34N., R.16E.

Quarter Corner between Sections 11 & 14; T.34N., R.16E., 4th P.M.

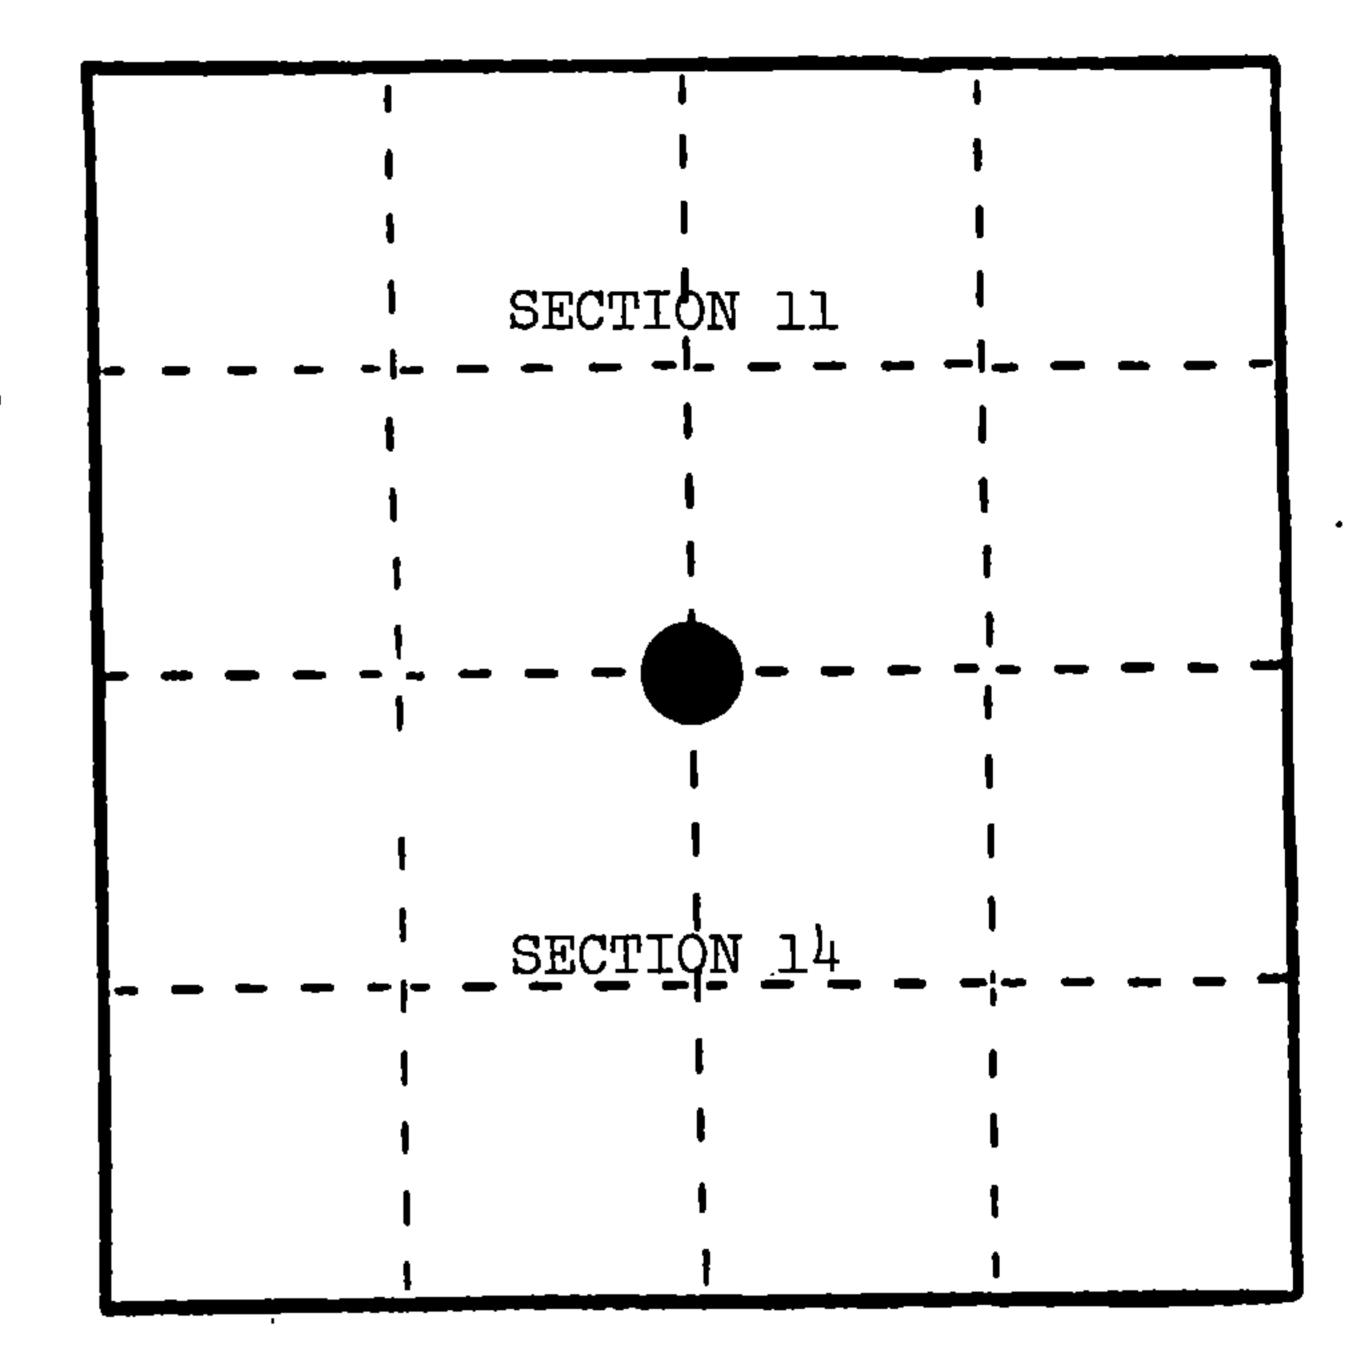
In 1858, James McBride set wood post with the following BTs: Birch, 14", S.61°W., 18 links; Sugar, 12", N.2°W., 20 links.

March, 1984, Alan Harrison set proportionate position--searched area, found no evidence of corner.

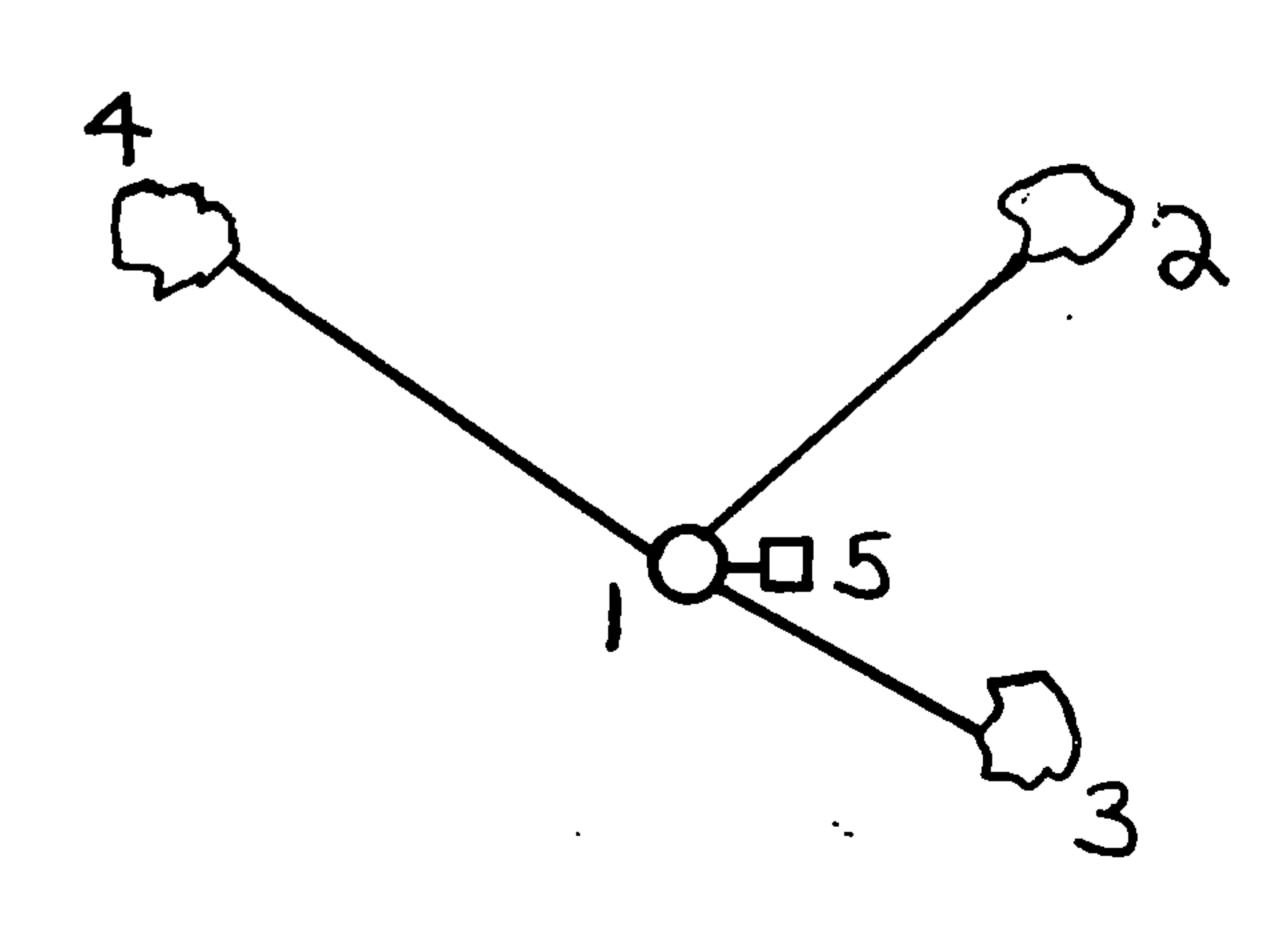
Describe witness monuments.
- (d) Show a plan view drawing depicting the relevant monuments and reference ties which is sufficient in detail to enable accurate relocation of the corner monument if the corner monument is disturbed. Indicate north.
- 1. 2" x 36" aluminum monument stamped to identify the corner.
- 2. Black Cherry, 5", N.25°E., 45.01'

3. Aspen, 7", S.47°E., 27.23'

4. White Spruce, 6", N.53°W., 55.44'

5. Steel Sign Post, East, 2.1'

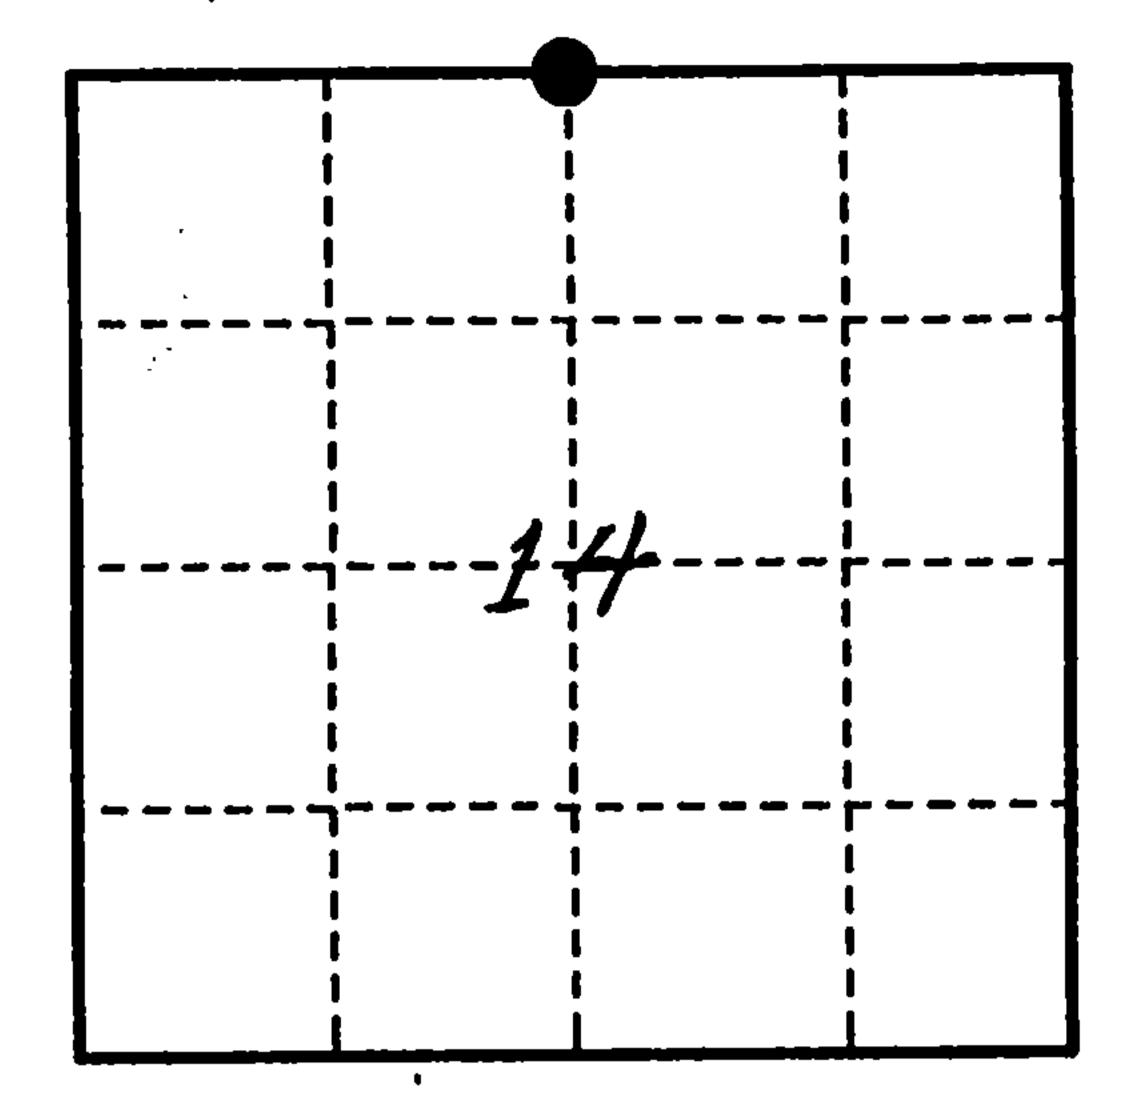
Found 2 1/2" aluminum monument with sign post and two BTs in good condition. We made one new BT: Balsam Fir, 5", N.76°E., 21.29'

This corner was restored by myself in 1983.
