U. S. PUBLIC LAND SURVEY MONUMENT RECORD

Section corner to Sections 17, 18, 19, and 20, T.35N., R.16E.

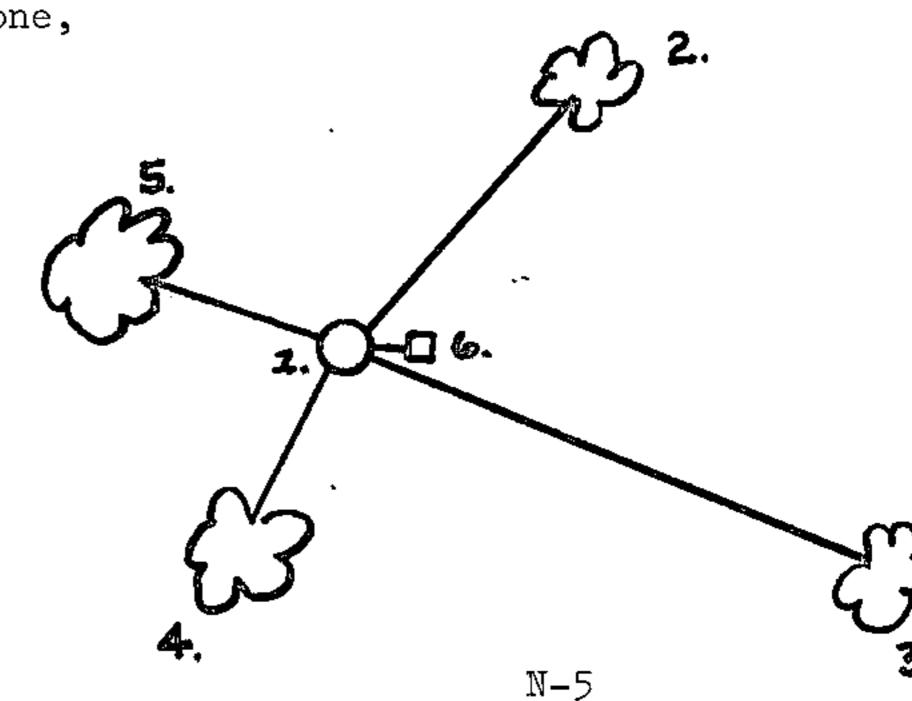
Describe witness monuments.
- (d) Show a plan view drawing depicting the relevant monuments and reference ties which is sufficient in detail to enable accurate relocation of the corner monument if the corner monument is disturbed. Indicate north.
- 1. 2" x 36" aluminum monument, in a mound of stone, stamped to identify the corner.
- 2. Sugar, 6", N.33°E., 54.79 feet
- 3. Sugar, 7", S.72°E., 90.66 feet
- 4. Sugar Clump, 4", S.22°W., 29.16 feet
- 5. Basswood, 5", N.77°W., 21.88 feet
- 6. Steel Sign Post, East, 1.96 feet
