CERTIFIED LAND CORNER RESTORATION

U. S. PUBLIC LAND SURVEY MONUMENT RECORD

- (a) Identify the corner by reference to the U.S. public land survey system.
 ○ = Corner monument restored.
 Quarter Corner common to Sections 28 and 33,
 T.39N., R.14E., Forest County, Wisconsin

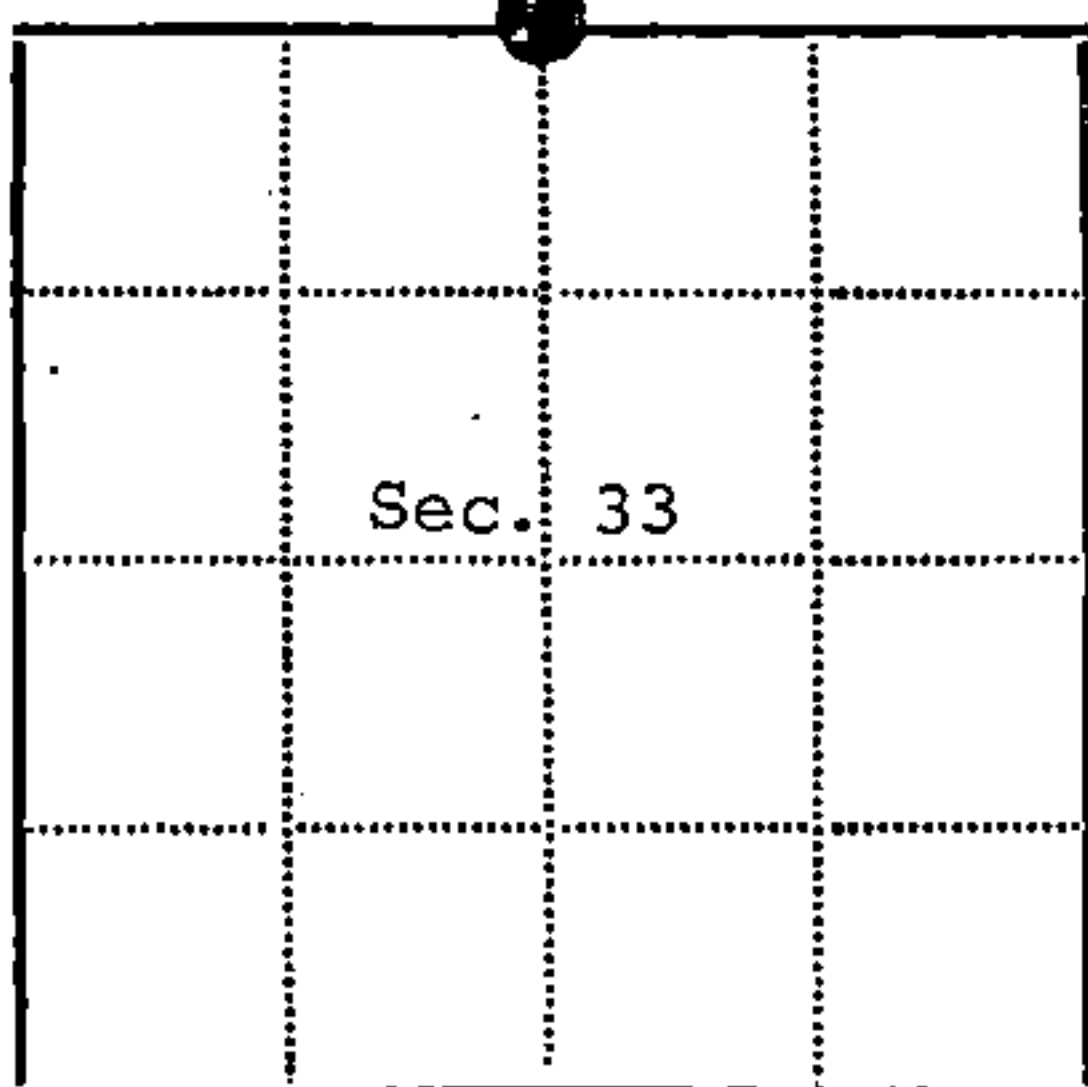
I replaced the wood post with a 2 inch inside diameter, galvanized pipe, 3 feet long, filled with concrete with a brass cap stamped: T39N, R14E, 1/4, S28, S33, 1975, S-1107, From which the following bear:
Hemlock, 21", S41°E, 50.40 feet
Norway pine, 26", N.27°W., 28.96 feet
Set a steel sign post, 2.0 feet, southeast of the monument.
Bastile Lake bears North, 94 feet to south shore.

⊙ - Corner monument restored
□ -

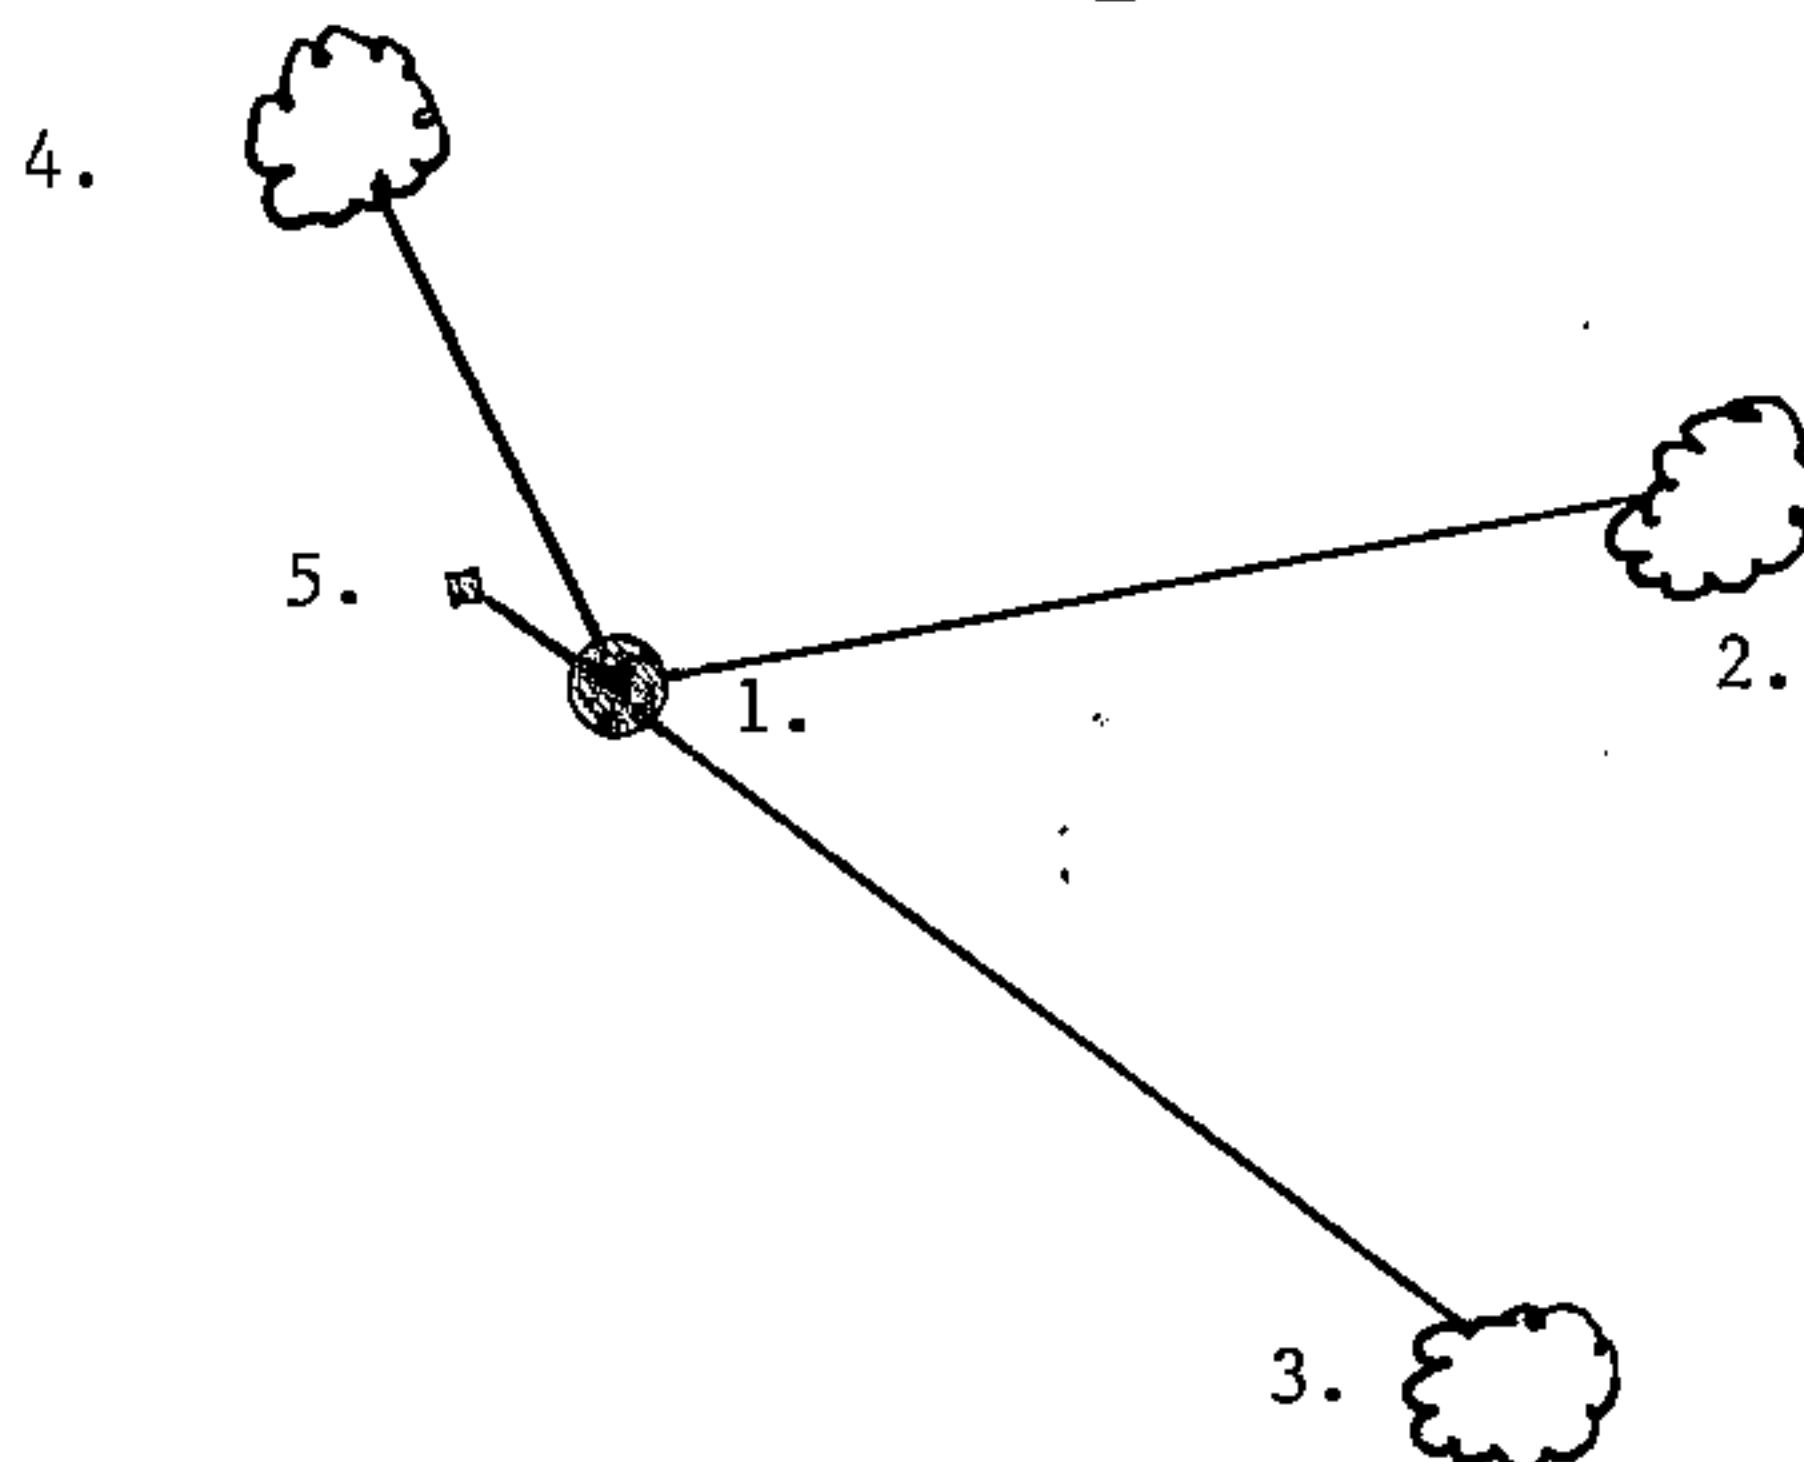
6. Bastile Lake

1. 1"x36" aluminum monument stamped to identify corner
2. Hemlock, 12", N.80°E., 45.40 feet (NEW BT)
3. Hemlock, 21", S.41°E., 50.40 feet
4. Red Pine, 26", N.27°W., 28.96 feet
5. Steel Sign Post, Northwest, 1.50 feet
6. South Shore of Bastile Lake, North, 94.00 feet

In 1977, Alan Harrison, RLS, found monument and steel sign post are gone. Set a 1"x36" aluminum monument with an aluminum cap stamped to identify corner. Made 1 new bearing tree as described below.
