U. S. PUBLIC LAND SURVEY MONUMENT RECORD

Quarter corner common to Sections 5 and 6,
T36N, R16E.

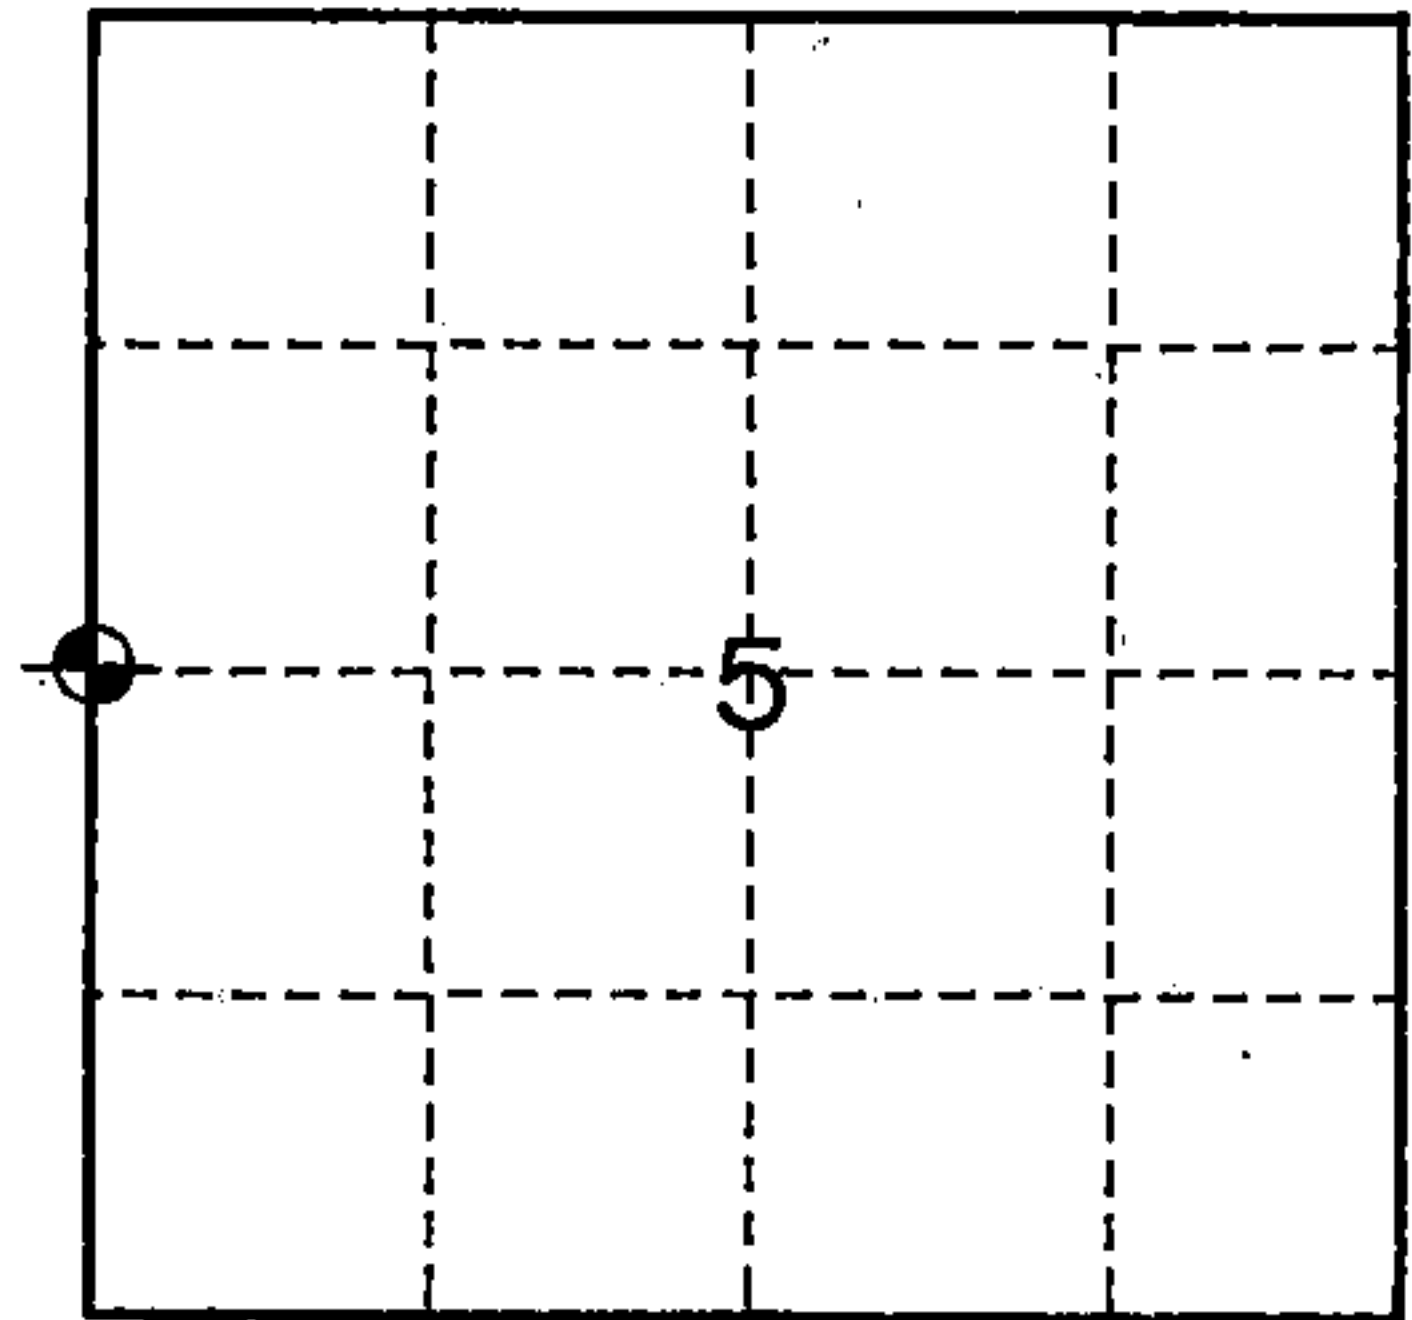
In 1858, James McBride, Deputy Surveyor, set a wood post with the following B.T.'s:
Cedar - 8" - S55°W, 38 links (25.08 feet); Spruce - 12" - N85°E, 22 links (14.52 feet).

In 1981, Milo Stefan, RLS 1558, found two fallen and very rotten posts with a picket alongside. He also found the decayed remains of the spruce bearing tree at record bearing and distance from the post and picket. A scribed 8" cedar bears N31°W, 15.2 feet and blazed lines run north and east. He replaced the post with a 2" x 60" aluminum monument with a stamped tablet.

In 1993, John Garske, RLS, found Stefan's aluminum monument in good condition.

- 1- Found aluminum monument with tablet stamped to identify corner.
- 2- Cedar - 11" - N35°W - 13.80 feet
- 3- Hemlock - 9" - N85°E - 32.65 feet
- 4- Cedar - 8" - S10°W - 16.07 feet
- 5- Steel sign post - 6' - NE'ly - 1.75 feet
